# **MOUNT POLLEY MINE AUGUST 2014 TAILINGS DAM EMBANKMENT BREACH RESPONSE AND APPROACH TO REMEDIATION**

## **ABSTRACT**

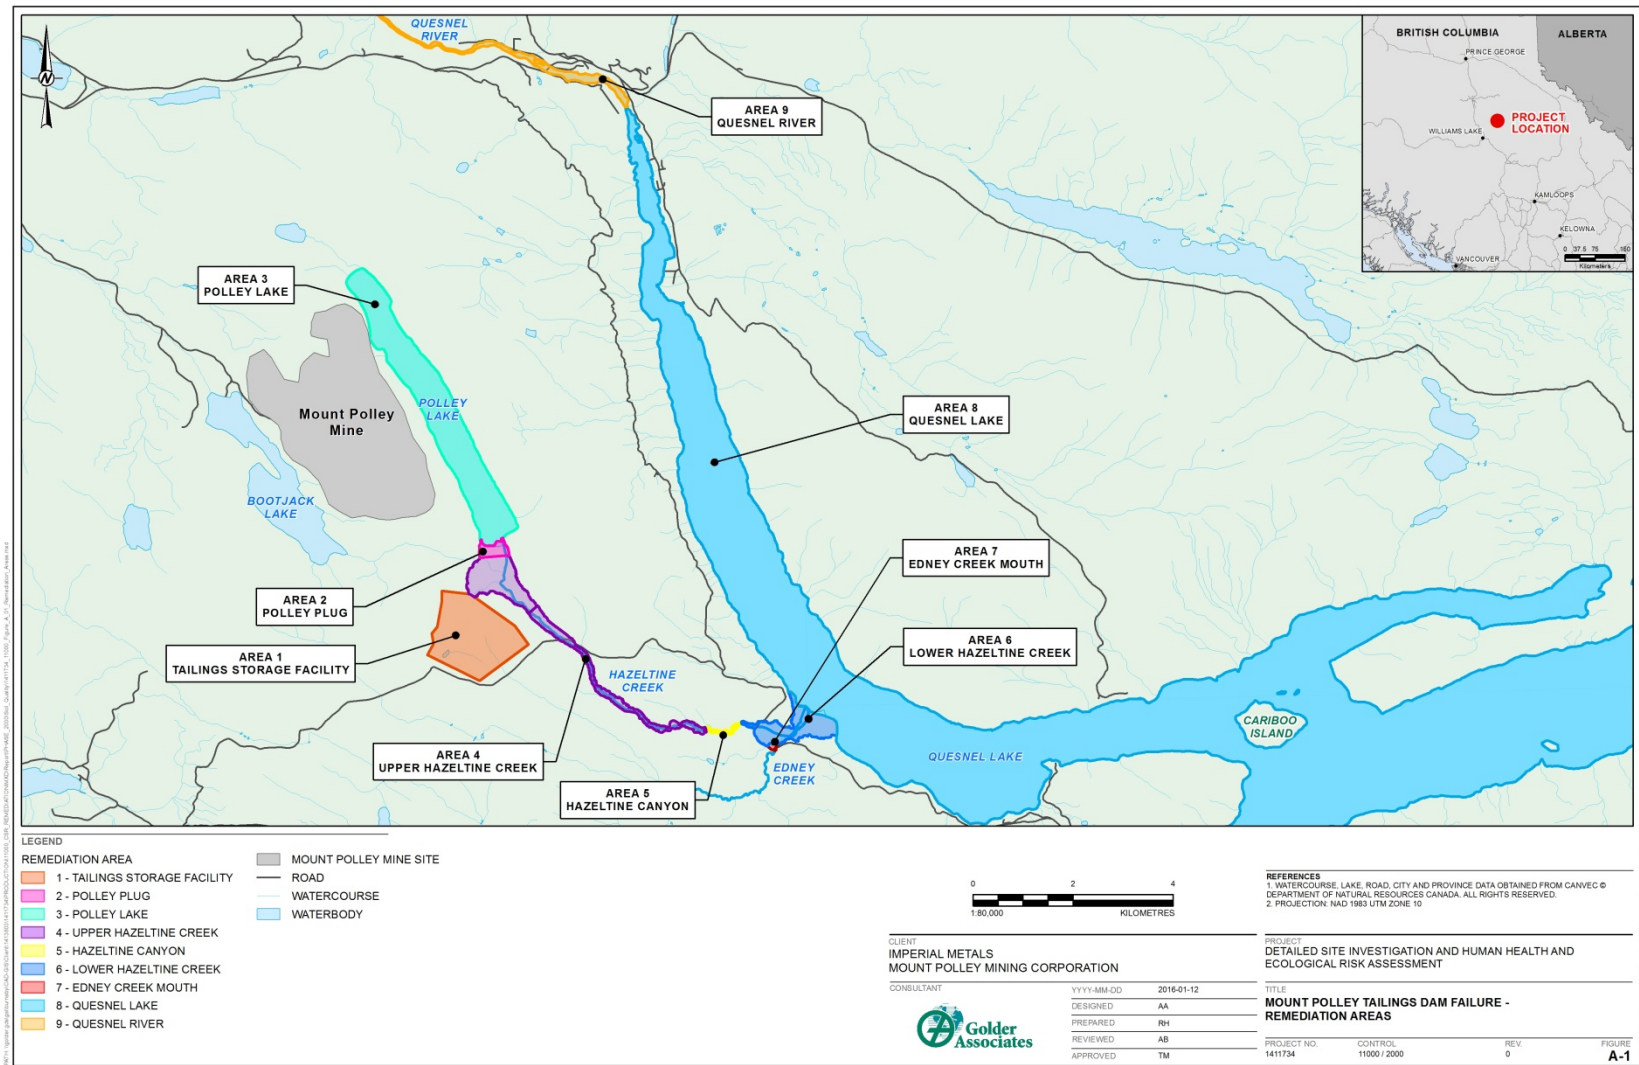
Figure 3 TSF embankment breach remediation areas (reproduced with permission from Zapf-Gilje et al. [2016])

ongoing to reduce erosion, as well as to create wildlife habitat and improved plant microsites (Figure 3). The woody debris also acts as a source of seed and long-term soil carbon. Revegetation to date has focused on the floodplain areas to reduce potential erosion into the channel. Willow (*Salix* spp.) wattles and live stakes and black cottonwood (*Populus trichocarpa*) wattles collected from site have been installed using bioengineering techniques (Figure 3). Black twinberry (*Lonicera involucrata*), red-osier dogwood (*Cornus stolonifera*), and prickly rose (*Rosa acicularis*) nursery seedlings have also been planted along one side of the floodplain, maintaining the other side for access to construct fish habitat features in the future. Planting of Sitka alder (*Alnus viridis*) seedlings grown from seed collected on site is planned for fall 2016 in areas between the floodplain and forest edge. Future revegetation of upland areas is anticipated to include additional early successional species, with seeds collected from Mine site where possible. These native species have been selected based on their role in primary succession in the region and projected ability to survive in the available habitats. The selected species are anticipated to be fast growing (and shade out invasive species), easily propagated, and produce leaf litter (and in the case of alder, fix nitrogen) to begin building soil. While primary succession in the region is typically dominated by shrubs, a light application (30 kg/ha) of a native blend of grasses and forbes is being applied to provide additional erosion control and organic matter inputs. Figure 3 presents photos of rehabilitation work in this area.

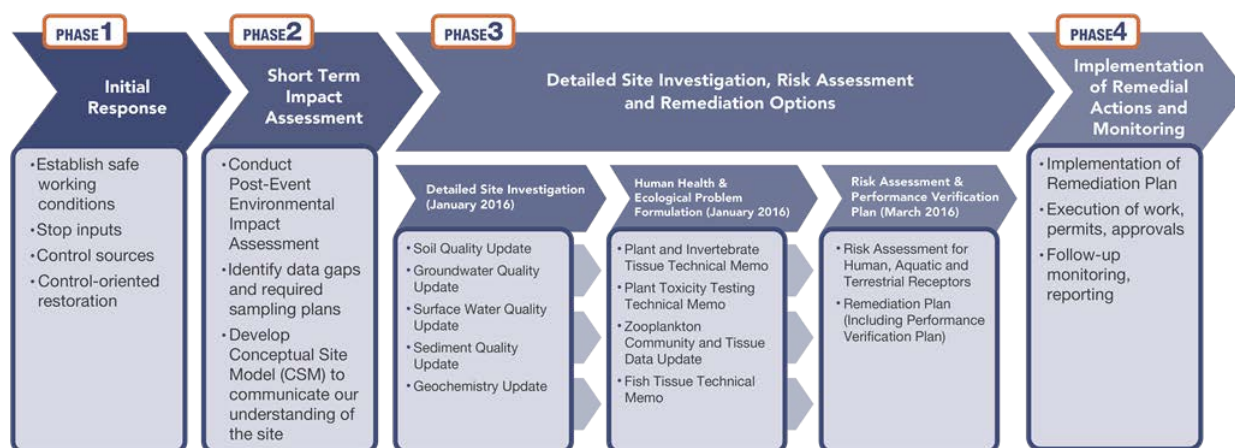
Figure 4 TSF embankment breach Rehabilitation and Remediation Strategy (reproduced with permission from Miller and Zapf-Gilje [2016])

**Depositional Zone (lower Hazeltine Creek corridor):** The deposited tailings and eroded native materials at the mouth of the Hazeltine Creek channel were not as deep as in the “Polley Lake Plug” near upper Hazeltine Creek (0.15 to 1.5 m). Tailings were, for the most part, removed, in particular from the channel and floodplain areas. Wood chips produced from trees recovered from Quesnel Lake were available and applied in spring 2015 to reduce erosion, hold moisture and eventually to provide organic carbon as they decompose. These chips were mixed and mounded in 2016, along with larger site preparation work across the area to expose mineral soil for planting and natural plant ingress. This site preparation work included mounding and application of woody debris as described for the Scour Zone above. Planting of the floodplain and revegetation of upland areas is ongoing as described in Scour Zone section above. The time series photographs in Figure 4 shows progression of reclamation in this area.
