**LARGE WOODY DEBRIS FISH HABITAT STRUCTURE
PERFORMANCE AND BALLASTING REQUIREMENTS**

A THESIS SUBMITTED IN PARTIAL FULFILLMENT OF
THE REQUIREMENTS FOR THE DEGREE OF
MASTER OF APPLIED SCIENCE
in
THE FACULTY OF GRADUATE STUDIES
(Department of Civil Engineering)

THE UNIVERSITY OF BRITISH COLUMBIA

August 1998

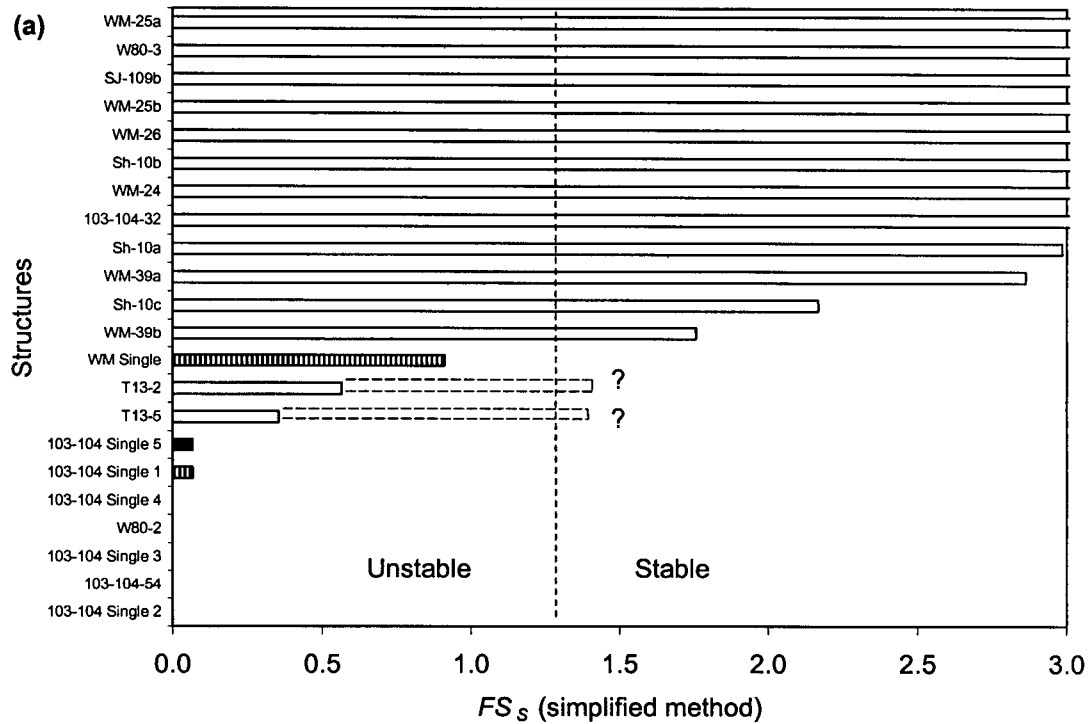
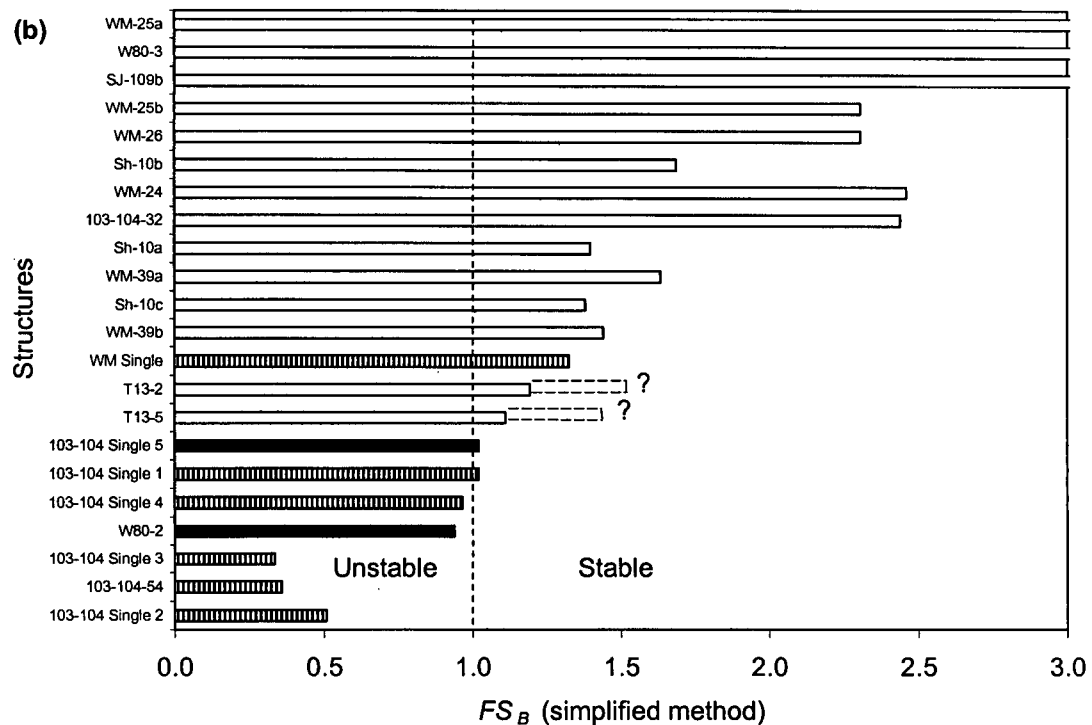
Factors of safety with respect to sliding and buoyancy were computed for the observed high water using the analysis presented in section 3.3. Note that almost all of the analyses are for partially submerged conditions. As can be seen in Figure 6-1, there is a very good agreement between predicted and observed stability of the single log structures based on their FS_S . All single log structures with a $FS_S > 1.0$ were immobile, while only 2 of the

structures with a $FS_S < 1.0$ did not move as expected. It was noted during the field assessments however, that both these structures (T13-2 and T13-5) had anchor boulders that were partially buried within the stream substrate. Hence, the size of the boulders may have been underestimated and the partial burial provided additional resistance to a buoyant or sliding failure. It was observed that most of the structures that moved were not fastened to a fixed bank anchor or were not provided extra ballast mass on the bank to counter transferred forces.

It is also evident that a good fixed bank anchor in the form of a tree or stump is required to ensure stability. Most of the failures observed were the result of not securing the LWD at the bank end. It must be emphasised that Millar (1997) assumed that half of the drag and buoyancy forces exerted on the piece of LWD were transferred to its bank end. Therefore, resting the LWD on the upstream side of a tree or stump and cabling it in place is a simple method to ensure stability. Alternatively, if no tree or stump is present, doubling of the ballast mass requirement ($BF = 2$) and fastening half of the boulders at the bank end of the LWD may replace a fixed bank anchor.

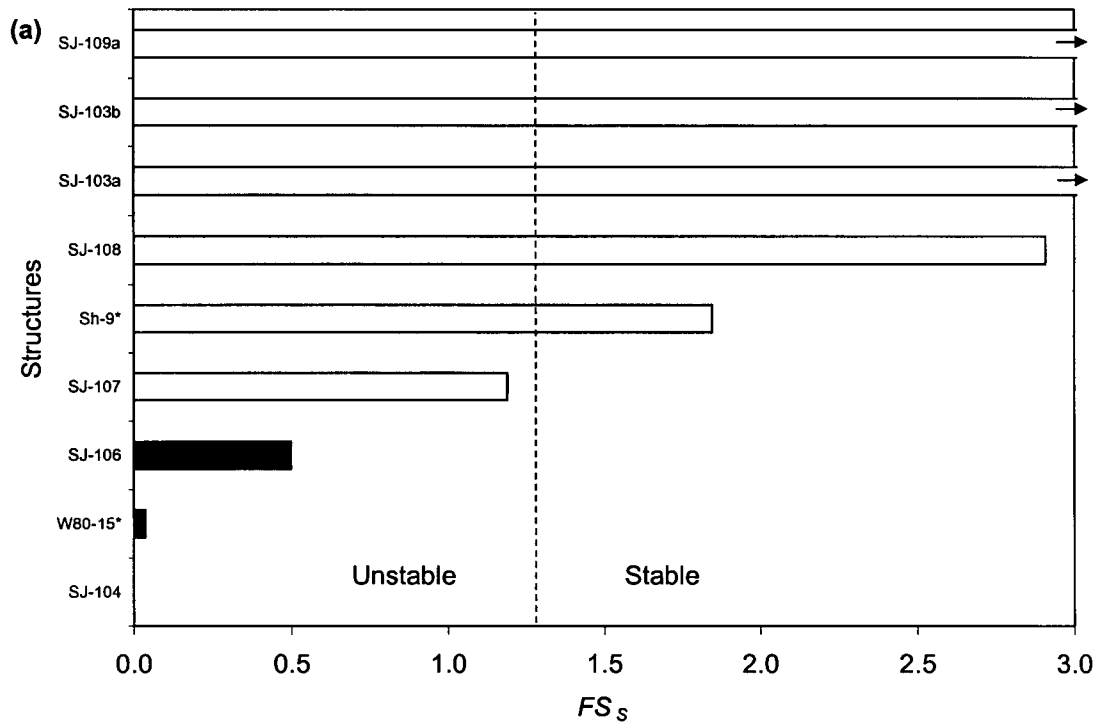
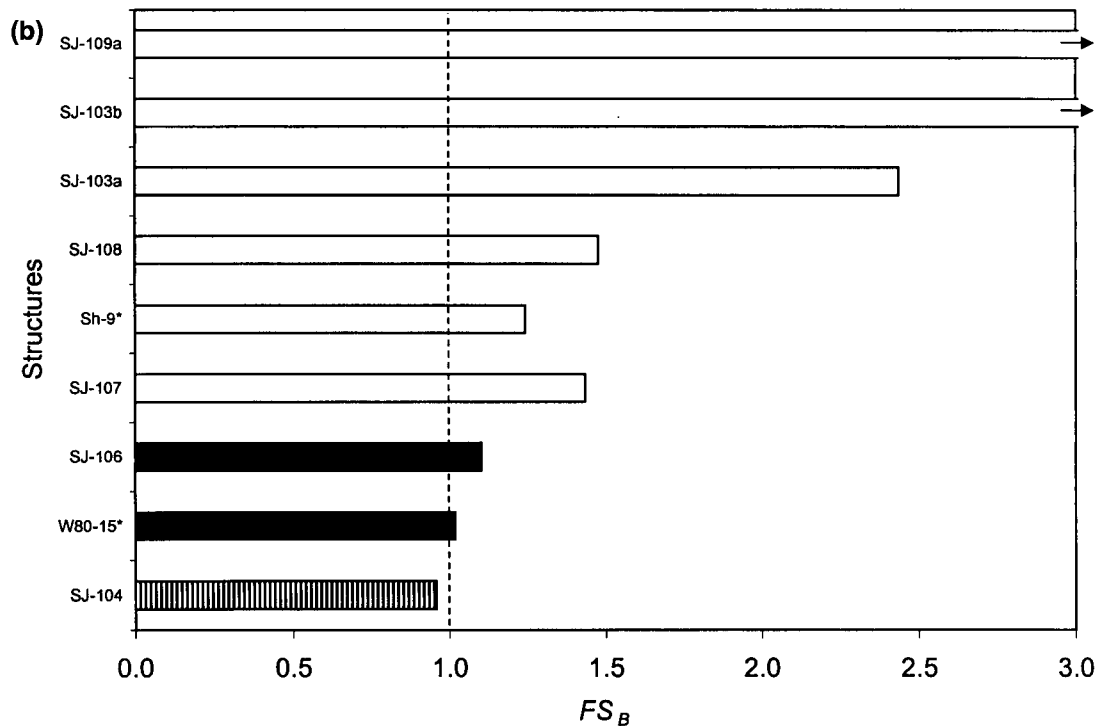
Factors of safety with respect to sliding and buoyancy were calculated for the observed high water for nine structures using the analysis presented in section 3.4. As illustrated by Figure 6-2, the predictions made with respect to structural stability based on the FS_s were accurate. As predicted, three out of the nine structures evaluated proved unstable.

Structure SJ-104 was completely washed away (Figures 6-3 and 6-4) while both structures W80-15 and SJ-106 shifted only slightly. Some small movement of structures SJ-103a and SJ-103b was observed, however the distance travelled by the “settling in” of the anchor boulders was less than 0.7 m. The FS_b of these 2 structures are well above 2.0. The factors of safety were also determined for the bankfull and design (50 year return) flows (Table 6-3).

It appears that close to half of the structures had a FS_S greater than the recommended 2.0 (Millar, 1997) during the last high flow conditions. Under bankfull and design flow conditions, only three out of nine structures would maintain a FS_S in excess of 2.0. In terms of buoyancy, all but one of the single-LWD with root wad had $FS_B \geq 1.0$. Five of the structures maintained a FS_B in excess of the recommended 1.25 for the three discharge conditions.

The design mass requirements for the single-LWD with root wad, summarised in Table 6-4, indicate that three out of the nine structures evaluated require at least a doubling of the as-built anchor mass to ensure a FS_S of 2.0 under design flood conditions. The three large spruce trees placed within the San Juan River require a considerable amount of additional mass (about 14 tonnes each) to provide a $FS_S > 2.0$ under design conditions. The average increase in ballast mass between bankfull and design flow conditions is about 20%. This reflects an average increase in main-channel velocity in the order of 20%.

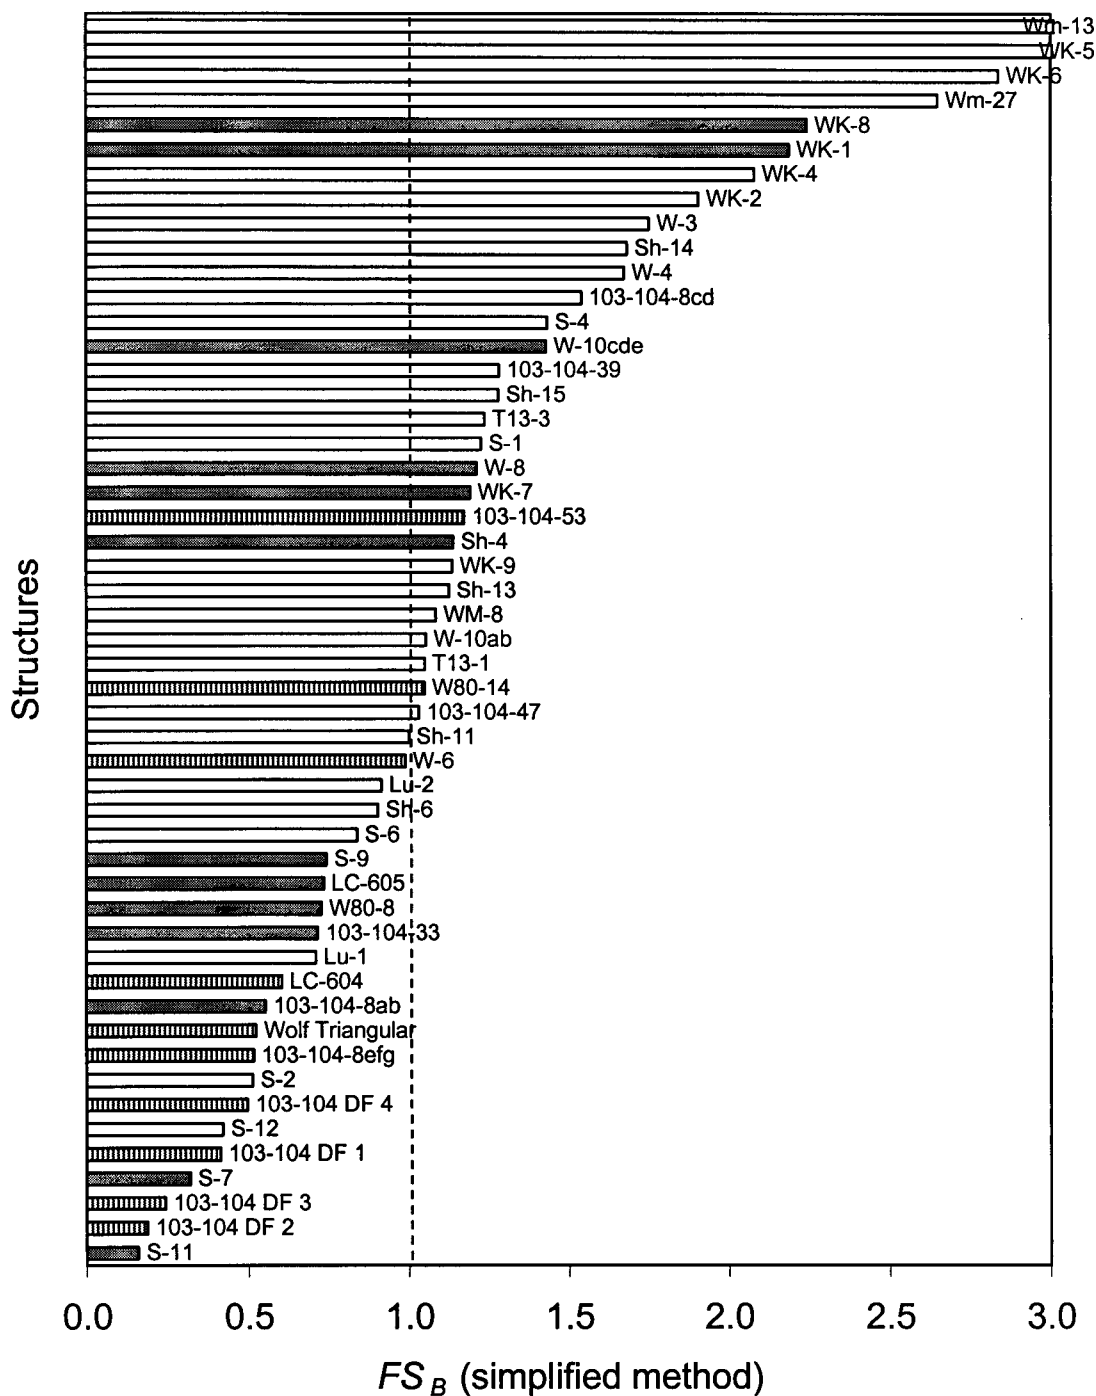
Factors of safety with respect to buoyancy were computed for the observed high flows using the analysis presented in section 3.2 and 3.3 (Figure 6-6). 27% (8/30) of the structures that had a $FS_B > 1.0$ under the recent flood conditions exhibited some movement, whereas 75% (15/21) of the structures with a $FS_B < 1.0$ proved unstable. Eight of the ten structures that were subject to the most shifting and/or designated as partially or non-functional had a $FS_B < 1.0$ during the observed high flows.

the simplified method since the mass of LWD above water is taken into account. If the stability predictions were based on FS_B computed based on the method of moments instead of the simplified method, 6 additional structures (LC-104, 103-104-33, S-6, S-9, S-12 and Sh-6) would have been expected to be stable under the observed high flow. Despite these revisions, three of these six structures proved unstable.

Based on the foregoing, it is not surprising that 80% of the multiple-LWD structures require additional ballast mass (on average 1,100 kg/structure) to provide a minimum recommended FS_B of 1.25 (Millar, 1997). Table 6-6 summarises ballast mass requirements for the multiple-LWD structures. The difference in ballast mass requirement between bankfull and design conditions is insignificant ($\approx 2\%$) since it is assumed that the LWD is fully submerged under both conditions. The only difference in mass is to compensate for increased lift forces (due to higher velocities) acting on the anchor boulders.

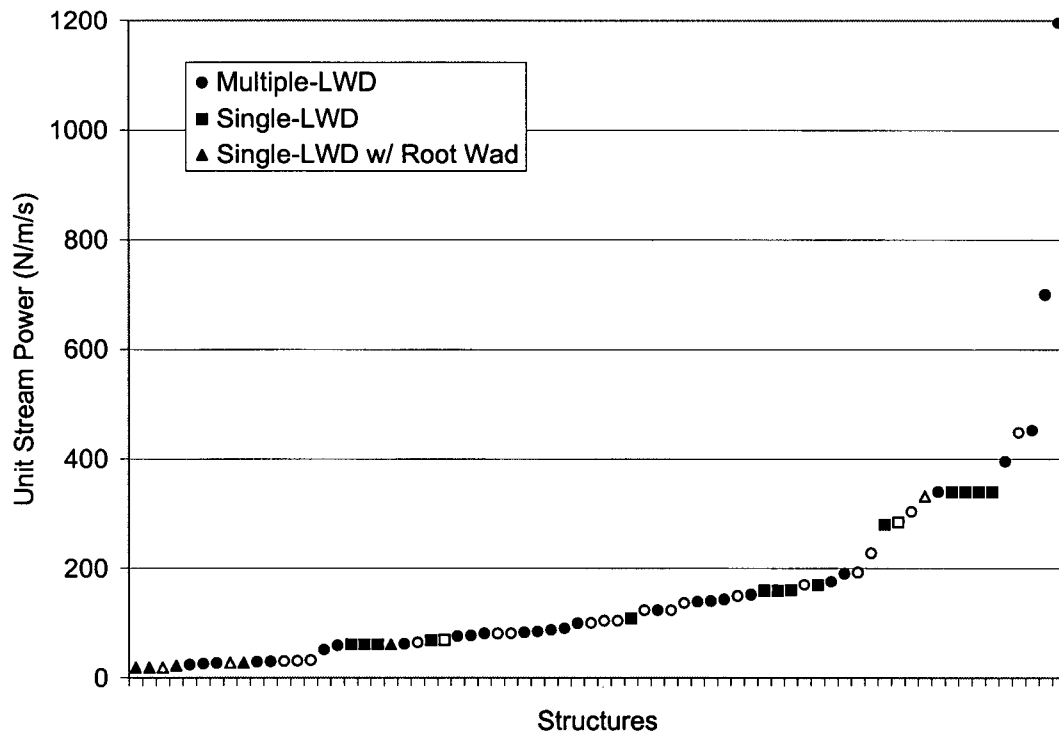
Figure 6-13: Observed structure stability vs stream power (solid symbols indicate stable structures and open symbols indicate unstable structures)

As depicted in Figure 6-13, no relationship was found between unit stream power and the observed stability. When all the structures are ranked based on their unit stream power, the instabilities were proportionately distributed among 4 arbitrary stream power classes (< 125, 125 to 250, 250 to 375 and > 375 N/m/s). In fact, only 20% of structures within the upper class exhibited instabilities compared to about 33% of structures for the other 3

stream power classes. This would tend to indicate that the design and construction of the habitat structures investigated has a greater influence on the physical performance than the stream power. It also supports the use of velocity as the design criterion of single-LWD structure rather than stream power.
