LANDSLIDES IN THE CHARLIE LAKE MAP SHEET,
FORT ST. JOHN

A THESIS SUBMITTED IN PARTIAL FULFILMENT OF
THE REQUIREMENTS FOR THE DEGREE OF

MASTER OF SCIENCE

(Department of Earth and Ocean Sciences)

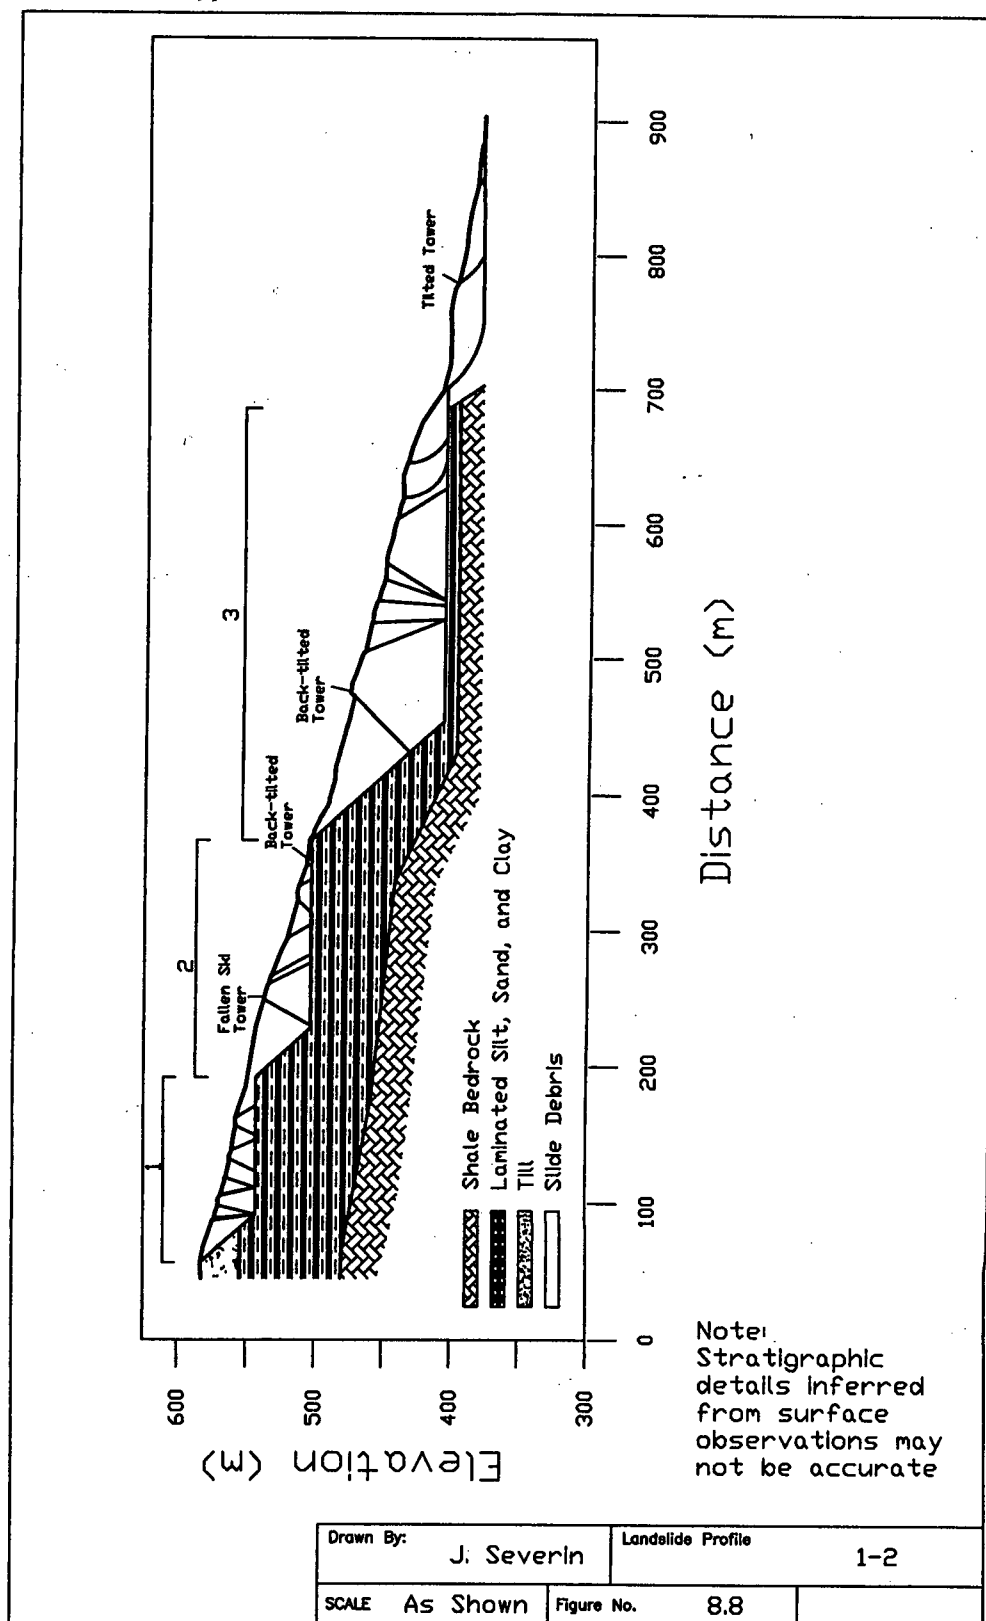
Figure 8.8 Landslide Profile 1-2

The second profile in the area was done along the tower line of the Big Bam Ski Hill that failed in 1997 closing operations permanently (Figure 8.5). The profile started near a farmer's field and continued down the north-facing slope on an azimuth of 345° . There were no exposures of shear planes or intact materials found during the traverse, however, many of the features can be interpreted from surface morphology and comparisons with nearby slopes. The slide is understood as having three failure planes, all within the pre-glacial sand, silt, and clay unit (Figure 8.8). During the upper part of the failure, the features were small indicating that the failure planes were relatively shallow.

There was enough displacement in the upper portion of the failure to force many of the ski towers to fall over or tilt, however, the movement appeared to have been compound with little rotational component. Further down slope, a large horst was observed, suggesting a new failure surface much deeper with little or no rotational displacement being observed. The bedrock is suspected to underlie the deep compound failure and then sharply dropping off causing debris to slide over and producing a steeper slope within the debris. The toe of the slide is remobilized debris.

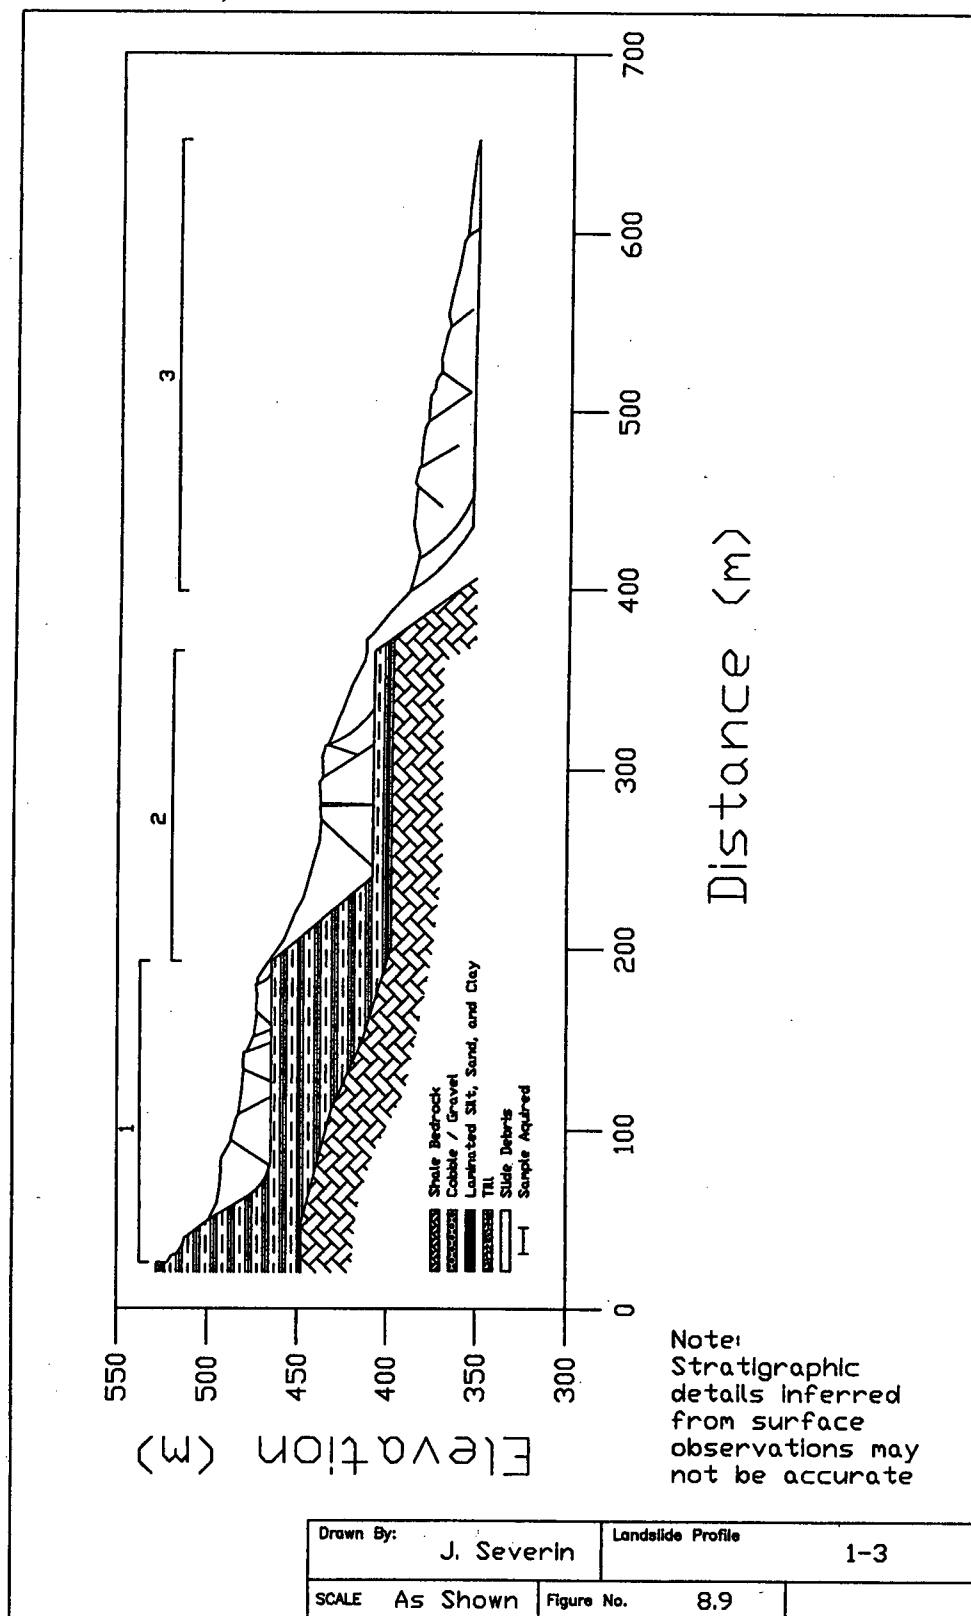
Figure 8.9 Landslide Profile 1-3

This active slide is at the western edge of the Big Bam ski area and has a north-facing slope. The profile starts on a ridge caused by an abutting failure on Septimus Creek. The profile goes down slope at an azimuth of 7^0 . The failure consists of two successive compound slides within the pre-glacial sand, silt, and clay unit (Figure 8.9).

No shear planes or intact sections were observed as they were covered by debris, but rather inferred by slope morphology. Both failures show a definite component of back tilting and the resultant ponding of water as well as horst and graben structures. Intact slopes underneath the debris are expressed as steeper slopes within the profile. The start of the profile is at the exposed head scarp of till above bedded silt-rich pre-glacial silts of a rotational component of the failure. The two failure plane hypothesis is supported by the small nature of most of the features seen on the slide. Locally, the bedrock is inferred from neighbouring slides, bedrock elevation across the Pine River, and that the site is completely within the pre-glacial valley (Mathews, 1978). The toe is made of remobilized debris that is heavily treed and shows small-scale back tilting and compound features.

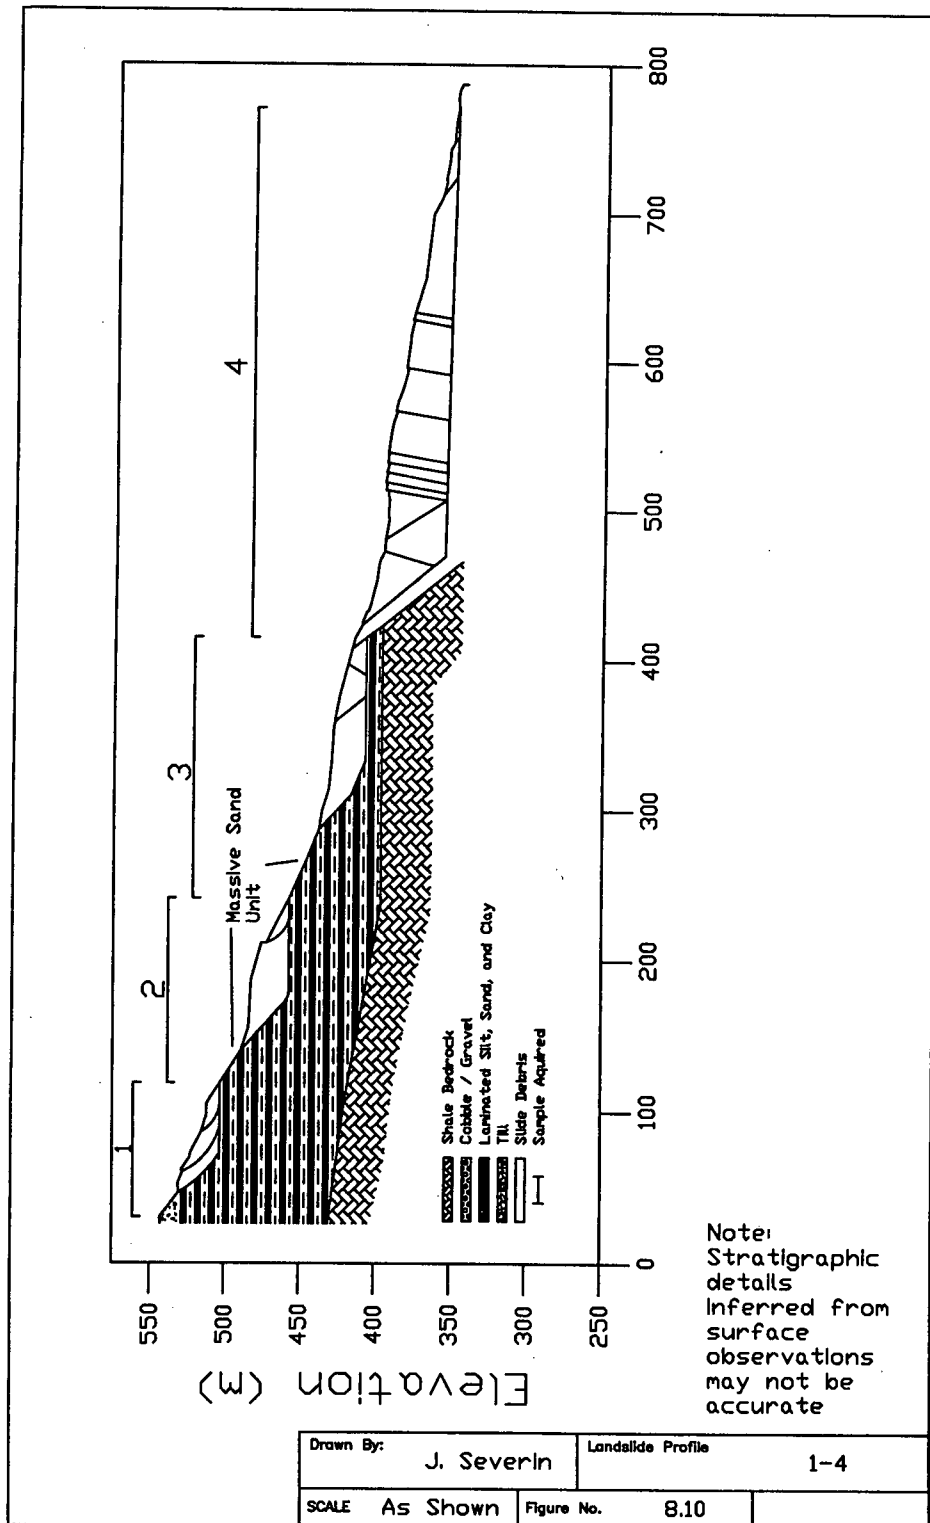
Figure 8.10 Landslide Profile 1-4

Slide 1-4 is an active failure consisting of three failure planes within the pre-glacial sand, silt, and clay unit (Figure 8.10). It is located in between Slides 1-2 and 1-3 and also has a north-facing slope. The profile started on an undisturbed surface near a field at the top of the failure and traversed at an azimuth of 0^0 to the toe. The head scarp of the slide is made entirely of till and the debris near the top was slightly back tilted suggesting a rotational component to the failure. The upper shear plane was observed and sampled (1-4A) during the traverse, however, the lower two failures are an interpretation. The upper failure plane lies directly above a massive intact sand bed with minor interbeds of silt and clay. The shear plane has a clay fraction of 38 with a liquid limit of 51% and a plasticity index of 33%.

The middle failure shows back tilting and ponding so it is also considered a compound failure. The debris of this failure had small features suggesting the failure

surface is shallow. Below this debris, another intact section of sand with clay beds was observed, however the shear surface above it could not be found. One of the intact beds of clay was determined to be mostly silt at 72%, with a liquid limit of 41% and a plasticity index of 24%. The horst and graben features within the debris mass of the lowest failure below the second intact bed of sand were also small so a third, shallow failure plane is inferred here. The bedrock surface is again assumed from other profiles to be below this failure plane forcing the debris to slide and remobilize below. An interesting element of this slide was a series of laterally extending ridges within the remobilized debris, which appeared to be compressional features as if the debris is being loaded on to and pushed toward the river.

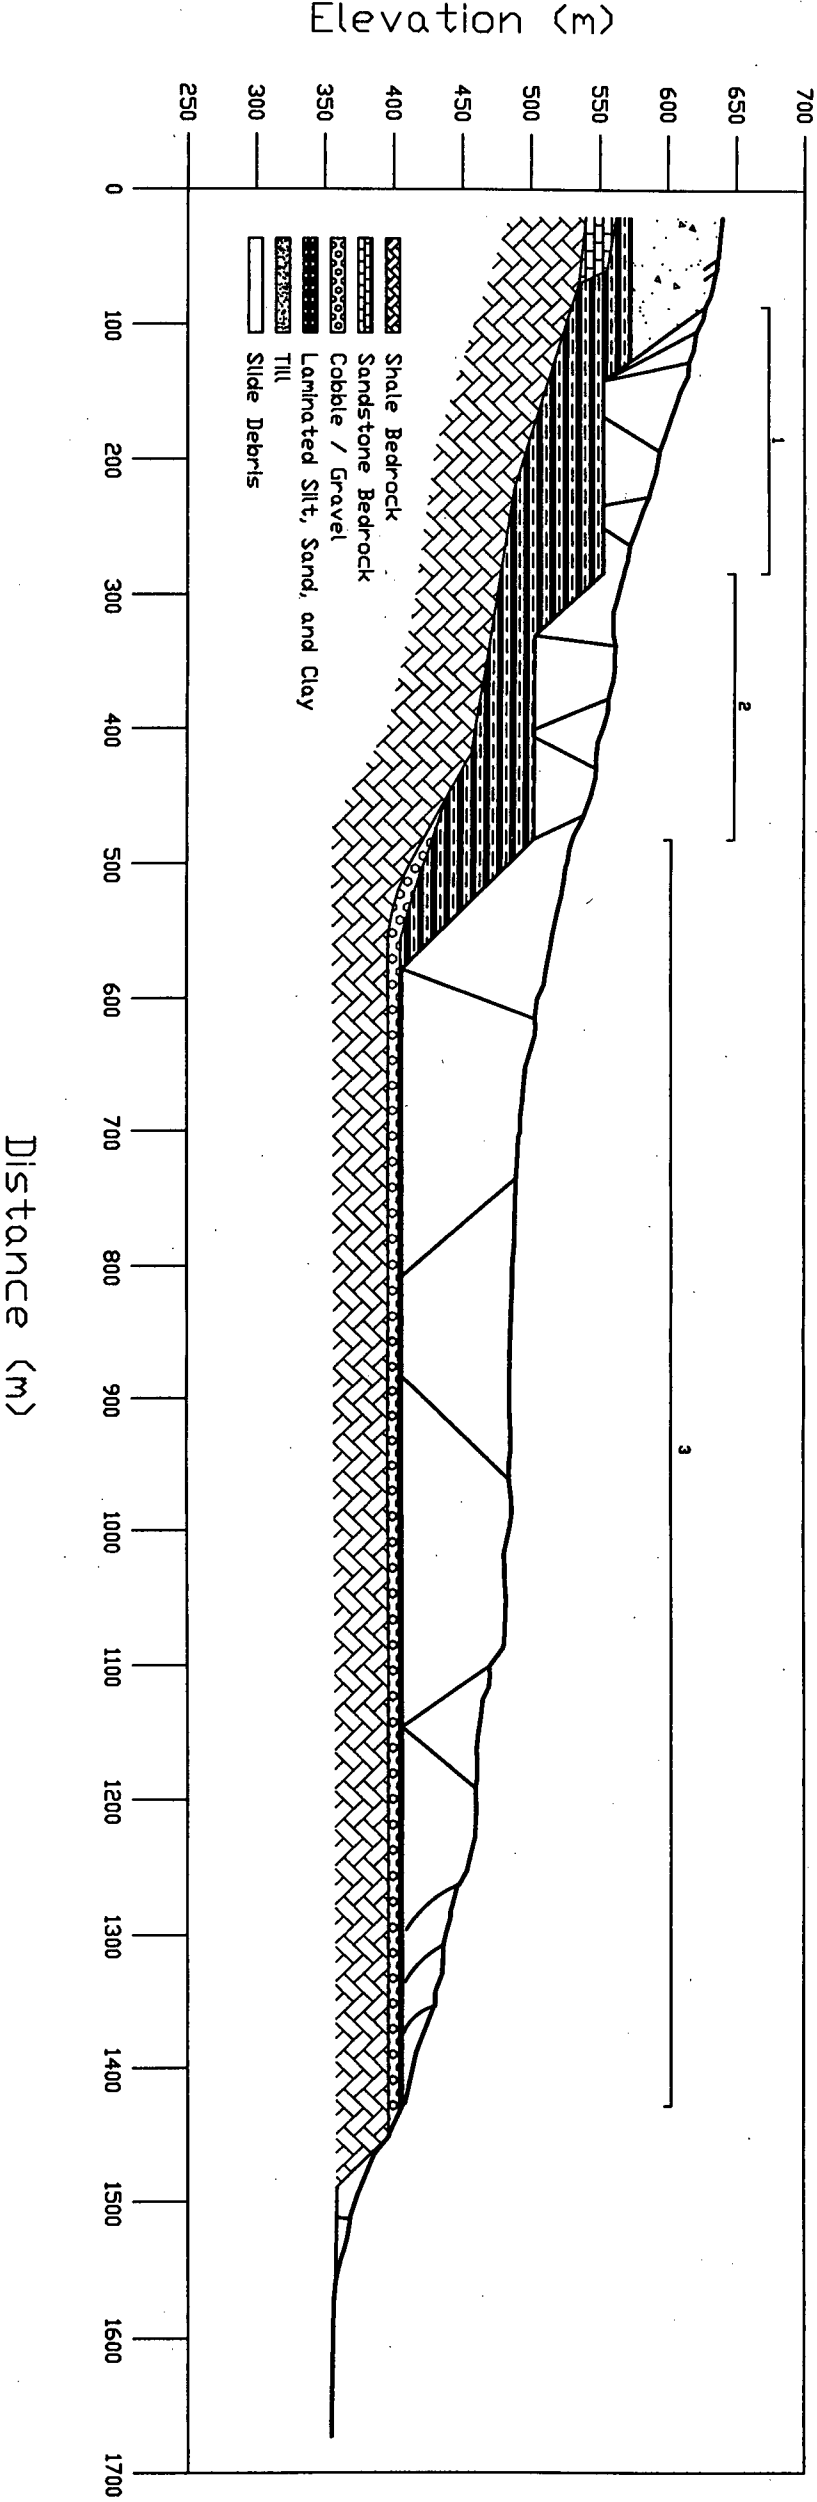
Figure 8.11 Landslide Profile 1-5

This failure is at the eastern end of the area and has a north-facing slope. The slide is dormant with three shear planes within the pre-glacial unit (Figure 8.11). The upper shear planes are interpreted from slide morphology and the lower shear was seen although not accessible. The profile starts in a farmer's field at an azimuth of 323° and continues down slope to an abandoned property. Within the field, a small crack was observed which might be a tension crack, however with the amount of seasonal modification caused by plowing of the field, features within a field can be deceptive. The head scarp for the upper failure is shallow at 23.5 and all the features are overgrown and muted. This is likely a compound failure with a shallow failure plane with little to no rotational movement. The trees on the slope are J-shaped and have an estimated age of 60 to 80 years. Wide scale ponding marks the head of the next compound failure and represents subsidence of a graben. Several large horst and graben structures were

observed representing a deep compound failure. The third failure plane is at a very low angle and is quite long, roughly 9000 meters, and is represented by large-scale horst and graben features and hummocky terrain. The toe of this section is remobilized and shows a rotational failure. The shear plane was covered along the traverse but it was detected in a ravine next to the profile, making sampling impossible. Gravel was also seen at this section as well as the intact shale below. Elevations were taken obliquely off the profile. The bedrock surface dips steeply toward the current river level. The debris below is remobilized and highly disturbed. The slide surface was modified at the toe due to the development of a residence.

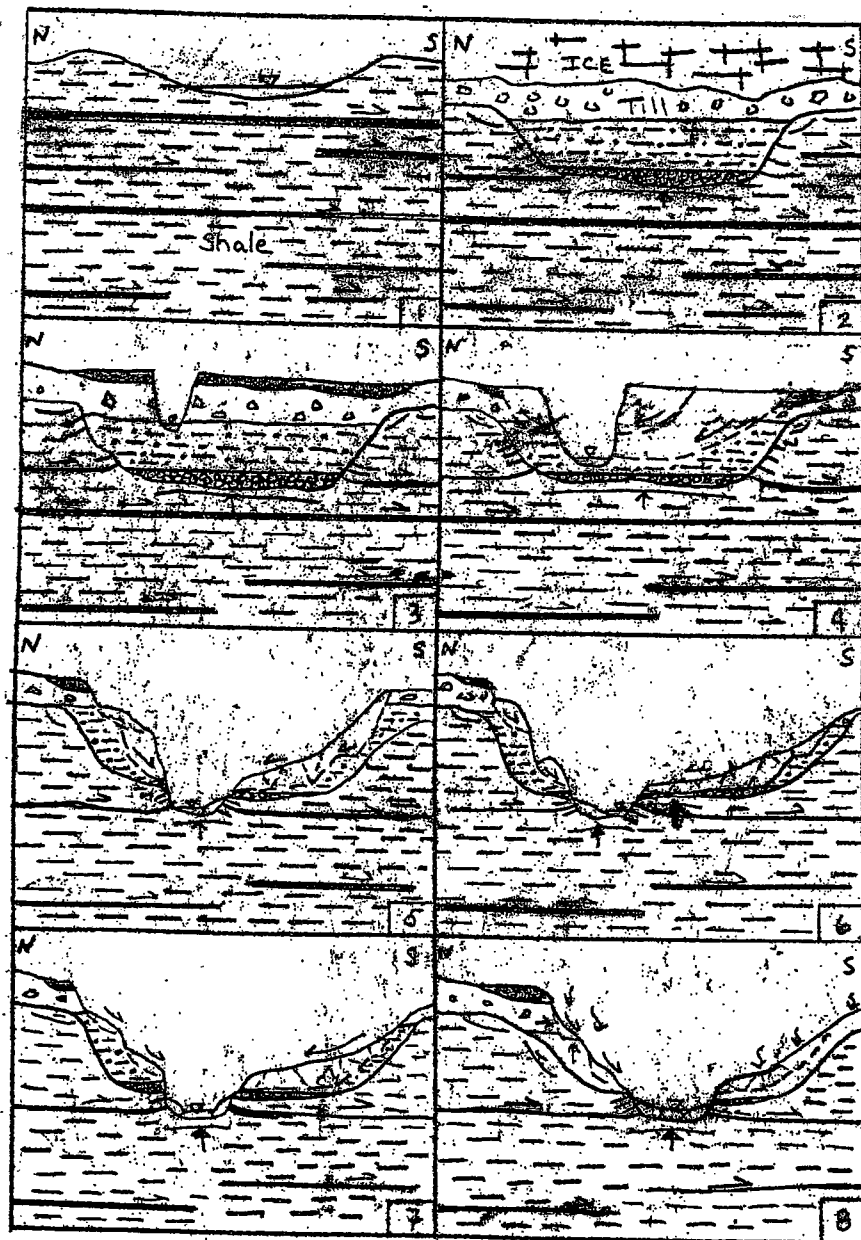
Figure 8.13 Landslide Area 1 - Geologic Model

This area is located completely (Figure 8.13) within the pre-glacial valley (1), which has undergone glaciation (2), re-established its drainage (3) and eroded to a lower elevation (4) (397 metres a.s.l). During this erosional event several landslides likely occurred, starting the valley widening process. The slides that occur in this area are completely within the Pleistocene sediments with at least two failure planes and sometimes three. The rapid downcutting into the soft sediments of the Pine River and Septimus Creek has exposed weak clay layers (4), on which the slides occur. The clay layers are pre-sheared surfaces, although the cause of the shearing is not obvious. The pre-shearing could have occurred due to glacial loading, syn-erosional slumping, or the release of lateral stresses during valley rebound. The valley expanded with a migrating river constantly eroding the resultant debris. As the river cut down into the bedrock, this abandons the basal shear surface (5). The first-time failures in this area are likely due to erosion from the river, however, reactivation of failures can occur if the debris mass is eroded and the river once again attacks the intact slope (6). Most continued failures are likely due to increased pore pressure from precipitation, softening of the clay layers, and simple creep along these pre-sheared failures (7 and 8).

In this area, there seems to be one major shear surface within a meter of the gravel contact, which was sheared in all the landslides. At the eastern edge of this area the plane is extended for quite a distance, allowing for a more translational movement. Several planes appear to extend over a few slides but not the whole area. These are smaller localized beds with limited area. There is another failure plane near the top of the

1) Broad, stable pre-glacial bedrock channel; 2) Aggregating deltaic environment into encroaching ice-dammed lake followed by glaciation; 3) Drainage re-establishes; 4) Post-glacial river erodes down into till leaving steep banks, once softer, laminated sediments below are reached, initial failures occur; 5 & 6) Failures continue to occur, on older, upper lower bedding planes and lower planes once exposed; 7) Debris at base acts as a berm for debris on slope; 8) Erosion of debris and intact bank and increases in pore pressure in pre-glacial units cause

sequence, which appears in all slides that reach this elevation. Bedrock plays little or no part in these failures except to provide an intact ledge for the debris to slide over.

In general, this area has a few clay beds within the Pleistocene sequence that seem to be more apt to failure; however, failure is not confined to these beds. As the lowest failure plane usually contains the largest slide, it seems unlikely that the failures are successive, but rather retrogressive. The lower slide would fail, unloading the toe for the next failure in sequence.

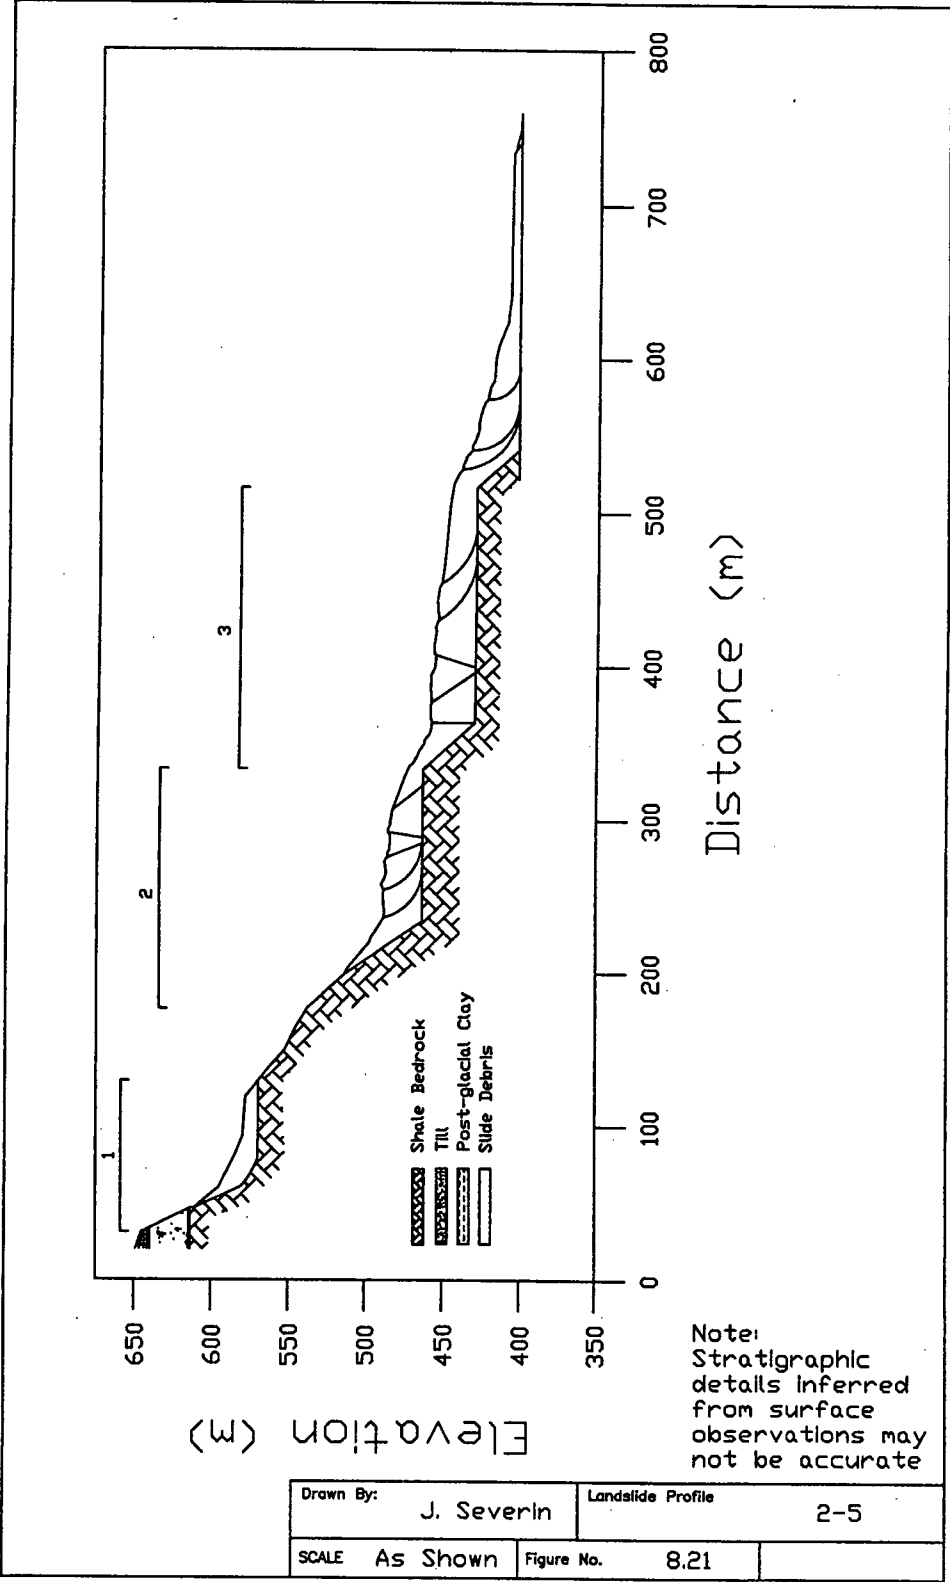
Figure 8.21 Landslide Profile 2-5

Slide 2-5 is on a southeast-facing slope within the Peace River Valley. The profile starts at the edge of a field, same field as Slide 2-1, and continues down slope at an azimuth of 132°. The slide is mostly dormant and contains three failure planes all within the Shaftesbury Shale (Figure 8.21). The head scarp of the slide shows a thick layer of glacial Lake Peace clay of 9.5 meters above a till unit of 25 meters in thickness. At the base of the till unit is the contact with the shale below. This contact is a zone of shale rip-up clast dominated till with a clay-rich matrix of about a meter in thickness. Below this contact is a 2.5-meter vertical section of intact shale above the talus of the slope. At the base of this intact section is a large slump block of a rotational failure. The failure plane was not observed, however, below the failure another section of intact shale was found suggesting that the failure is in shale. The intact section of shale is approximately 50 meters thick and below this is two compound failures interpreted from surface morphology with several small horst and graben features. The toe of this failure is a modified river terrace that has since been farmed that shows no natural features.

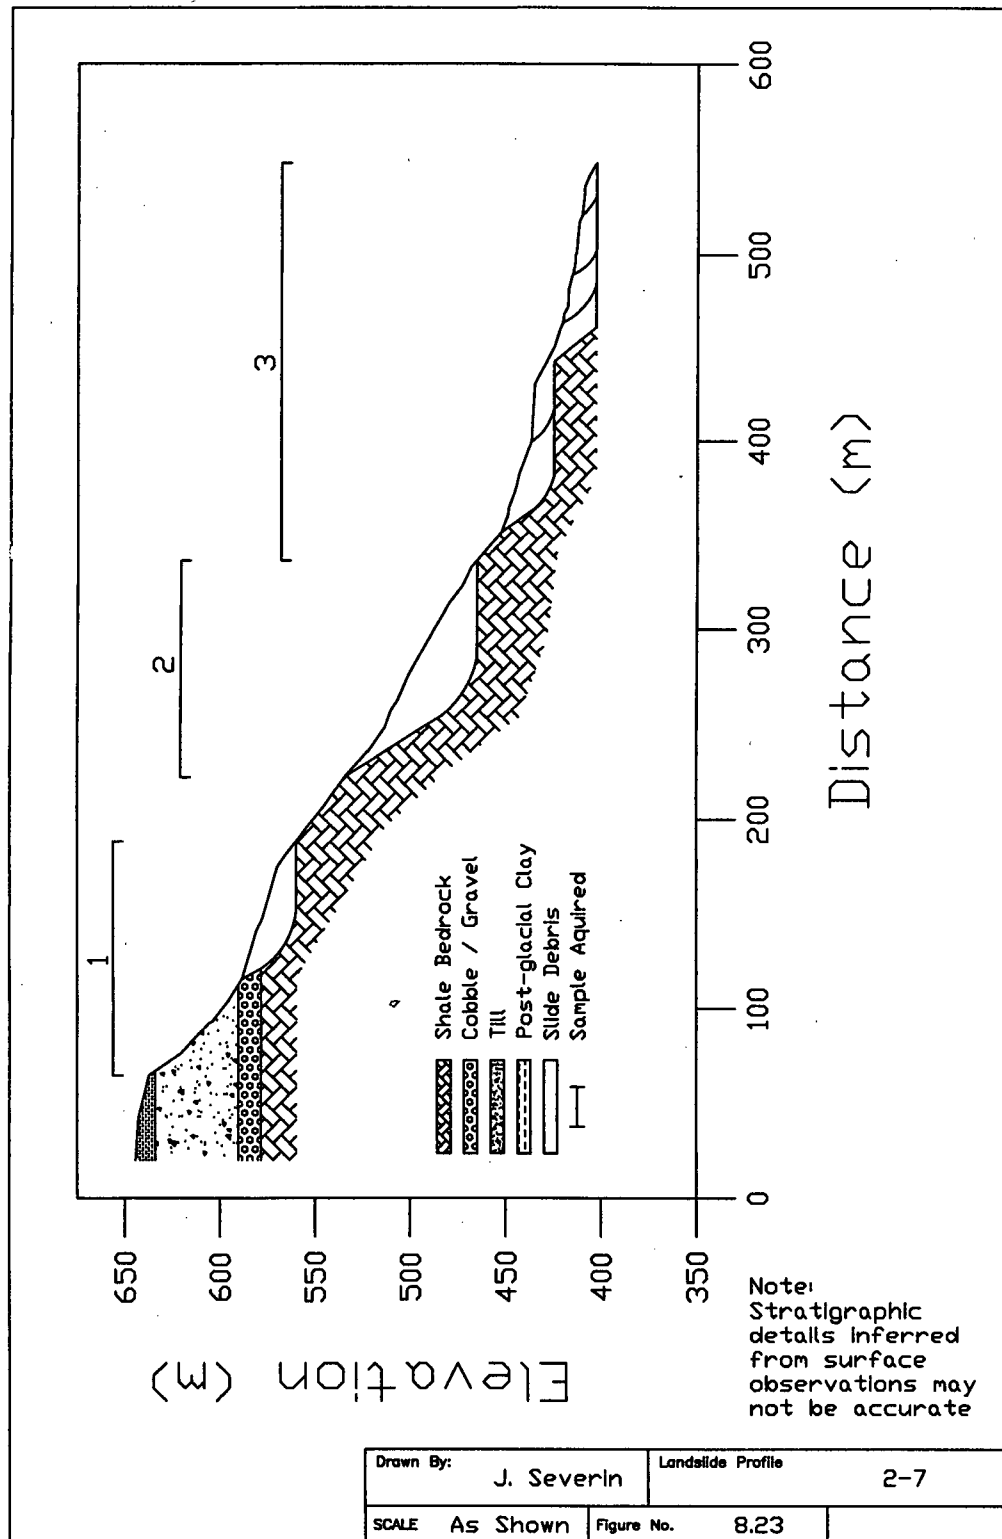
Figure 8.23 Landslide Profile 2-7

Slide 2-7 is south-facing with an aspect of 188° in the Peace River Valley. The profile begins on a hummocky, plowed field within a Bison Ranch belonging to Mr. Bouffieux. This is an active failure with three shear planes within the shale (Figure 8.23). The head scarp of the failure shows an anomalous section of Quaternary sediments. This section is at least 56 meters thick and dominated by a unit of till. The top of the section displays a 10-meter unit of glacial clay underlain by 44 meter thick of till and at least 2

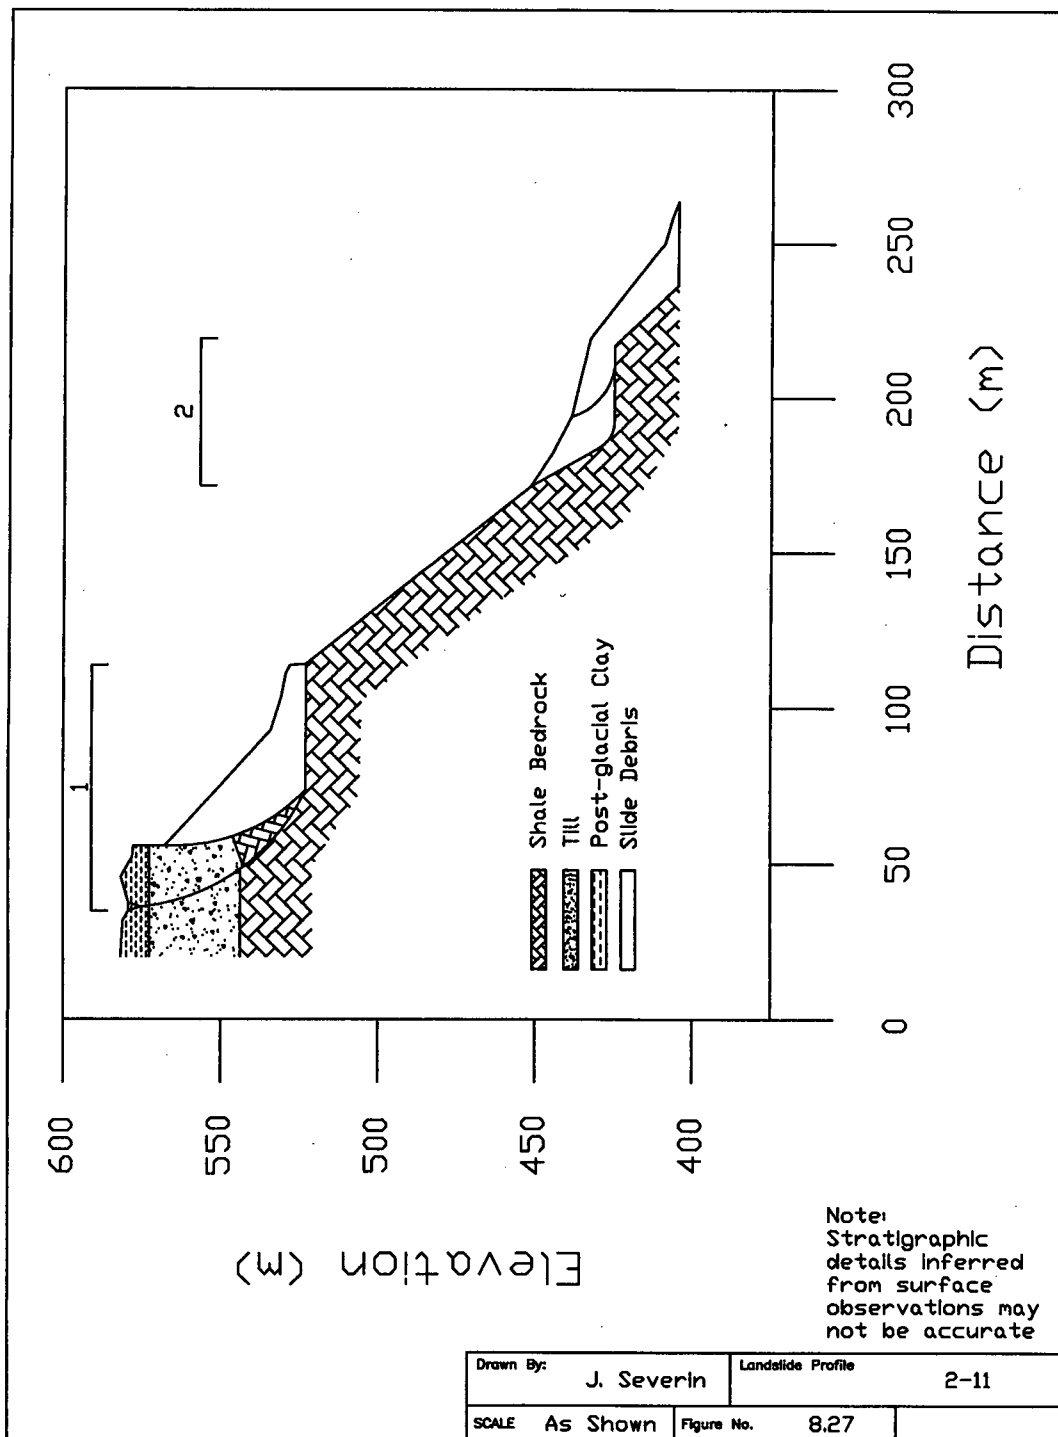
Figure 8.27 Landslide Profile 2-11

This short failure occurs within the Peace River Valley on a south-facing slope. The profile begins on a ridge between coulees and follows along it and down slope on an azimuth of a 192 . The failure is very active and has two failure planes within the Shaftesbury Shale (Figure 8.27). The head scarp is composed of 9 meters of glaciolacustrine clay above 5 meters of exposed till. Pre-glacial sediments were not

detected during the profile. Behind the head scarp is a large crack thought to be a tension crack connecting with the failure plane used for the upper failure. It is likely that this whole section is unstable. The talus below the vertical section is till-like and ends at a bench within the slide. The upper failure is a rotational failure completely separated from the lower failure. The failure plane was observed in the shale but could not be sampled. Below this shear plane, an intact section of weathered shale was found and extends until a debris bench overlying a stable bedrock layer likely containing another shear plane within the shale.

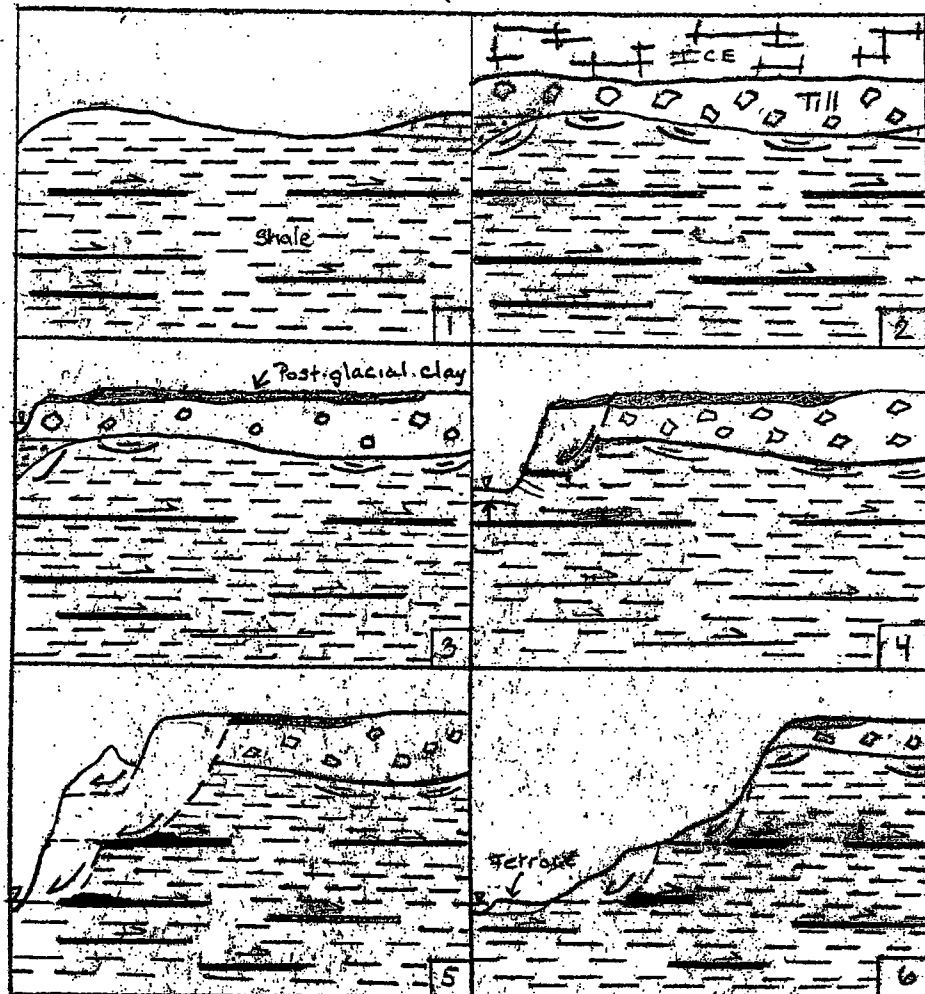
Figure 8.28 Landslide Area 2 – Geologic Model

In general, there are several weak layers within the shale due to the inclusion of bentonite allowing the shale to fail at many elevations. All of these failures occurred post-glacially as the current valley wall did not exist and as scouring action of the glaciers eroded previous landslide deposits. Therefore, the rapid erosion of the current Peace River Valley, caused relaxation of the valley walls along bedding planes, pre-sheared surfaces caused by tectonic forces, and perhaps glacio-tectonics. As the river level dropped, many of the slides became abandoned and some debris features were destroyed by river erosion.

1) Bedrock dominated plain near edge of pre-glacial river valley; 2) Aggregating deltaic environment into encroaching ice-dammed lake followed by glaciation; 3) Drainage re-establishes in pre-glacial river valley; 4) Migrating river allows intact material to be eroded and failures to occur exposing weak strata; 5) Migrating river continues to expose weak strata allowing failures to occur; 6) Debris from failures acts as a stabilizing berm of unstable material, although erosion of debris may cause reactivation of failure plane.

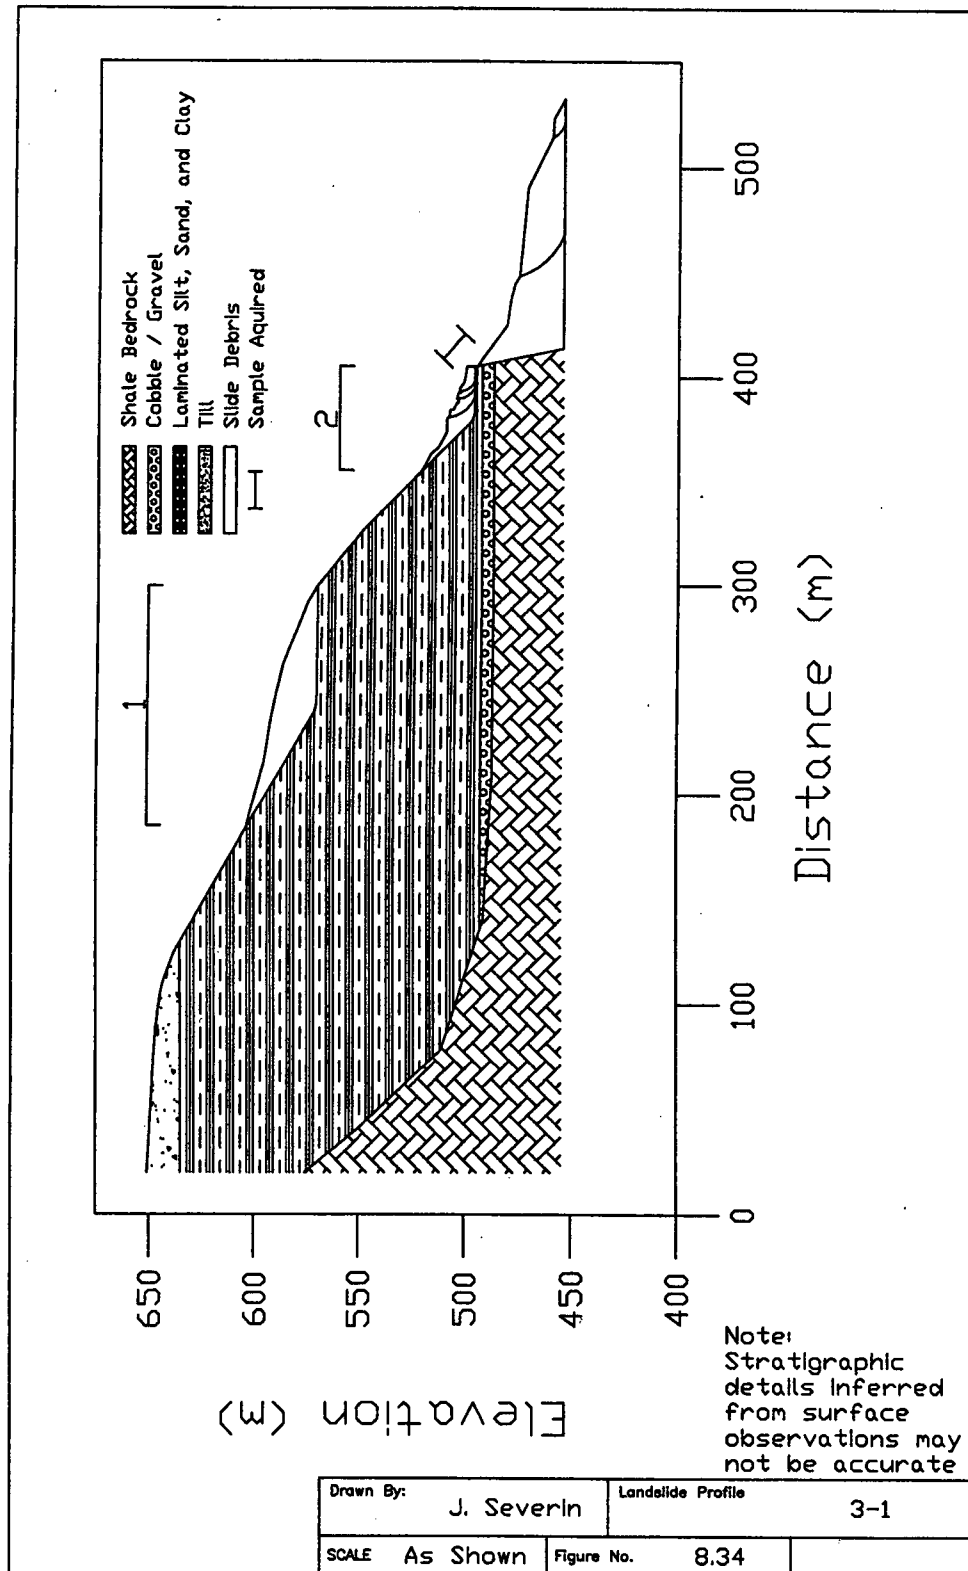
Figure 8.34 Landslide Profile 3-1

headed down slope towards St. John Creek, near its confluence with Stoddart Creek (Figure 8.29). The slide has two failure planes both within the pre-glacial sequence (Figure 8.34). The top failure is abandoned and completely independent of the lower, very active bottom failure. The head scarp is completely grassed over and appears stable, though morphology indicates that this part of the slope was previously active. The upper failure plane was not observed but rather inferred from the terrain. The lower failure has fresh features even though the main scarp is grassy and appears stable. The lower failure is rotational with many scarps within the debris mass. The failure plane was observed with the vertical face visible from the roadway and sampled (sample 3-1A). Slickensided surfaces were located near the bottom of the pre-glacial unit, 3 meters above the gravel. The debris mass protruded up to 7 cm from the intact section. The shear plane consisted of 47% clay and 52% silt. The liquid limit of the layer is 54% and a plasticity index of

34%. The gravel unit extends for 5 meters until the shale was reached. The toe of the slide, on which a roadway is located, is remobilized debris. This toe has been armored at the creek level in order to stop the remobilization of the debris and to add stability to small slumps that threaten the roadway.

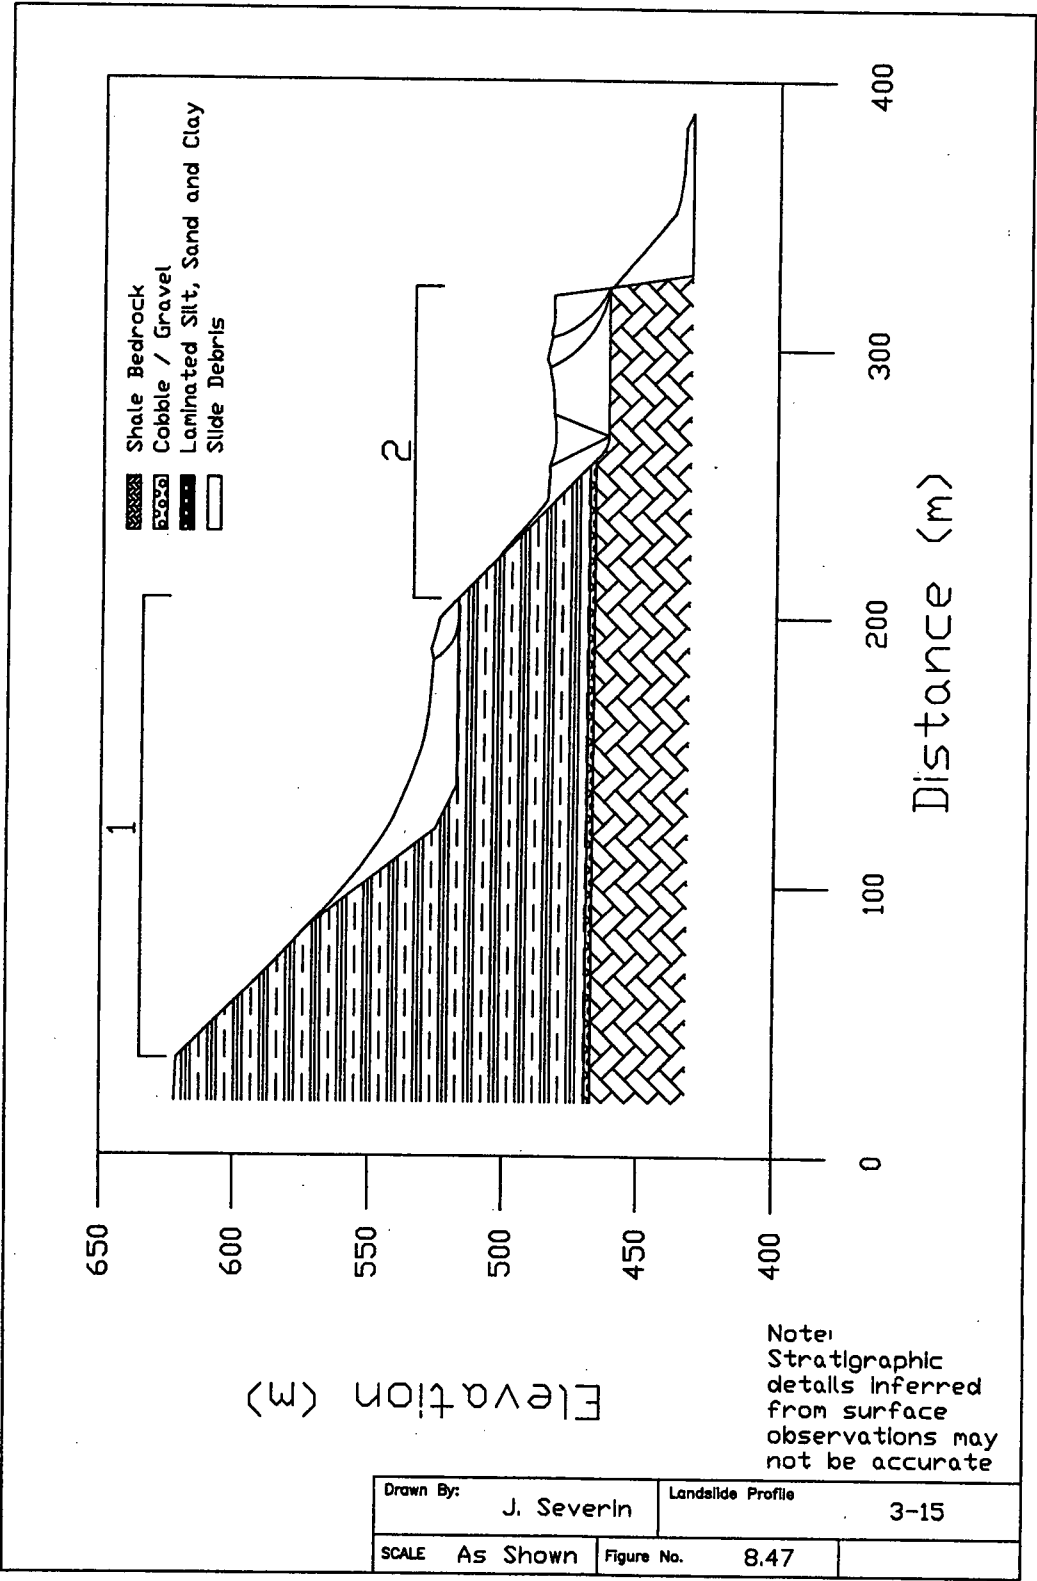
Figure 8.47 Landslide Profile 3-15

Slide 3-15 is on a south-facing slope of the Beatton River less than 1 kilometer up stream from Slide 3-14 (Figure 8.29). The profile starts at the river level and continues up to the plateau at an azimuth of 350 . This is a multi-level slide incorporating two independent failures, with the upper section being abandoned and the lower section being active (Figure 8.47). The upper failure has a steep, grassy head scarp with a disturbed and back tilted debris mass. The failure by itself could be described as a single rotational failure. The shear plane of this failure was not observed as it likely daylights behind the lower grassed scarp below the ledge. The total lack of sandstone and shale within the debris, allows the assumption that the failure is within the pre-glacial unit to be made. The grassed scarp below the first failure is the head scarp of the active lower failure. The lower failure is a compound slide with a shear plane with in the shale. This shear plane was located and sampled (sample 3-15A) in the vertical face below the second debris mass. The shear plane consists of 22% sand, 57% silt, and 21% clay. The Liquid Limit of

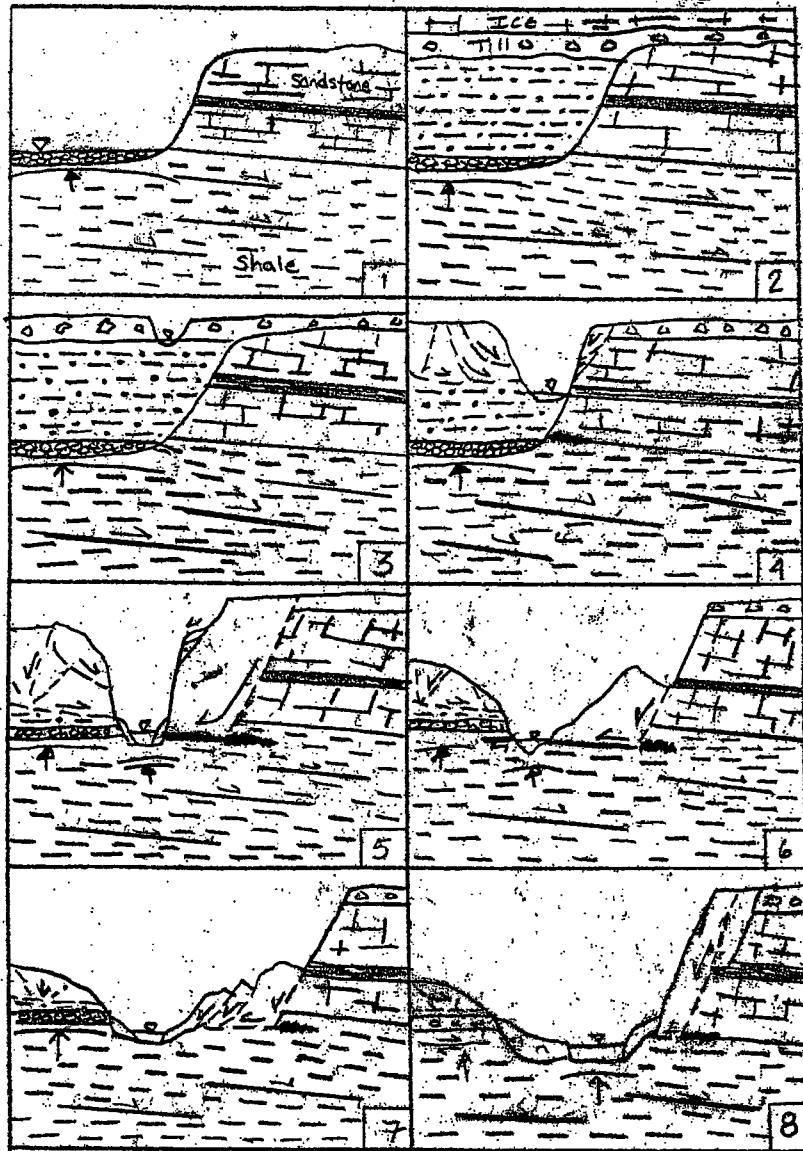
Figure 8.48 Landslide Area 3 – Model 1

plane from failing. Lower in the slope, where the sandstone interbeds occur less frequently, the weak bedding planes are mobilized making deep failures with steep head scarps possible (Figure 8.48).

The initial river valley (1) was filled with ice-dammed pre-glacial sediments and eventually glaciated (2). The formation of the failures occurs by an initial stage of river erosion near the edge of the pre-glacial valley (3) causing the nearby pre-glacial sediments to fail (4). Eventually the river erodes to a weak layer that can be mobilized (5). The slide may utilize a slip surface caused by horizontal stress relief during the valley rebound process (Matheson and Thomson, 1973). After the slope fails, the river adjusts its course around the debris and active erosion takes place (6). After enough erosion has occurred, a remobilization of the debris will occur (7). Eventually the failure plane will be allowed to fail again after the buttressing debris is removed (8). The local dip and the sandstone layers allow the south-facing slopes to stand at much steeper angles than their north-facing counterparts and only allow for short failure planes.

1) Broad, stable pre-glacial bedrock channel; 2) Aggregating deltaic environment into encroaching ice-dammed lake followed by glaciation; 3) Drainage re-establishes; 4) Post-glacial river erodes down into till and sandstone leaving steep banks; 5) Once softer shale is reached, initial failures occur along near-horizontal surface unloading slope; 6) Failures continue to occur, on older, upper bedding planes and lower planes once exposed; 7) Debris at base acts as a berm for debris on slope, internal deformation of debris occurs; 8) Erosion of debris and intact bank cause failure.
