LANDSLIDES IN THE CHARLIE LAKE MAP SHEET,
FORT ST. JOHN

A THESIS SUBMITTED IN PARTIAL FULFILMENT OF
THE REQUIREMENTS FOR THE DEGREE OF

MASTER OF SCIENCE

(Department of Earth and Ocean Sciences)

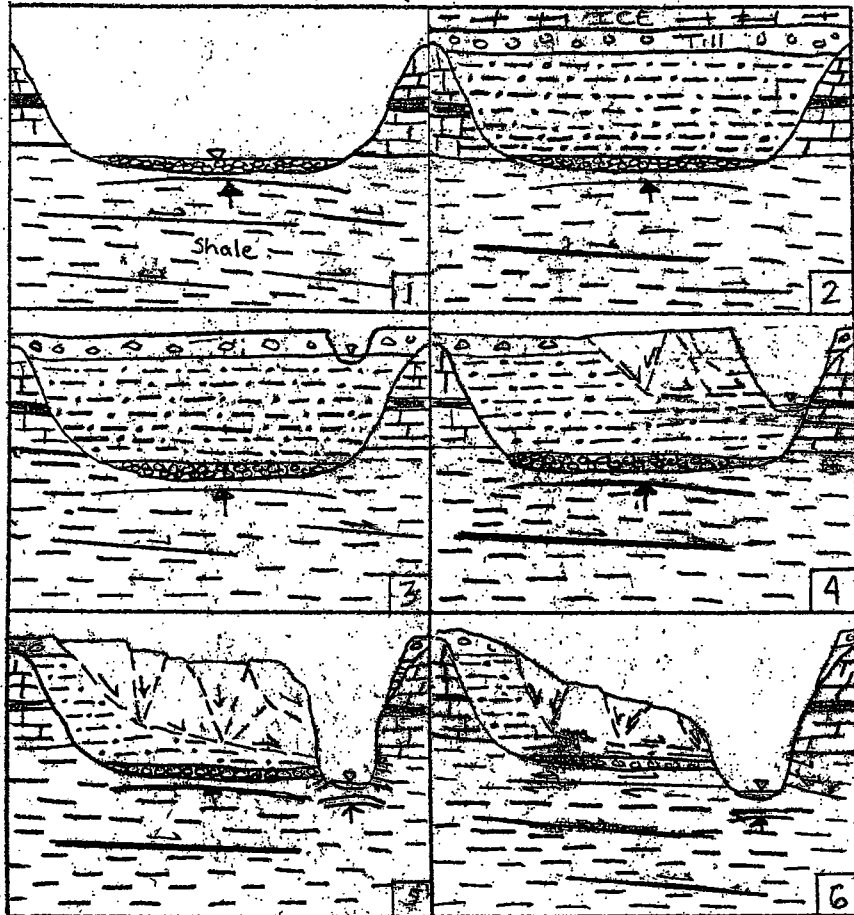
Figure 8.49 Landslide Area 3 – Model 2

1) Broad, stable pre-glacial bedrock channel; 2) Aggregating deltaic environment into encroaching ice-dammed lake followed by glaciation; 3) Drainage re-establishes; 4) Post-glacial river erodes down into till and sandstone leaving steep banks, once softer, laminated sediments below are reached, initial failures occur; 5) Failures continue to occur, on older, upper lower bedding planes and lower planes once exposed, debris at base acts as a berm for debris on slope; 6) Erosion of debris and intact bank and increases in pore pressure in pre-glacial units cause failure.

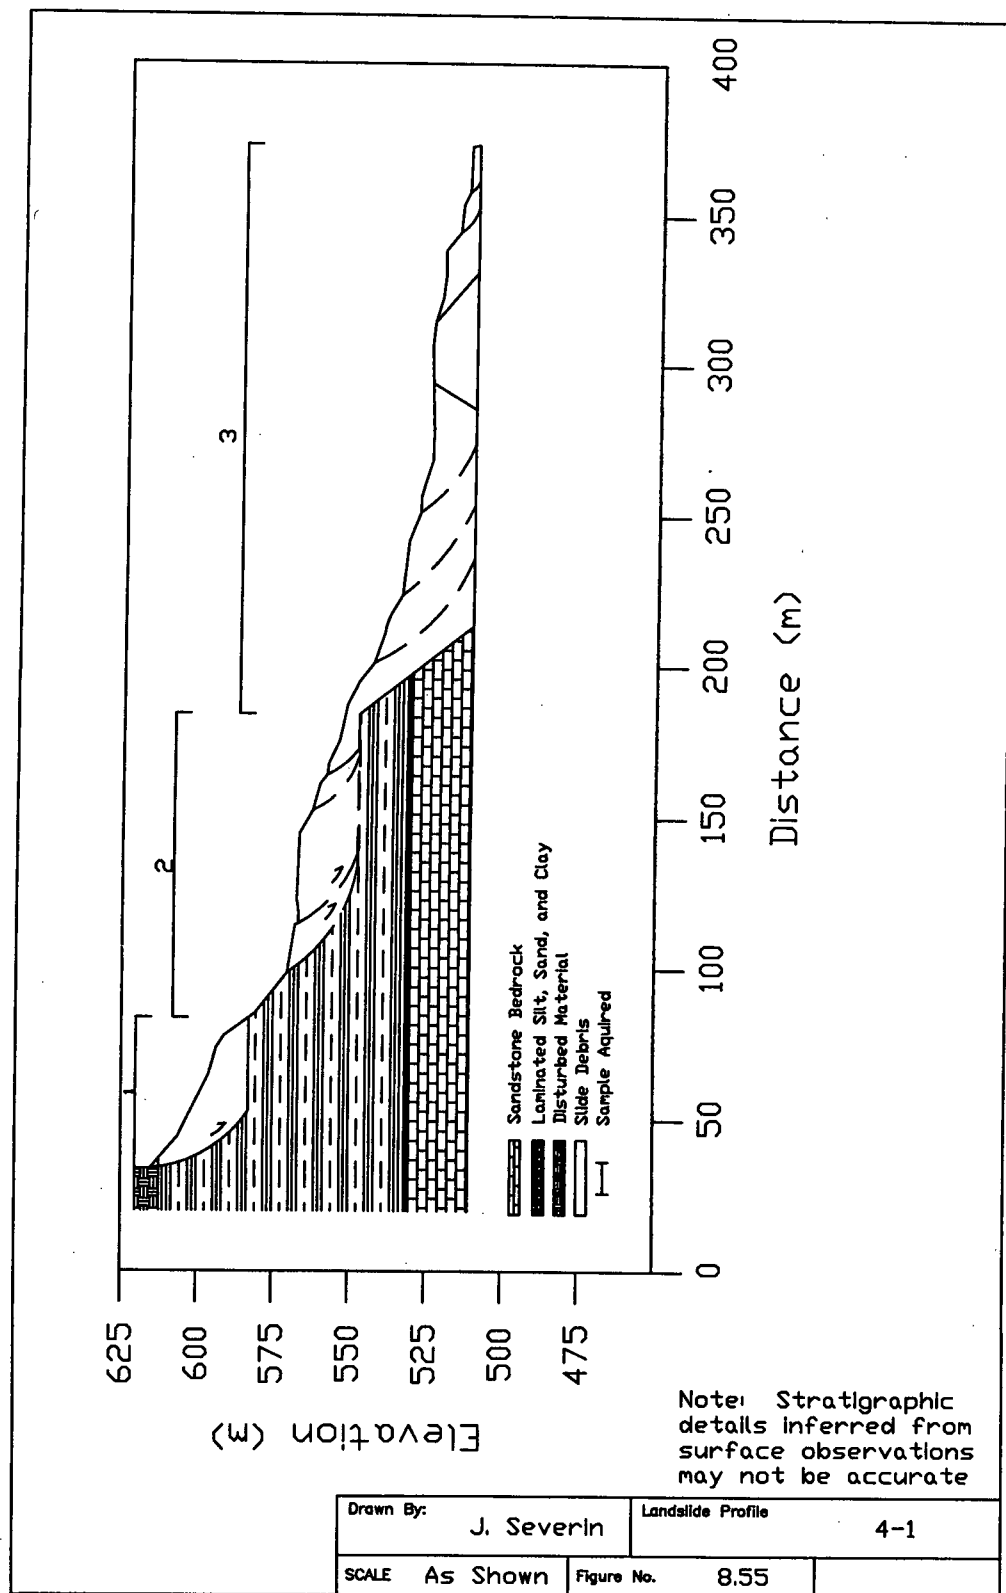
Figure 8.55 Landslide Profile 4-1

Slide 4-1 is an active, multi-leveled failure with two slide planes within the pre-glacial unit (Figure 8.55). The slide occurs on a west-facing slope along the Beaton River directly across the river from the Christian Campground (Figure 8.50). The profile begins on a knife-edge with a larger dormant slide with an aspect that is opposite of the 256° azimuth of this slide. The head scarp is made of a disturbed material likely caused by the older abutting failure. The upper shear zone was observed to be within silt dominated facies of the pre-glacial unit at an elevation of 595.65 meters a.s.l. A slickensided surface was not found within this degraded and modified shear zone, however, a sample of the clay zone was taken (sample 4-1A). An intact section of the facies was found 30 meters to the north (Figure. 8.53) and was found to be sand dominated with larger cross beds and few clay layers. The fine-grained beds below the

shear surface have smaller-scale cross beds with a higher percentage of clay. The second failed mass shows some back tilt and horst and graben structures although the shear plane was not observed. The morphology of the slope suggests that the debris slides over an intact section and the toe appears to be remobilized debris. A bedrock elevation was found at an outcrop near the toe of the failure with a thin (< 1 m) intact unit of gravel above along with a sand-dominated pre-glacial section.

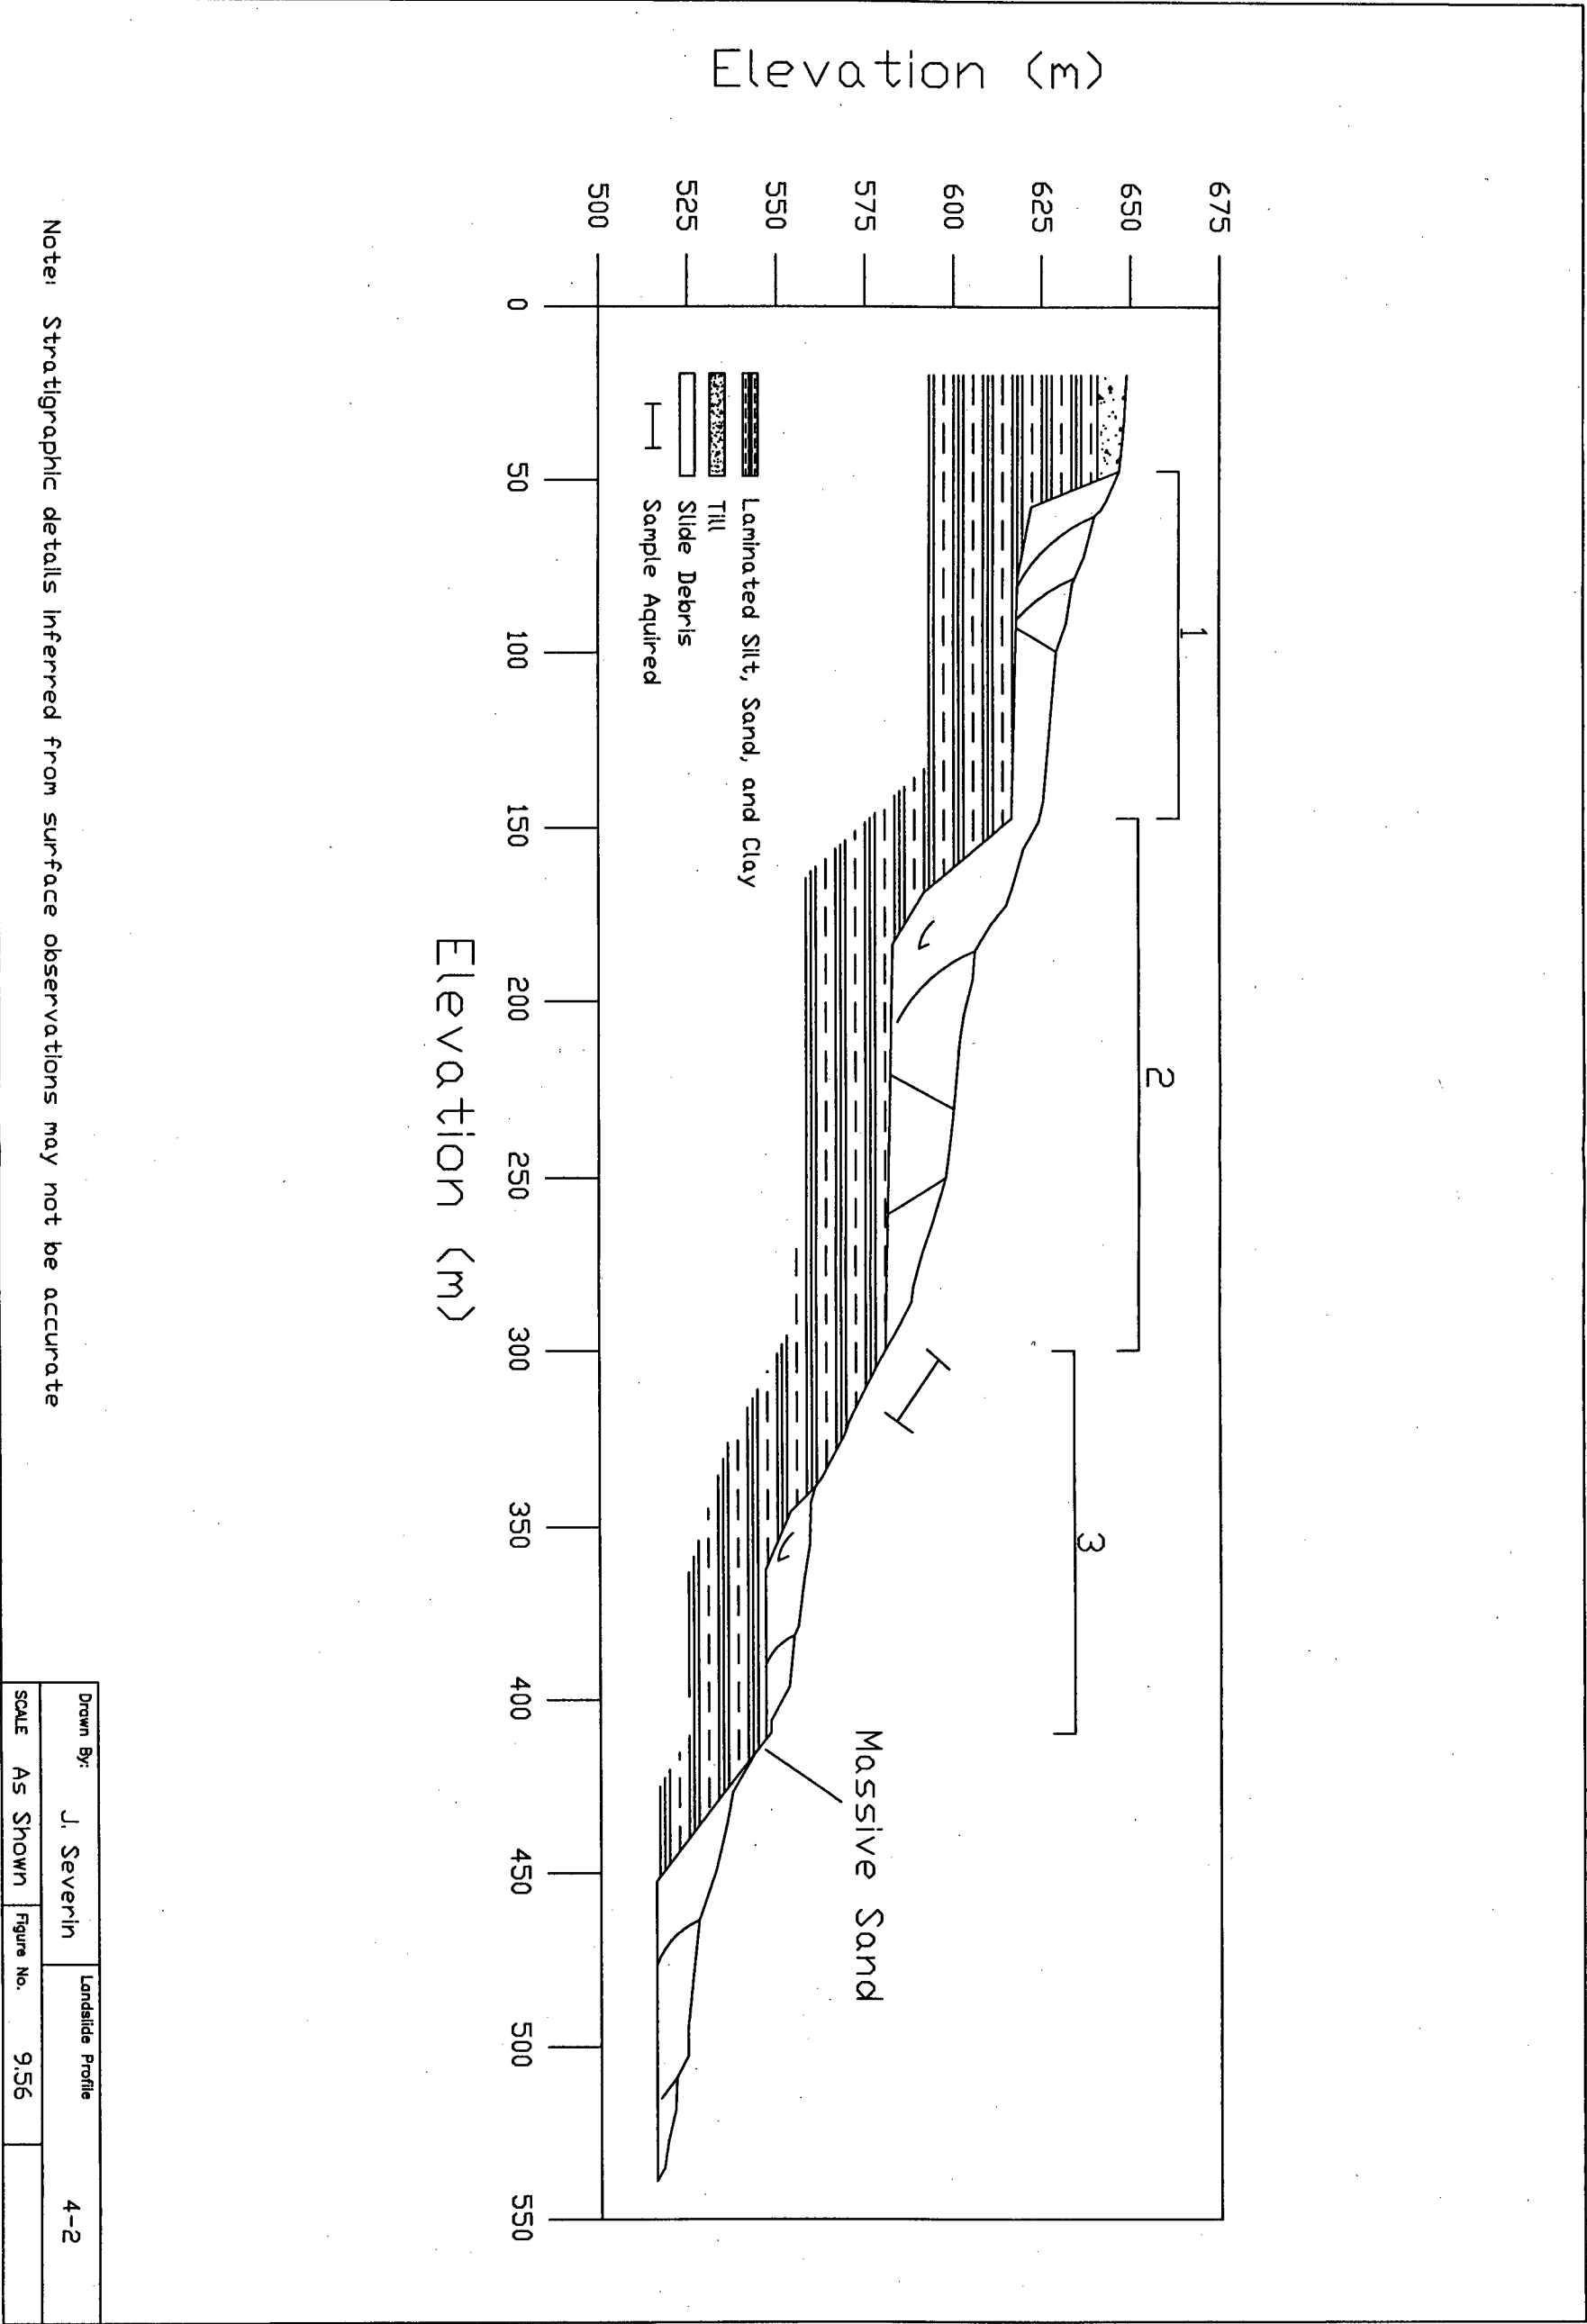
Figure 8.56 Landslide Profile 4-2

This failure is a very active multi-level failure within the Pleistocene sequence on a north facing slope on the Beatton River (Figure 8.56). The failure is located approximately 500 meters upstream from the bridge within the area. The profile begins upon a stable plateau underlain by till and heads down slope at an azimuth of 26°. The failure contains three failure planes all within the sand-dominated pre-glacial sediments. Most of the upper section of the slope is covered in colluvium and the shear planes are

Most of the upper section of the slope is covered in colluvium and the shear planes are not visible. The upper failures are interpreted from slope morphology to have rotational and translational failure mechanisms. Most of the features are muted and older than the toe. Below the upper failures is an intact section of massive sand with small interbeds of silt and clay. The lower failure is fresh with a shear surface (sample 4-2 A) within a silt-rich package within the sequence (sample 4-2 B). The shear plane is composed mostly of silt (77%) with some clay (18%). The plasticity of the sheared material is fairly low, with a liquid limit of 39% and a plasticity index of 24%. The intact clay bed sampled is actually 97% silt, which has low plasticity with a liquid limit of 28% and a plasticity index of 8%. Below the intact section where the shear plane was found, is a toe of remobilized debris.

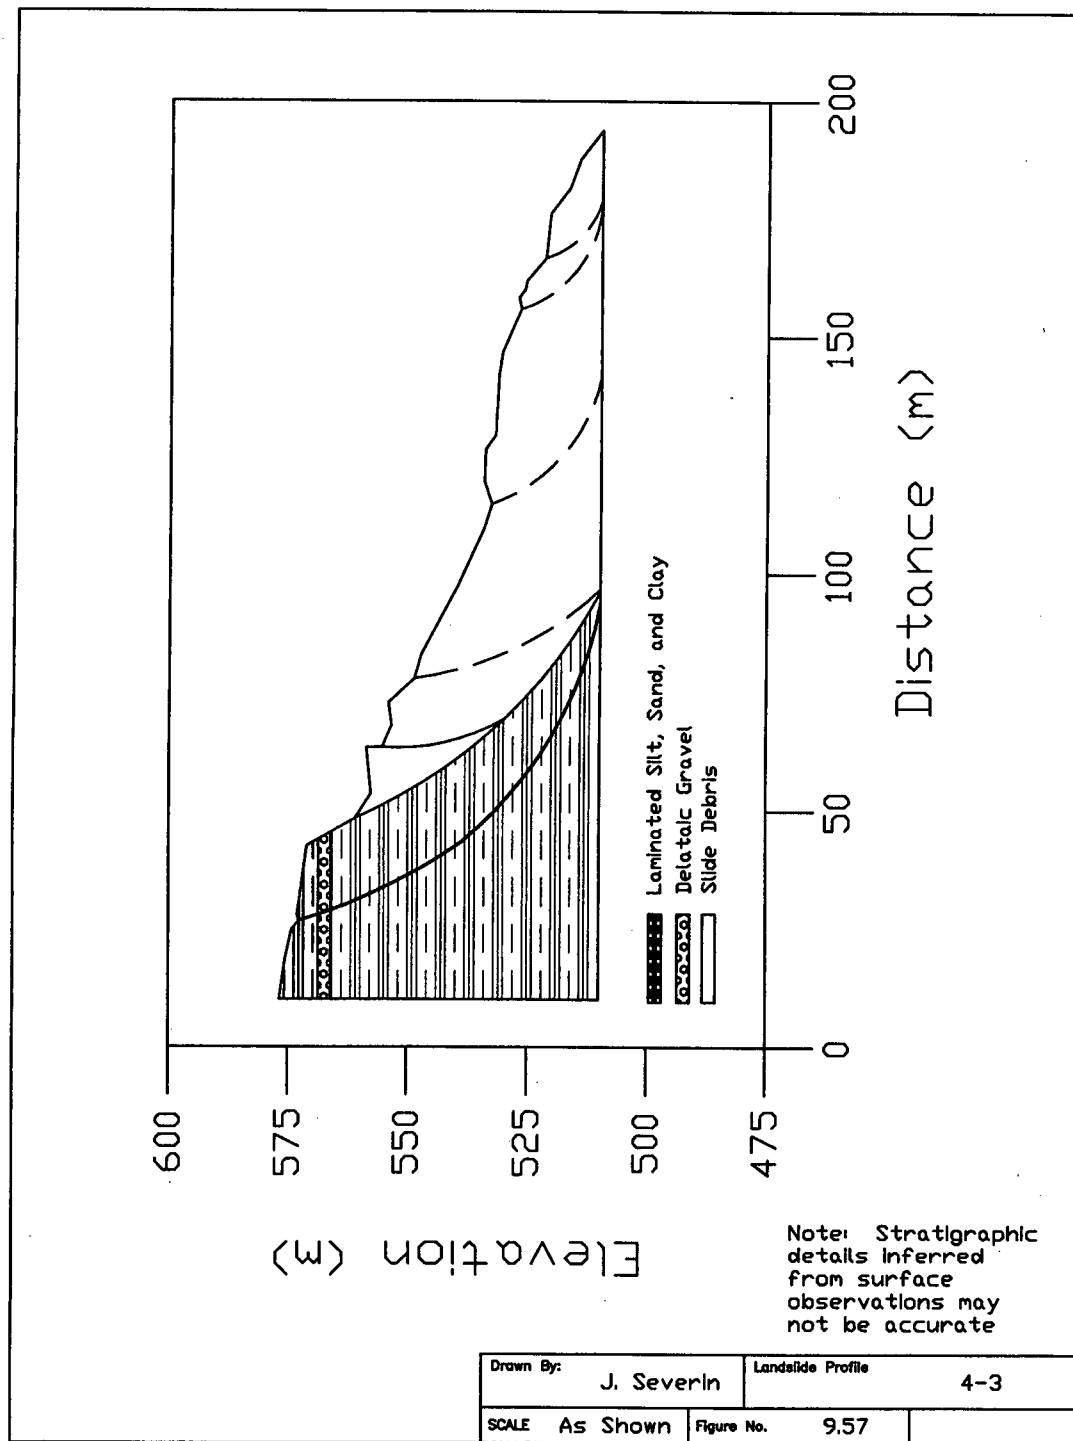
Figure 8.57 Landslide Profile 4-3

Slide 4-3 is a small, very active, rotational failure on a south-facing slope on the Beaton River (Figure 8.57). The profile begins mid-slope on a stable bench and heads down towards the river level at an azimuth of 147 (Figure 8.50). The slope above this failure is likely part of a separate failure. It could not be profiled, as the roadway that bisects the slope was heavy with traffic. The debris surface is fresh with ponding and intact slump blocks within the debris mass. The head scarp has a complex stratigraphy with silt, gravel, and massive clay. The single failure plane for this slide is within the pre-glacial unit with the bedrock missing at this section. The basal shear plane was not found but is interpreted as being slightly below the river level. The slump blocks within the debris have matching stratigraphy found in the head scarp and in an intact section near the slide.

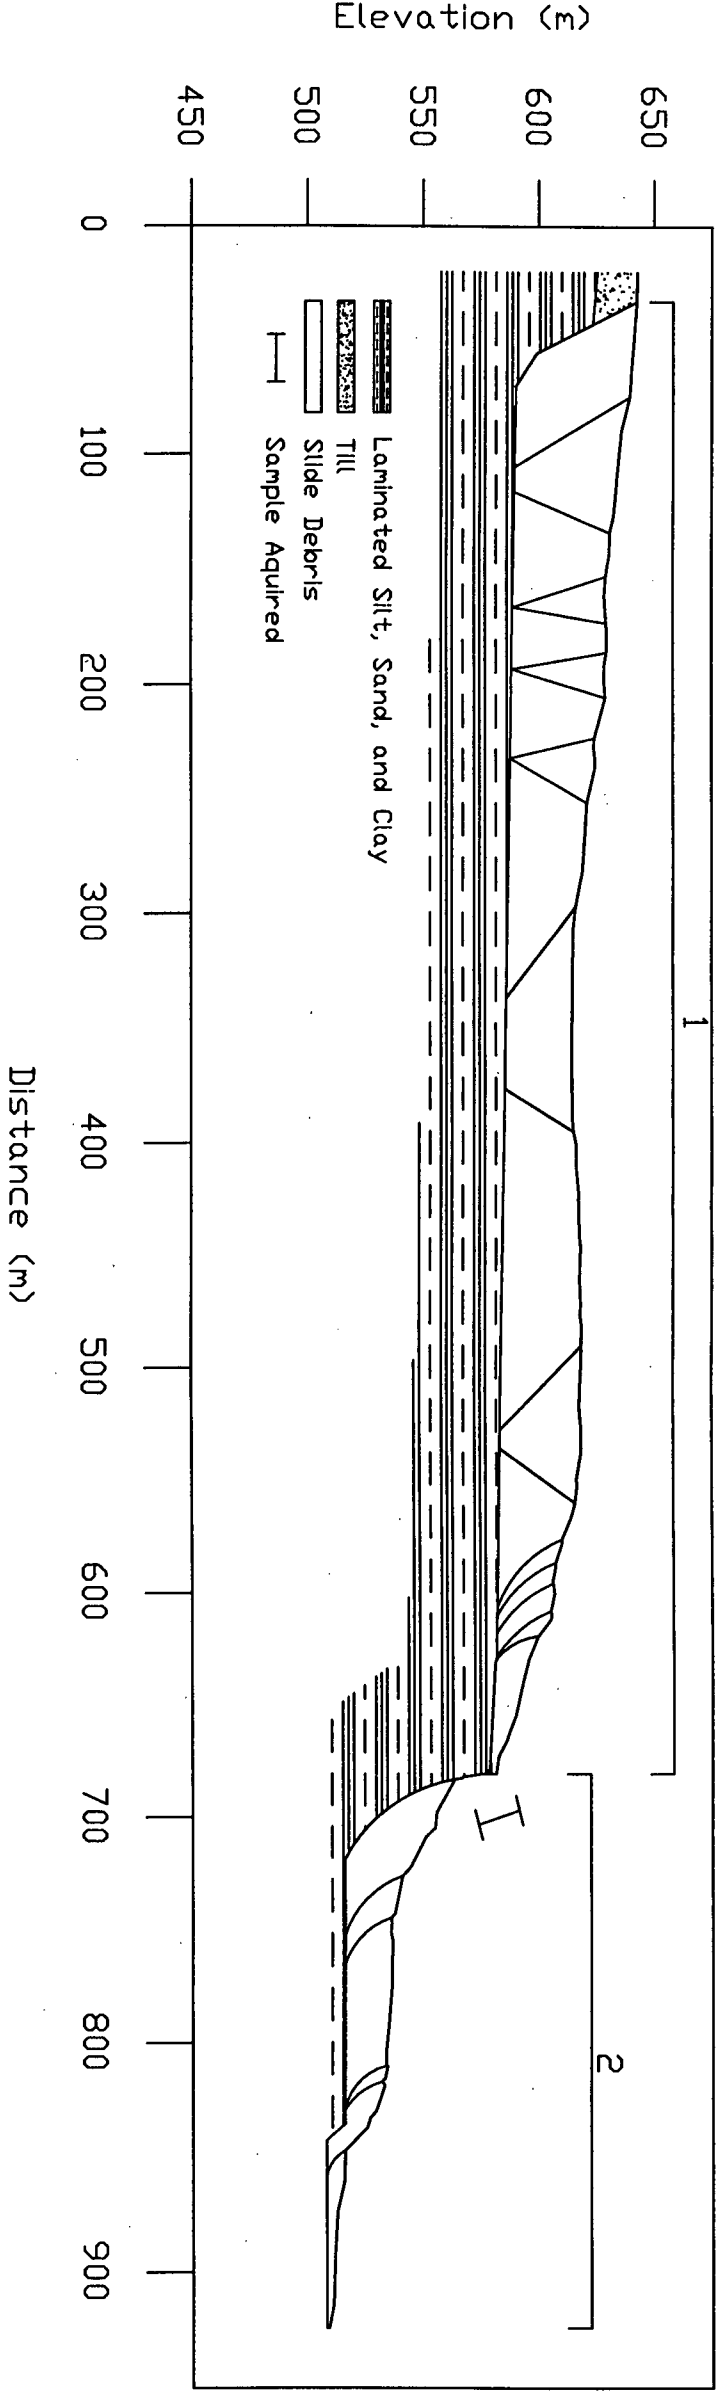
Figure 8.58 Landslide Profile 4-4

Slide 4-4 occurs on a north-facing slope on the Beatton River roughly 3 kilometers south of the Christian Camp (Figure 8.50). The profile begins on a stable section of the slope. It is presumed stable due to the lack of any landslide features and the low angle of the slope (1°). The profile continues down the slope at an azimuth of 330°. The slide has two failure planes, both within the pre-glacial sediments (Figure 8.58). The upper failure is a deep, compound failure approximately 700 meters long and 50 meters deep. The debris mass exhibits dormant, translational features, i.e. horst, grabens, and cross-tilted trees. A rotational failure occurs behind the toe of the upper slide because of an intact scarp in which the shear plane for the compound failure was located (sample 4-4 A). The shear plane is made of silt, 76%, and clay, 13% and has a medium plasticity with a liquid limit of 58% and a plasticity index of 35%. Below the main shear, smaller shear planes were found and sampled (sample 4-4 B). These shear planes are also mostly made up of silt, 86%, with minor clay, 10%. The secondary shears are much more plastic with a Liquid Limit of 73% and a Plasticity Index of 53%. The intact face shows a complex stratigraphy (Figure 8.54) with several shear planes and massive clay unit with drop stones and gravel lenses. Below this intact face exists a second debris mass with rotational slide features, including ponding and back tilted slump blocks and trees. This lower failure has fresh features and is very active as it occurred 2 years ago. The toe of the slide is assembled of remobilized debris.

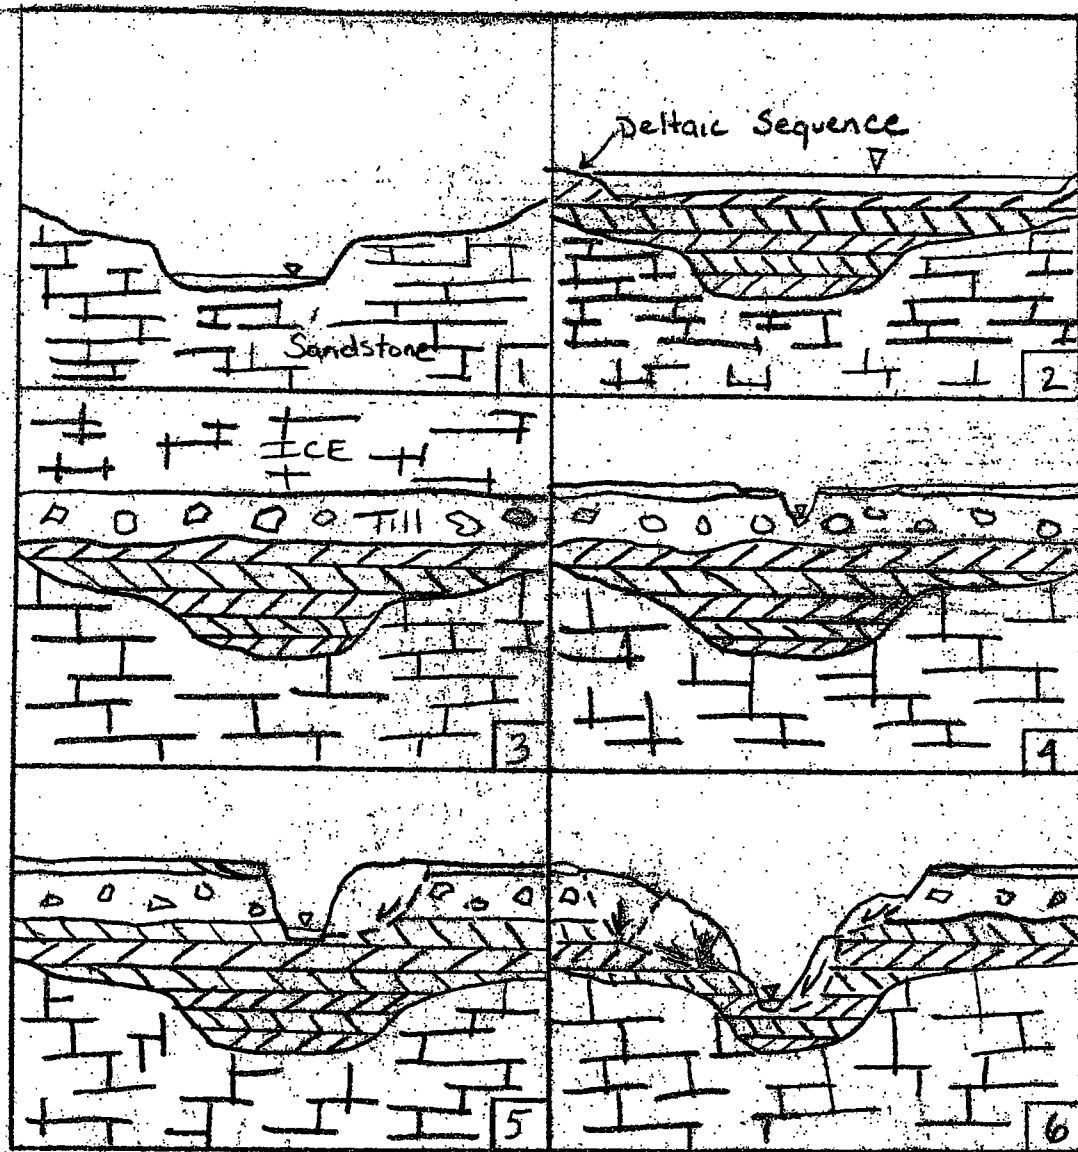
Figure 8.59 Landslide Area 4 – Geologic Model

This area represents a deltaic sequence within the pre-glacial materials above a stable bedrock channel of sandstone (1). The materials of this sequence are variable and therefore the failure planes cannot be correlated over a longer distance (Figure 8.59). The pre-glacial unit represents a deltaic environment as the Beatton River continued to transport sediment into an expanding ice-dammed lake within the river valley (2). The area then became glaciated (3) as evidenced by the till and post-glacial lake sediments. Drainage became re-established (4) and eventually cut into the deltaic silts, sands, and clays. The river channel at this time likely had steep walls, as the till in this area is mostly competent. Once the river eroded down into the pre-glacial sediments, layers of weaker, more plastic materials were exposed and failures occurred along them. The debris mass likely acted as a protection berm until it was eroded. As the river continued to cut downward, new layers were exposed and failures occurred along several failure planes as the intact material weakened and softened. This process is still occurring, shown by the high activity of landslides found on this river. Several of the failure planes occur at similar elevations, so there may be larger beds which can extend over a large area, but for the most part, failures that occur at similar levels at this site do so by coincidence. The failures at this location are generally rotational with shorter shear planes than in other areas. The variability of the materials is directly responsible for the shorter shear planes. The valley was created by rapid erosion and down cutting. This process has exposed the plastic layers and allowed them to fail. The clay beds within the sequence may have been pre-sheared by glaciotectionics and by horizontal relaxation during the valley rebound. During valley rebound, the weakest layers undergo the most deformation; in this case, the

- 1) Stable pre-glacial bedrock channel; 2) Aggregating deltaic environment into encroaching ice-dammed lake;
- 3) Glaciation; 4) Drainage re-establishes; 5) Post-glacial river erodes down into till leaving steep banks, once softer, laminated sediments below are reached, initial failures occur; 6) Failures continue to occur, on older, upper lower bedding planes and lower planes once exposed. Debris at base acts as a berm for debris on slope.

plastic clay layers are the victims. As downcutting occurs, these failure planes are exposed and allowed to fail. Often the upper sections of the slope contain older, dormant failures, suggesting that toe erosion is the major trigger of landslides in this area.
