**A FRAMEWORK FOR UNDERSTANDING POST-EARTHQUAKE DECISIONS ON
MULTI-STOREY CONCRETE BUILDINGS IN CHRISTCHURCH, NEW ZEALAND**

A THESIS SUBMITTED IN PARTIAL FULFILLMENT OF
THE REQUIREMENTS FOR THE DEGREE OF

THE FACULTY OF GRADUATE AND POSTDOCTORAL STUDIES
(Civil Engineering)

THE UNIVERSITY OF BRITISH COLUMBIA
(Vancouver)

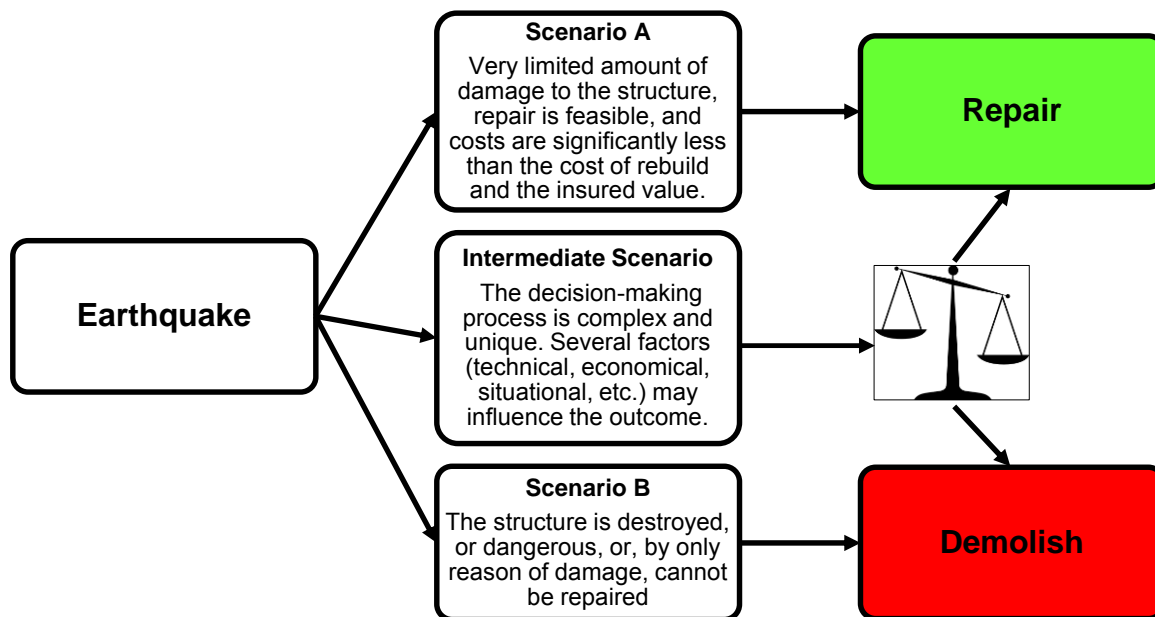
Figure 1: Possible courses of action on earthquake-damaged buildings - simple model

Building owners in Christchurch, New Zealand were faced with unexpected and challenging decisions after the 2010-2011 Canterbury earthquake sequence. As evidenced in this thesis, the decision on an appropriate course of action (whether to repair or demolish) for a building damaged during an earthquake depends on a number of interrelated factors. This research explores the factors surrounding the decision-making process for multi-storey concrete buildings in the post-earthquake Christchurch Central Business District (CBD). Although the rationale behind such decisions is typically complex, a simple model may be used to introduce the research problem (Figure 1). Scenario “A” refers to a building that has insignificant damage (i.e. little to no effects on the structural integrity, stability, and building contents), and where the remediation costs, expressed as a ratio of the insured value of the building, are significantly low to justify a repair decision without any detailed analysis. On the opposite side, scenario “B” implies a heavily damaged building where the demolition is the only course of action available, both from a technical and economical perspective. These two scenarios (A and B) are relatively simple and straightforward in terms of the decision process. The “intermediate” scenario, however, represents an area of uncertainty (grey zone) and complex decision-making, where a wide range of damage may be observed and different variables and alternatives need to be considered by the building stakeholders. The aftermath of the Canterbury earthquakes has revealed the importance to understand the conditions surrounding decisions on damaged buildings. This thesis explores the boundaries and implications of these scenarios, with a focus on the complexities associated with the “intermediate” scenario.

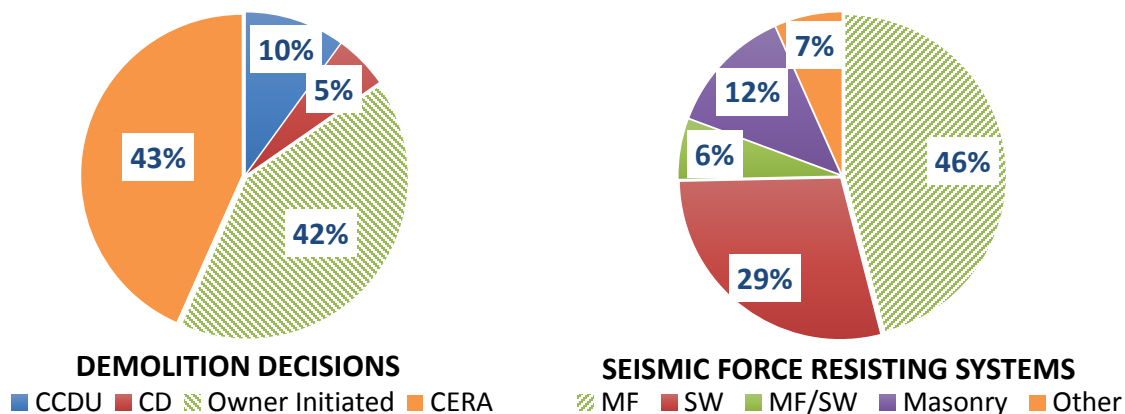
Figure 9: Summary - Significant building demolitions (out of 150 demolitions)

(Data source: Canterbury Earthquake Recovery Authority, Silverfish Database)

(Legend - CCDU: Christchurch Central Development Unit; CD: Civil Defence; CERA: Canterbury Earthquake Recovery Authority; MF: Moment Frame; SW: Shear Wall; MF/SW: Mixed system with both moment frames and shear walls)

In September 2014, the Canterbury Earthquake Recovery Authority (CERA) reported that approximately 150 significant buildings (generally commercial and multi-unit residential buildings over five storeys in the CBD) had been demolished, representing about 65% of the significant buildings in the CBD and immediately surrounding neighborhoods. This number includes Civil Defence (CD) demolitions immediately after the February earthquake and compulsory acquisitions under the Christchurch Central Development Unit (CCDU) recovery plan, accounting for 5% and 10% of the demolitions of significant buildings, respectively (Figure 9). The majority (~80%) of demolished significant buildings were reinforced concrete structures, with the dominant seismic force resisting systems being moment frames (MF) and shear wall (SW), representing approximately 46% and 29% of the considered buildings, respectively (Figure 9). Only nine steel structures with more than 5-storeys were recorded in the CBD and three such buildings have been demolished. The geographical distribution of commercial and residential building demolitions (including partial demolitions, i.e. the removal of part of a building for immediate safety reasons) within Christchurch CBD is presented in Figure 10. CERA has issued demolition notices (Section 38 Notice) on approximately 65 significant buildings which have been identified as dangerous (out of 150 demolitions). According to the CERA database, a similar number of demolitions (62 significant buildings) were initiated by the owners, although the buildings were not declared dangerous by CERA.

Because of the absence of any specific legislation or guidance for the repair of damaged buildings, compliance to the building code (including triggering fire protection and disability access) has increased the costs covered by insurance and complexity of claims. Interviewees also stressed that many tenants, banks (mortgage) and insurers are demanding premises to be at least 67%NBS (in some cases even requiring 100%NBS), but additional rental income will not necessarily be generated from the expenditure, rendering the repair of older buildings less economic, especially in a market generating a surplus of new office buildings at 100%NBS (PCNZ 2014). Informed occupants, including large multinational tenants and government tenants, have changed their perception of earthquake risks, which resulted in pressures on building owners to meet higher earthquake strengthening standards than required by the law, which also had repercussions on the property market in other cities in New Zealand. Another factor, although less significant than other factors in this study, is that parcels of land in the central city have been designated for the Anchor Projects under the Central City Recovery Plan, which affected the course of action for a small number of repairable buildings (Figure 9, Figure 16).

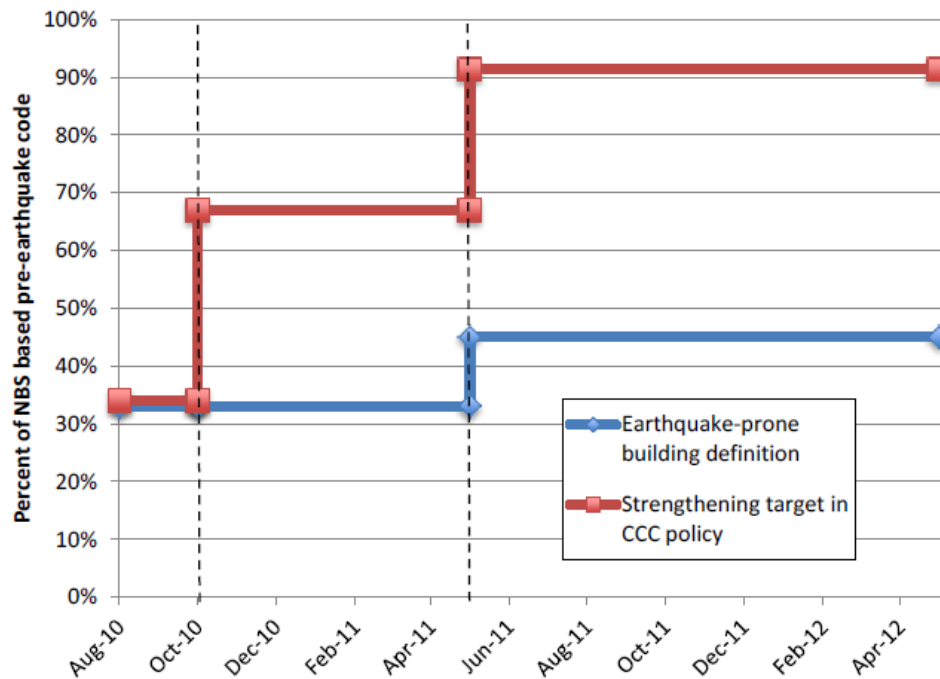
Figure 12: Impacts of the legislation changes and EPB policy since September 2010 (Source: Taylor 2013)

The Christchurch City Council (CCC) is the local government authority for Christchurch. As required by section 131 of the Building Act 2004, CCC had in place an Earthquake-Prone, Dangerous and Insanitary Building Policy. Before the 2010 September earthquake, this policy required all earthquake-prone buildings for which there was a change of use or significant modification to be strengthened at least up to 34% NBS within a timeframe varying from 15 to 30 years. As a result of the September 2010 earthquake, CCC amended their policy and raised the level that a building was required to be strengthened to from 34% to 67% NBS (CCC 2010). This requirement was qualified as a ‘target level’ specifying that the actual strengthening level for each building deemed earthquake-prone should be determined in conjunction with the owners on a building-by-building basis. The amendment included a section covering the repair of buildings damaged by an earthquake, also including a target of 67% NBS for a repaired building. Although the 67% NBS was considered as a target rather than a requirement, exemptions from achieving this requirement were typically limited when applying for a building consent for earthquake repairs, with significant heritage value or other relevant considerations the only reasons for non-compliance. Therefore, by combining the increase in the basic seismic design load for Christchurch and the CCC’s strengthening ‘target level’ for earthquake-prone buildings, the differential between pre-September 2010 and post-February 2011 earthquake design loads was significantly raised for such buildings, as illustrated in Figure 12. As discussed in this thesis, the minimum seismic standard adopted by the Building Act and the CCC’s recommendation of a higher seismic performance level has created misinterpretation among building owners and other stakeholders (e.g. insurers) regarding appropriate strengthening level for the repair of EPBs. The liability for the increase in repair costs was also a critical issue, since insurance policies for commercial buildings typically stated that the repair of the building, including additional costs necessary to comply with current regulations, are covered but such increase in costs were not included in earthquake insurance risk models.

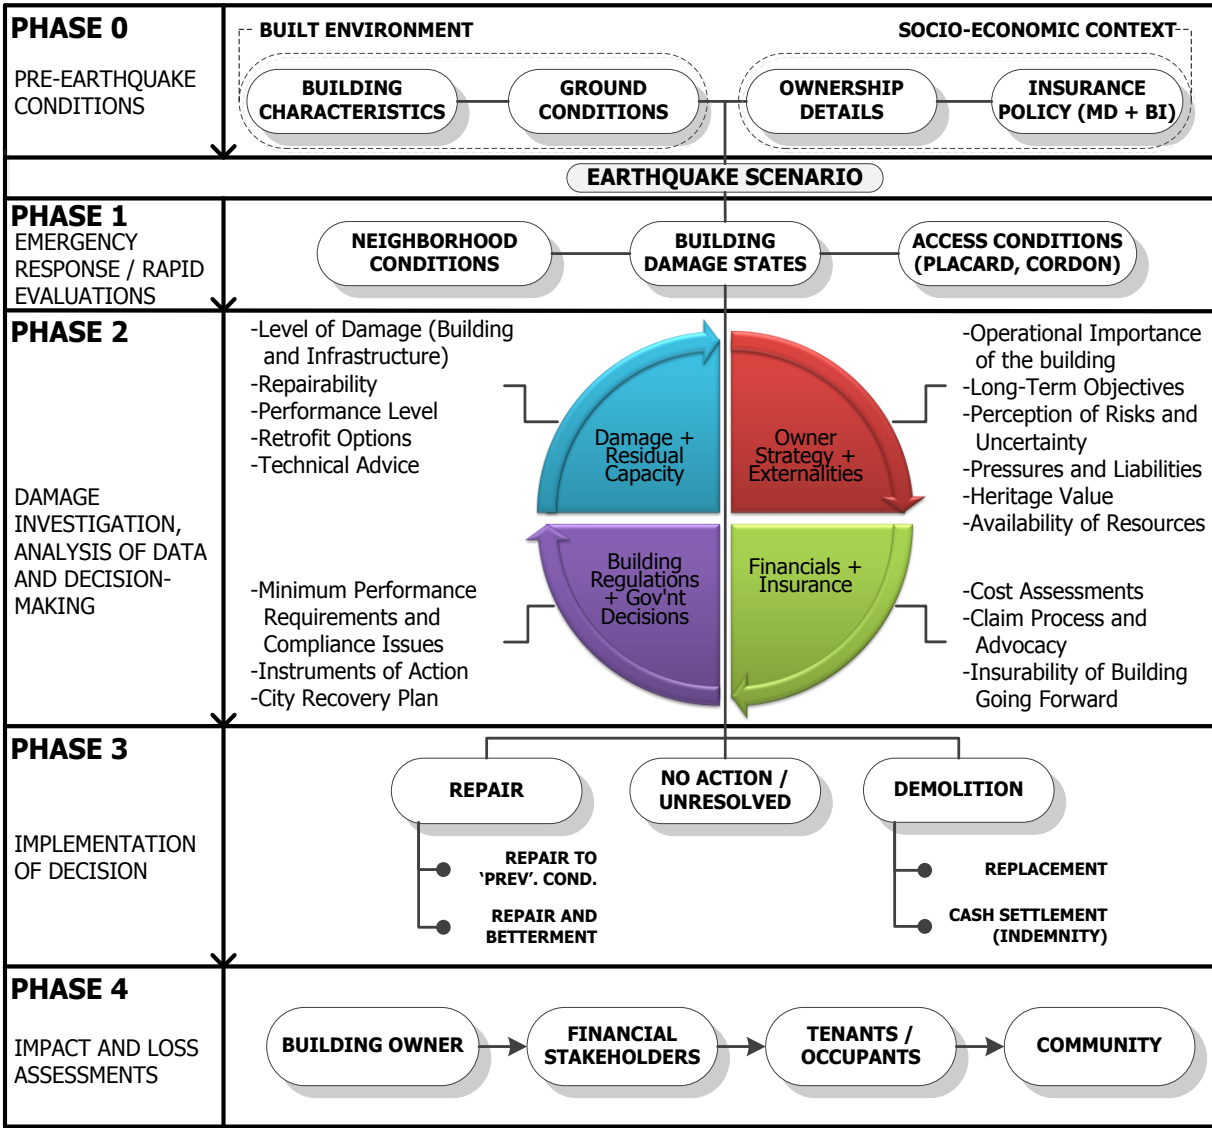
Figure 15: Conceptual framework for studying variables influencing post-earthquake decisions

A conceptual multi-phase framework was developed prior to the interviews and refined based on observations from the interviews and data collection (Figure 15). The framework is a tool to study how building owners and organisations responded to the Canterbury earthquakes and made decisions on the future of their buildings, with consideration given to the different players involved in the process (engineers, insurers, tenants, etc.).

The sequential phases of the framework facilitated the organisation of the data collection process in a chronological order, from post-earthquake visual inspections to subsequent impacts on building stakeholders, together with possible outcome scenarios. For the sake of completeness, a contextualisation phase defines the pre-earthquake conditions of the building, ground conditions, ownership details, and insurance policy (material damage and business interruption). The framework adopts a holistic perspective by providing the necessary background for a specific building, in addition to taking into account any particularities of the built environment or socio-economic conditions that may have influenced the final decision (as discussed in sections 2.1 and 2.2). Although some variables may be more significant than others in relation to a specific building, findings from the study suggest that decision-making variables influencing the course of action on earthquake-damaged buildings may be grouped into four themes: insurance, damage and residual capacity, decision-making strategies, and legislation. Observations from the interviews revealed that the interrelation of these factors, in addition to the unique features of the earthquake sequence and uncertainties in the recovery of Christchurch, added complexity in determining appropriate courses of action. Results presented in this thesis are organized based on these four interacting themes (Chapters 4 and 5).

This chapter describes the results from the interviews in relation to the decision-making themes identified in the framework (insurance, damage and residual capacity, decision-making strategies, and legislation) (Figure 15 – Chapter 3). As the framework suggests, the four themes address the major considerations for building owners and property managers in the process of determining the fate of earthquake-damaged structures. The following sections discuss the conditions in Christchurch and how the factors are interrelated in arriving at the final decision. The first section (recovery progress) does not explicitly relate to the decision-making framework variables, but provides the necessary background to examine how the government and the community response to the earthquakes may have influenced the whole context of decision-making for earthquake-damage structures in the central city.

Building owners generally took a simplistic and pragmatic approach to decide on the future of their buildings. As illustrated in the framework (Figure 15), there are a number of possible scenarios: a building is repaired to the same performance level; a building is repaired to a higher standard; a building is demolished and replaced with an equivalent building (same site or different location); or a building is demolished and not replaced (cash settlement). Although there are some variations, decisions were usually based purely on economics. Interviewees also reported other decision-making variables, such as business strategies, perception of risks (by owners, tenants and insurers) and uncertainty, technical advice, building regulations (e.g. changes in building code, compliance issues), and government decisions (e.g. cordon, mandatory demolitions, compulsory acquisitions). Access and neighborhood conditions (expressed as demolition percentage of buildings that are located within a 100 m radius) appeared not to be very significant in the decision to repair or demolish, but very significant in terms of business interruption and speed of the recovery. The majority of commercial property owners in Christchurch were passive investors, but some interviewees reported they had to assume a greater role in property development and day-to-day affairs after the earthquake due to all the complexities of complying with both the insurer's and government's requirements. Most investors interviewed considered it a good outcome if their building was declared a total loss and demolished, because of the financial benefits, flexibility, and speed of cash settlements (as explained above). They preferred to demolish their buildings, in part because of uncertainties in the recovery of Christchurch, and move forward more quickly with cash. Building investors and tenants reportedly preferred new buildings over repaired old buildings. One building owner involved in the accommodation sector reported that a repair scenario would be a massive disadvantage to the rest of the market in terms of new build hotels or low-rise hotels moving forward. Furthermore, one interviewee reported some issues around the taxation system that may have financially favored demolition scenarios rather than repair, although this research did not assess the influence of this factor in the decision process. In New Zealand, demolition costs are generally not deductible for tax purposes, however the Central Government made changes in December 2010 that allow demolition costs to be included as a tax deduction under certain circumstances. This provided some tax relief in a situation where a demolition of a building is required. Moreover, a cash settlement (including the scenario where the insurance proceeds are more than the depreciated value of the building) is generally tax free. On the other hand, any repair works which improve a damaged building beyond its earlier condition is generally considered as a capital improvement rather than a tax deductible repair. Therefore, there were some tax benefits to demolish rather than repair, especially for earthquake-prone buildings or structures needing strengthening to higher %NBS.

This thesis provided numerous insights into these questions. The conceptual framework described in Chapter 3 (Figure 15) captures key variables influencing post-earthquake decisions in the 2010-2011 Canterbury earthquakes. An improved understanding of the rationales behind building owner's decision-making strategies and engineering recommendations has been achieved through the investigation of case-study buildings in Christchurch and semi-structured interviews with various building stakeholders in New Zealand. Moreover, correlations of post-earthquake decisions with structural building characteristics, observed damage, insurance, business strategies, and building regulations were established in Chapters 4 and 5. Although there is a need for further research, the second question was addressed in Chapter 5 by discussing how the regulatory environment and the substantial lack of standards directed towards the repair of earthquake-damage buildings played a role in the demolition and repair decisions. Recommendations arising from the research findings are presented in this chapter (section 6.4).

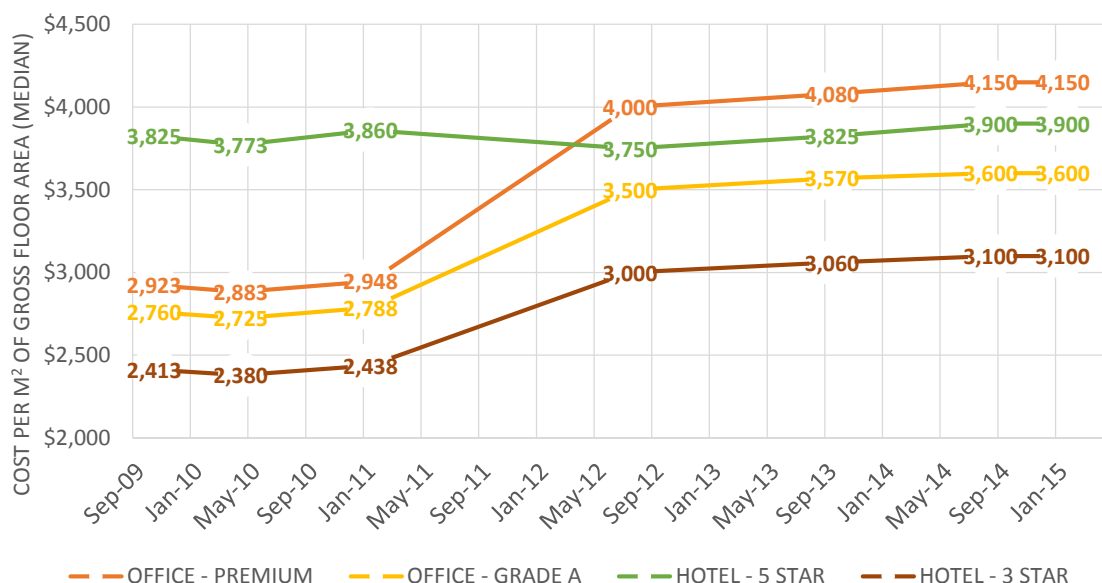
Figure 20: Median construction rates (in \$NZD) between 2009 and 2015 in Christchurch (Data source: Rider Levett Bucknall 2015)

Rider Levett Bucknall (RLB) publishes hard construction cost estimates for office, retail, hotel, car parking, industrial warehouse, and residential multi-storey buildings in Christchurch. These costs are expressed per m² of gross floor area and typically include the base building costs (structure) and fit-out. We have used RLB's values to estimate the replacement cost of specific case-study buildings and compare against the sum insured for material damage in the insurance policy to evaluate the degree of underinsurance. We have selected the median values for office and hotel buildings for each year between 2009 and 2015 from the RLB reports. As shown in Figure 20, there was a significant increase (approximately 25% to 30% increase) in the construction costs after February 2011 due to post-disaster demand surges in the construction industry and resources shortages (excluding 5-star hotels for which pre-earthquake construction rates were relatively higher in comparison to other types of building occupancy). These cost estimates do not include the costs of demolition, contingency, FF&E, professional fees, and taxes (GST).

Based on observations from the interviews, experience of local engineers, and actual construction cost for new buildings in Christchurch (RLB 2015), we estimate that 1980s-1990s office and hotel buildings with less than approximately 320% sum insured (expressed as a ratio of the building value, including depreciation) were not fully covered for replacement (demolition and rebuild) (Table 26). This threshold is greater for older or heritage buildings (e.g. the rebuilding cost for building R74 was about 850% of the building value according to the 2014 insurer's valuation) and lower for more recent buildings (between 150% - 200%). Therefore, only two case-study buildings are estimated to have had sufficient coverage to rebuild (D192, R113) when accounting for demolition costs, contingency (10%), furniture, fixture and equipment (FF&E - \$NZD 100 per m²), professional fees, permits (12.5%), and taxes (GST – 15%). The actual cost of demolition for each building was considered when available and a cost of \$NZD 200 per m² of gross floor area (excluding taxes) was used otherwise (when demolition costs were not available or for repaired buildings). These costs are consistent with the local practice based on recommendations from two industry professionals.
