RECLAMATION ACTIVITIES AT THE NICKEL PLATE MINE TAILINGS FACILITY

Sonia M. Sahota P.Eng., Graham R. Greenaway P.Eng. and Bruce S. Brown Ph.D. P.Eng

Knight Piésold Ltd.
Suite 1400 - 750 West Fender Street
Vancouver, B.C., V6C 2T8
Canada

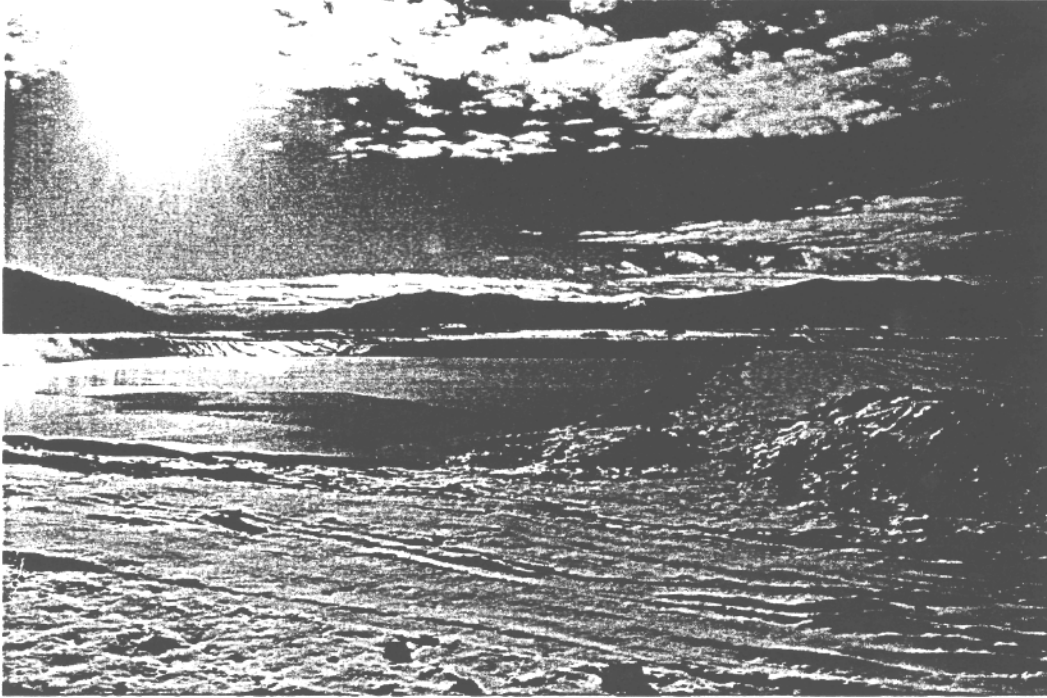
Photo No.3 - Seepage Storage Pond.

approximately 1.5 million US gallons of water. The seepage pumpback at present varies between 80 and 200 USgpm and seepage rates are estimated to reduce to less than 5 USgpm within five years of closure. The pond has been conservatively designed to provide approximately 5 days of storage based on a seepage return rate of 200 USgpm. The seepage storage pond at completion is shown by Photo No. 3.
