FORDING RIVER DIVERSION

Paper Presented by:

J.A. Wood  
Vice President  
Kerr Wood Leidal Associates Ltd.  
North Vancouver, B.C.

## FORDING RIVER DIVERSION

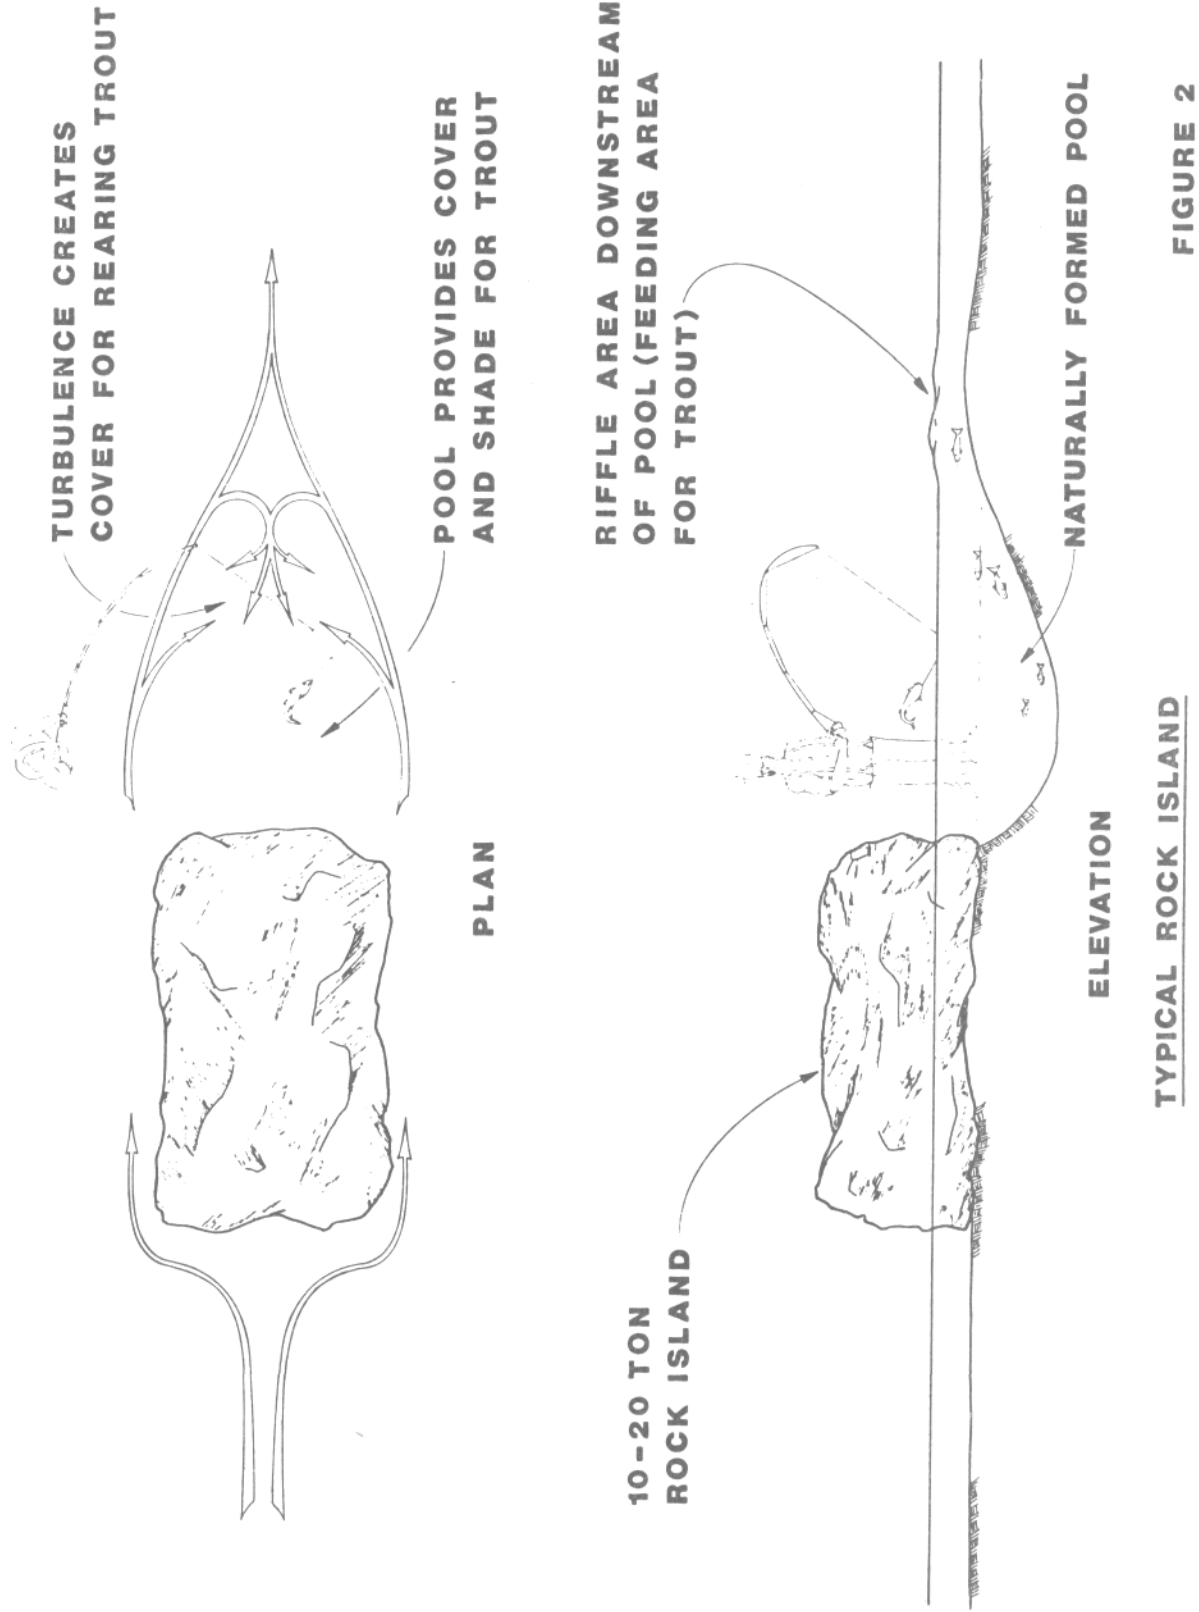
In conjunction with the drop structures, approximately 60 large rock islands were installed along the length of the channel, roughly in the center half of the diversion. These islands create areas of concentrated flow and back eddies resulting in a non-uniform regime which results in gravel-bar formation and river sections of varying depth. It has been found with other diversions that a relatively large pool will form immediately downstream of the rock island after the first freshet, generally as shown on Figure 2. This area becomes a feeding and holding area for trout. The turbulent section below the pool results in cover for the fish and generally coincides with a higher velocity riffle area. Generally the fish will feed in this area and then hold in the actual pool behind the rock where the velocity is lower and often reverse to the normal direction of flow.
