WATER MANAGEMENT AT BRENDA MINES

Ronald Brown, B.A.Sc

Brenda Mines Ltd.

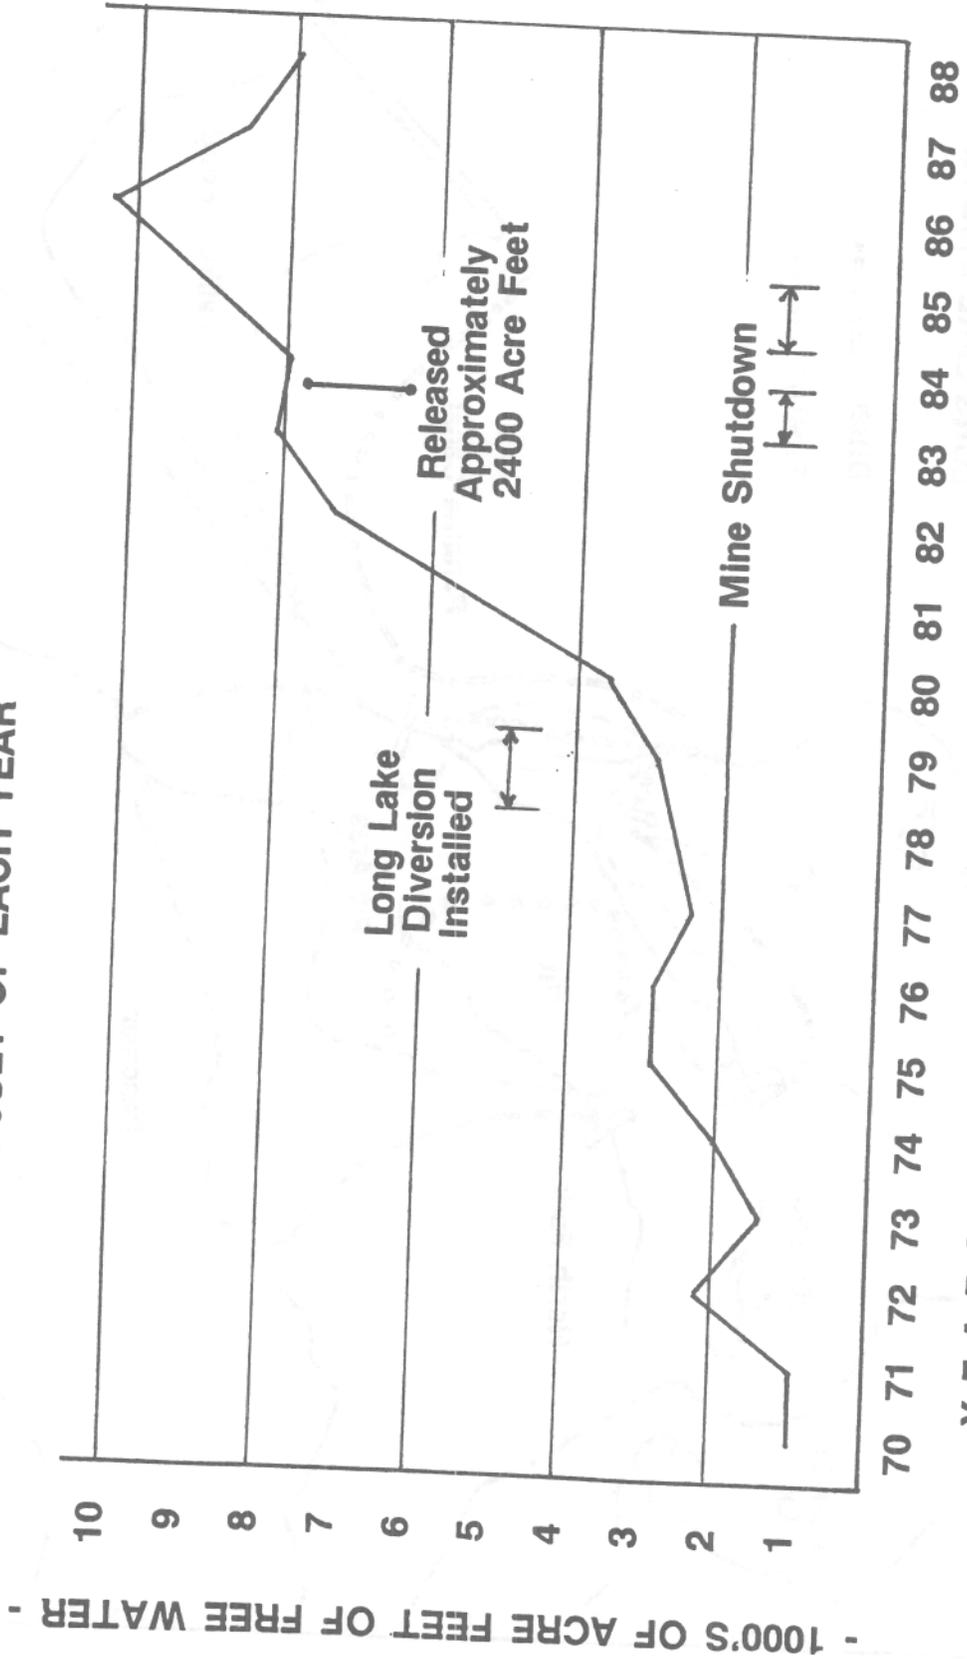
**BRENDA MINES LTD.
VOLUME OF FREE WATER
IN TAILINGS POND IN ACRE FEET
SURVEYS DONE IN JULY OF EACH YEAR**

appear. From the start of the mine we had the tailings pond surveyed and the amount of free water calculated. In 1970 this was 1,000 acre feet. During the 1970's the amount rose but stayed in the 2,500 to 3,000 acre feet area/ its rise or fall apparently dependent on precipitation, spring run-off, and evaporation. With rock pile and pit water now going to the tailings pond the free water started to rise steadily. In August 1979 it was 2,900 acre feet. By August 1983 it was 8,050 acre feet. See Figure 4. However, the combination of increased pond area and dam building allowed us to maintain a satisfactory beach and dam height.
