DURABILITY PERFORMANCE OF ECO-FRIENDLY DUCTILE CEMENTITIOUS COMPOSITE (EDCC) AS A REPAIR MATERIAL

ABSTRACT

The objective of the experimental program in this thesis is to investigate the durability performance of Eco-friendly ductile cementitious composite (EDCC), a newly developed repair material for seismic retrofitting.

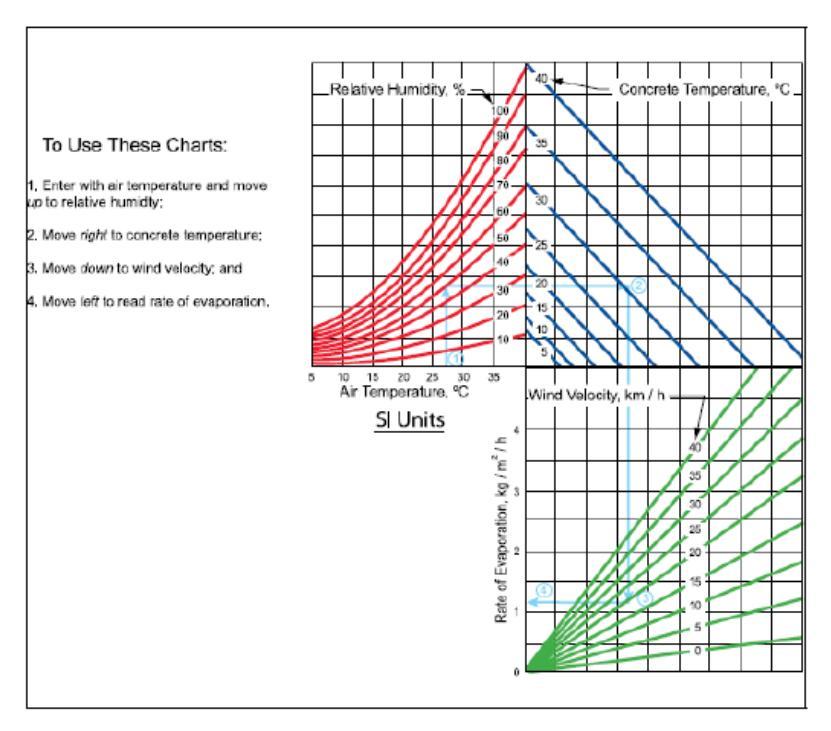
Figure 1 ACI evaporation nomograph [6]

In terms of external factors, moisture loss due to evaporation is the most critical one. As shown in the ACI evaporation nomograph in the ACI Manual of Concrete Practice, Section 305R, "Hot Weather Concreting," (ACI 305R-96, 1996) in Figure 1 [6], four main key external factors (air temperature, relative humidity, concrete temperature and wind velocity) affect the evaporation rate of moisture.

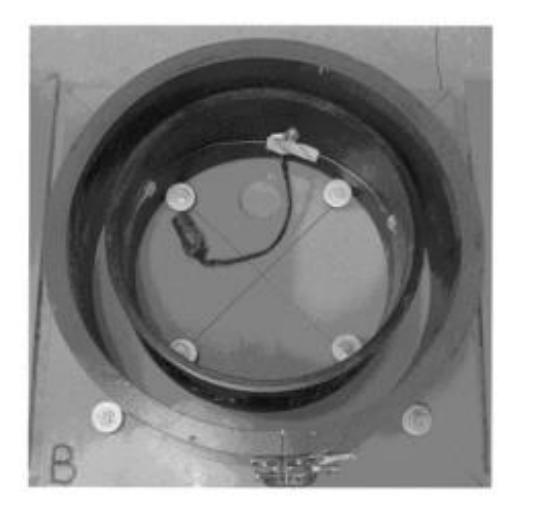
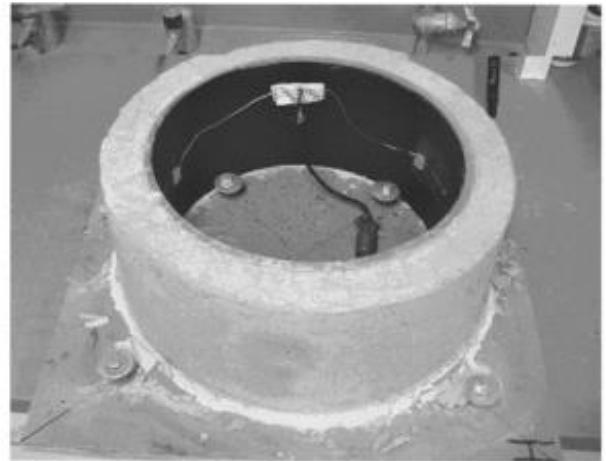
Figure 2 Steel ring mold and concrete ring specimen [11]

This test was employed by Grzybowski et al. [10] and is based on the principle that shrinkage is developed in concrete ring specimens in the mold (Figure 2) which is restrained by a steel ring mold at the center. Tensile stresses developed which can be then monitored and recorded over the course of time to help evaluate the performance. Now this method has been introduced to ASTM standard C1581 [11] to determine the age at cracking and induced tensile stress characteristics of mortar and concrete under restrained shrinkage as shown in Figure 3.

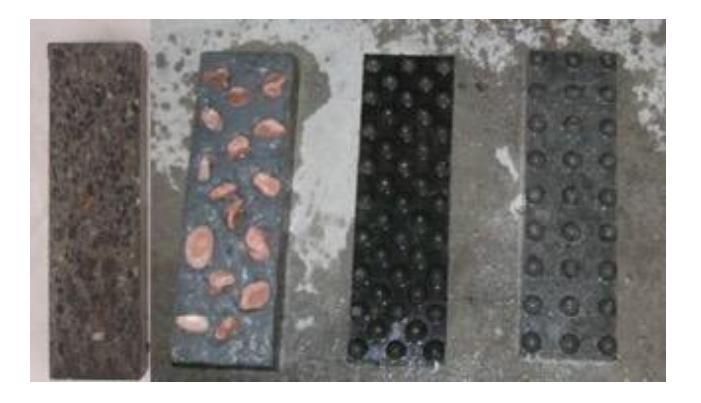
Figure 4 Different substrate surface finishes [3]

The protrusions on the base are used to provide full restraint of the overlay, originally achieved by different methods, such as aggregate finish and concrete protrusions, as shown in Figure 4.

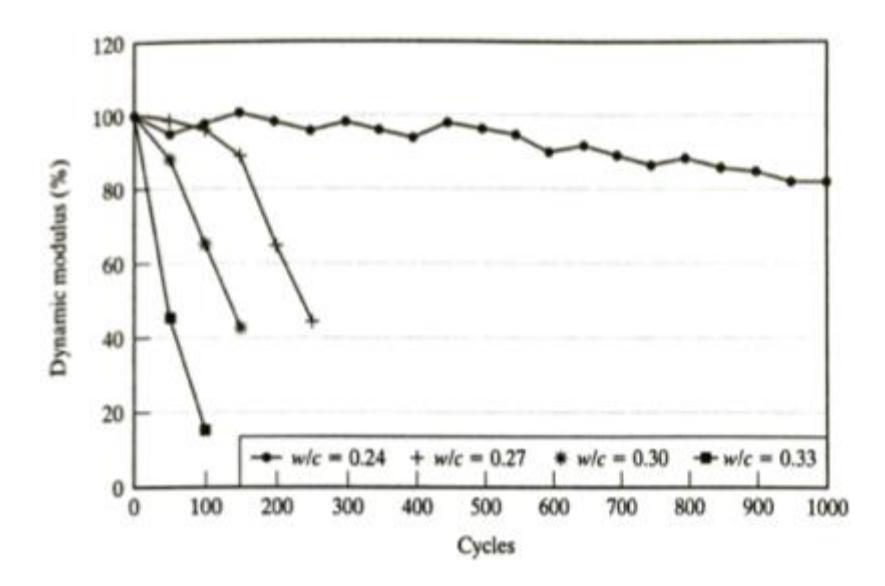
Figure 6 Freeze and thaw durability of non-entrained concrete without silica fume [16]

Theoretically, when the water cement ratio drops below 0.36, an air-entraining agent will would not be needed because the amount of freezable water is would be insufficient to cause frost damage [15]. Experimentally, it is shown that an air entraining agent is not needed when the water cement ratio drops under 0.24 as given in Figure 6. [16]

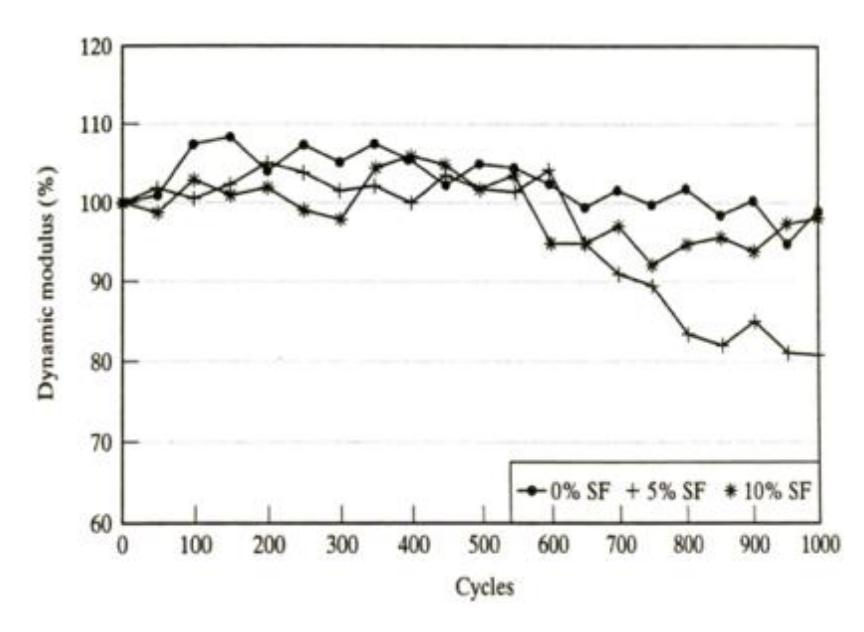
Figure 7 Freeze-thaw durability of non-air-entrained concrete with varying silica fume contents [17]

Usually, a relatively high amount of silica fume is found in high strength concrete giving it its high strength, as shown in Figure 7. It is has also been found by Y. Li et al. [17] that the amount of silica fume also has an impact on the frost resistance of high strength concrete. A mix with 10% silica fume exhibits an over 20% drop in frost resistance after 1000 cycles, compared to mix without any silica fume. Therefore, it is also suggested that it is preferable to keep the silica content under 10%.

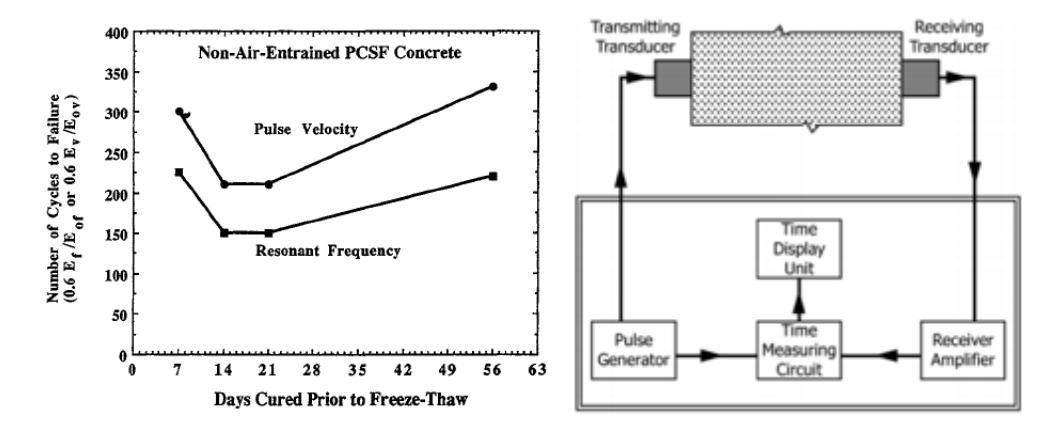
Figure 8 Pulse velocity and resonant frequency method comparison (left [18]) pulse velocity test schematic (right) [44]

In this experimental program, due to a machine issue, the pulse velocity testing method (Figure 8 right) was used as a way to quantify the freeze and thaw deterioration.

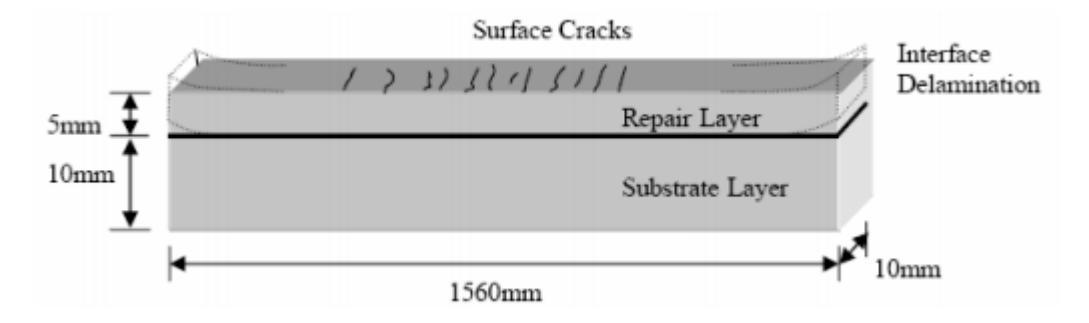
Figure 11 Layered repaired system for ECC [22]

In terms of the shrinkage resistance of ECC, Li et al. [22] developed a layered repair system shown in Figure 11 to measure the delamination and crack width of 3 repair overlay materials – concrete, SFRC (steel fiber reinforced concrete) and normal ECC, by exposing the system to a dry environment after a 28-day moisture cure. It was found that the ECC repair exhibited 53 μ m interface delamination at the end of 50 days, as compared to 65 μ m to the concrete repair and 275 μ m as compared with the SFRC repair overlay. As for cracks, 76 micro-cracks were found on the surface with a maximum crack width of around 60 μ m as compared to SFRC with 3 visible 270 μ m wide localized fractures, and 4 visible 140 μ m wide localized fractures on the

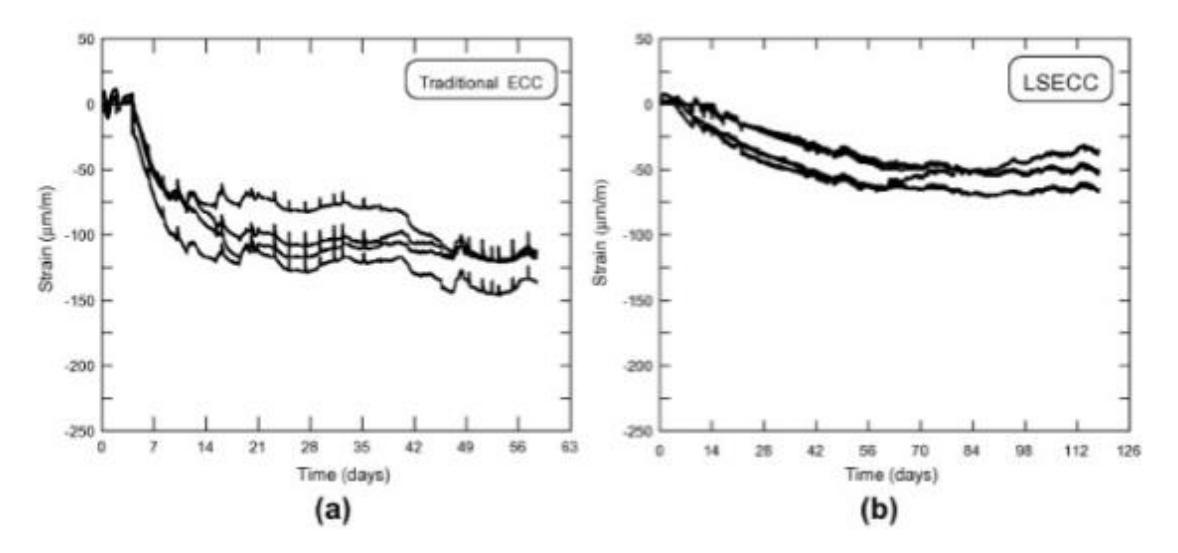
Figure 12 Shrinkage strain comparison between LSECC and traditional ECC [23]

Based on normal ECC, Low Shrinkage ECC (LSECC) and ECC with internal curing have been developed and tested to further improve the shrinkage resistance of normal ECC. Zhang et al. [23] experimentally evaluate the shrinkage induced cracking performance of LSECC, through standard ring tests, by changing ordinary Portland cement with the newly developed low dry shrinkage composite cement. The results in Figure 12 show a significant reduction in shrinkage tensile strain on the steel ring, without compromising the anti-cracking advantage and strain-hardening behaviour.

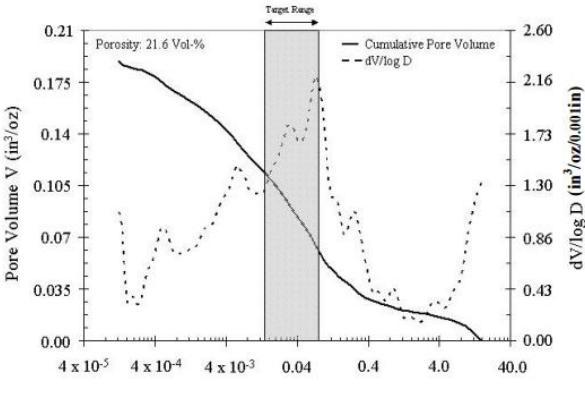
Figure 13 ECC pore distribution [25]

When evaluating the durability of ECC, especially in the harsh environment of the Canadian winter, freeze and thaw resistance is another important property. Li et al. [25] carried out mercury intrusion and porosimetry of the standard ECC mix, and found a large porosity of 21.6% small pores discovered because of fibers. It is expected that ECC should possess a very good freeze and thaw resistance based on current pore distribution (Figure 13) even without the help of an air entraining agent.

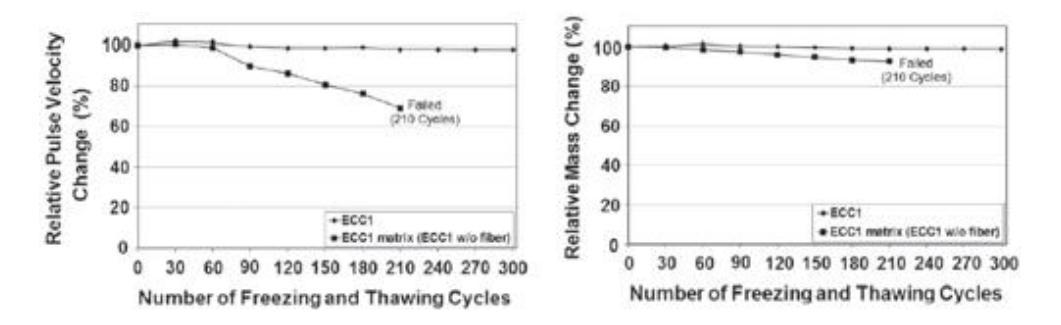
Figure 14 Relative pulse velocity and mass loss with number of freeze and thaw cycles [27]

Mustafa et al. [27] also assessed the frost resistance of ECC containing fly ash and found that fly ash replaced ECC also has great durability in terms of freeze and thaw resistance. ECC in their case survived 300 cycles and maintained good residual flexural strength compared to plain ECC matrix without PVA fibers. This is shown in Figure 14. The addition of PVA fibers should be responsible for this excellent frost resistance improvement.

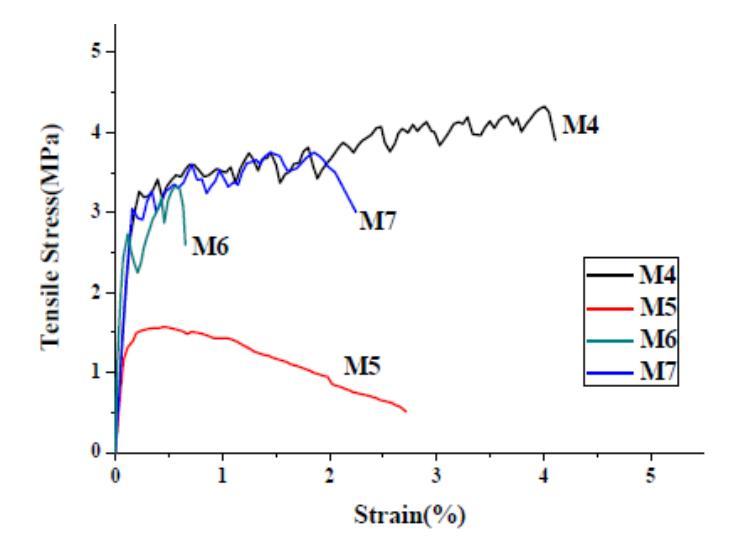
Figure 15 Tensile behavior of different EDCC fiber mixtures [30]

The entire experimental program in this thesis is based on these EDCC mixes that have been developed here at UBC to further evaluate the durability performance.

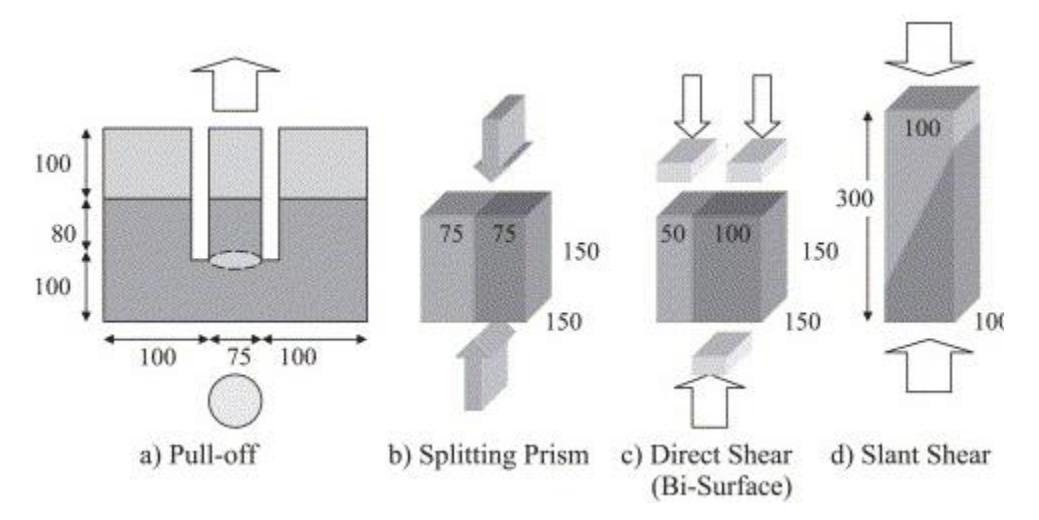
Figure 16 Different bond test methods [32]

There are three main categories of bond test methods: bond under tensile stress, bond under shear stress and bond under a combination of shear and compression, as shown in Figure 16. The dominant method for bond under tension is the pull-off test (a) which is adopted in this thesis and the splitting test (b). Shear bond test methods mainly include the direct shear test (c). The third category of both shear and compression is the slant shear test. [32]

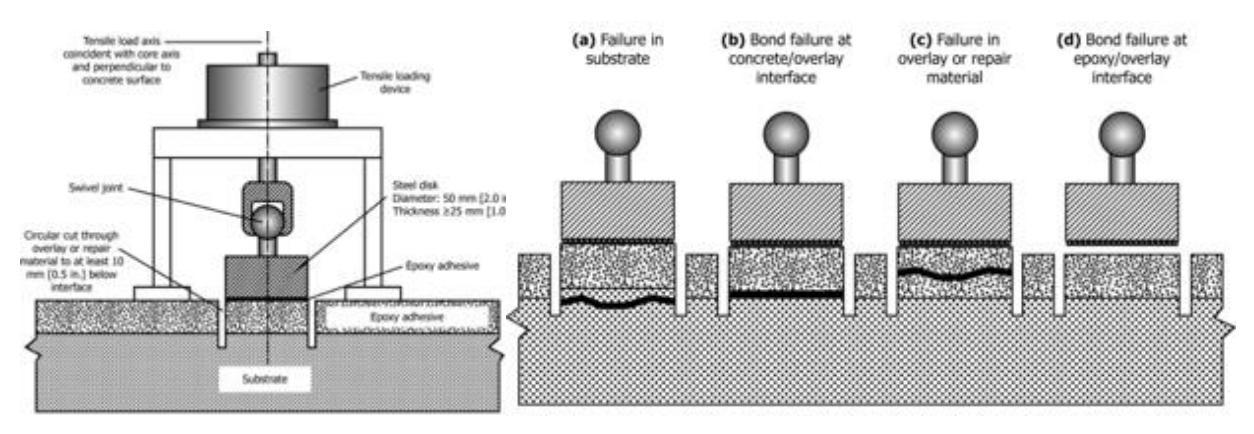
Figure 17 Pull-off test method schematic and different failure modes [4]

The pull-off test is used in this experimental program according to ASTM C1583. The principle of this test method is fairly simple. By attaching a steel disk to a pre-drilled circular cut, a pulling force is applied to the steel disk until the core is pulled off under a constant loading rate. The force/pressure is recorded as the bond strength between the overlay and substrate. There are generally four failure modes, as shown in Figure 17: failure in the substrate, failure at concrete/overlay interface, failure in the overlay and bond failure at epoxy/overlay interface. One of the disadvantages of this test method is that the bond strength value is always the lower bound of the real interfacial bond strength because it cannot be guaranteed that the failure occurs precisely at the interface every time.

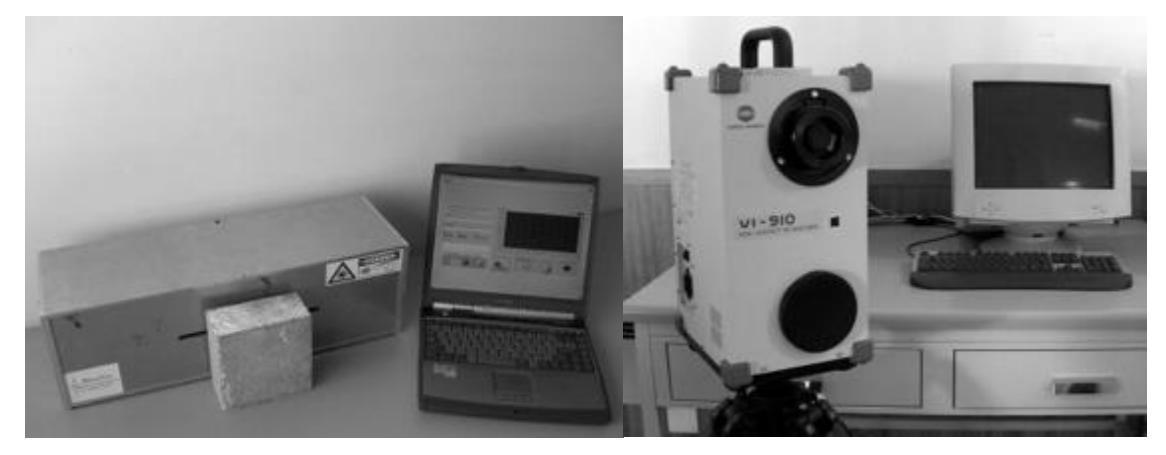
Figure 20 2D and 3D laser scanner [38]

For 2D laser scanning, firstly, several typical and representative lines on the surface are scanned with a 2D laser scanner. Then the data obtained is processed with a professional commercial software. Finally, related surface roughness parameters and curves are plotted using the software. With the advent of the 3D laser scanner, a full surface profile can be re-established on a computer and more detailed surface parameters derived from the scanned surface profile [38]. Obviously, 2D laser scanning is much more easily implemented than 3D laser scanning and many researchers build portable 2D laser roughness analyzer for in-situ purposes.

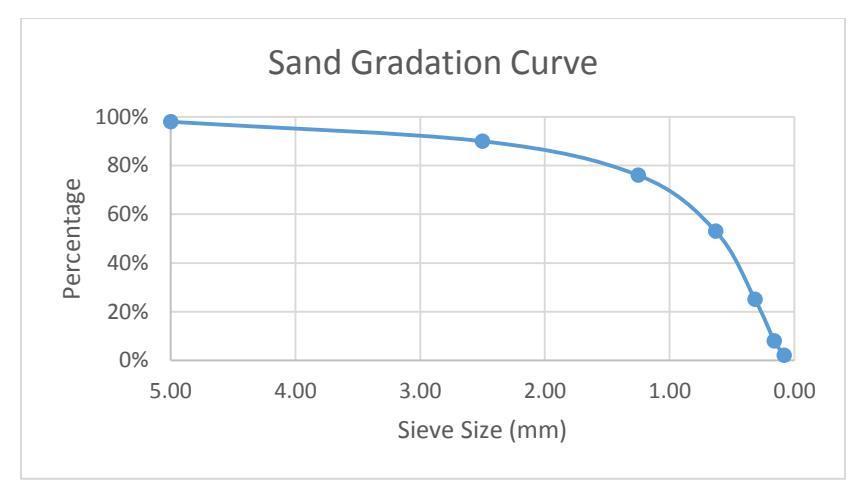
Figure 22 Sand gradation curve

Sand with a fineness modulus of 2.55 provided by Lafarge was used. The moisture content of the sand was also strictly monitored and calculated before every mix and the moisture content ranged from 2.1% to 4.9% due to different sand batches. The gradation curve for sand is shown in Figure 22.

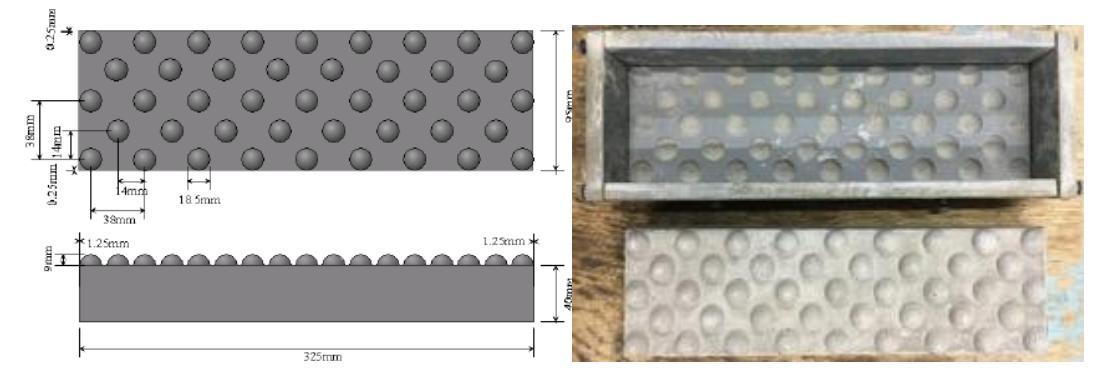
Figure 26 Substrate for shrinkage test (Rishi, 2008)

In order to simulate the real stress conditions in repair and substrate assembly, a novel and effective testing method has been developed to simulate extreme plastic shrinkage conditions. A very stiff base, reinforced with rebars and high strength concrete with compressive strength around 85MPa can provide extreme restraints with protuberances for overlay repair materials during early plastic shrinkage. In Figure 27 the dimension, mold and cast substrate are shown.

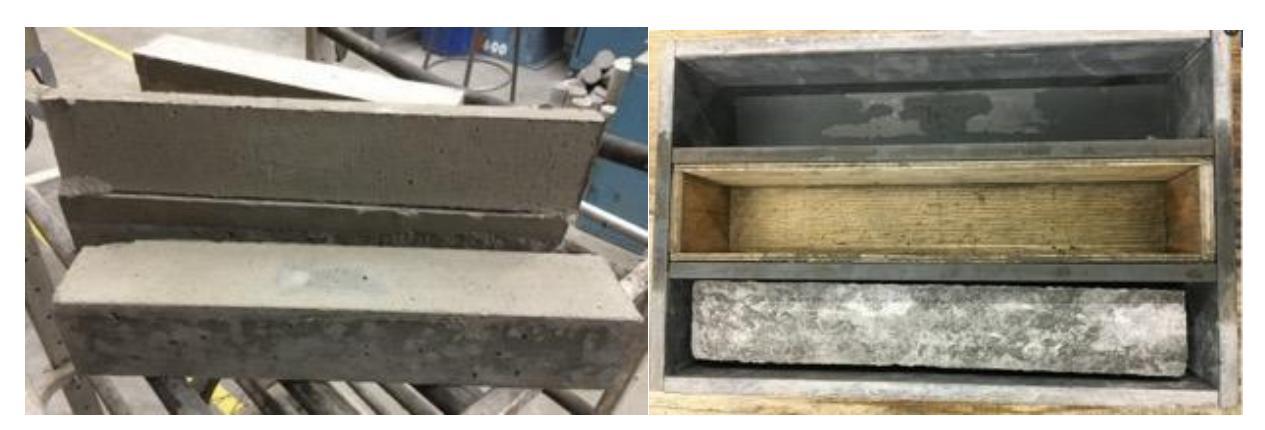
Figure 29 Repair overlay detached from substrate

In the beginning of the experiment, the dimension of the base is designed as $405 \times 75 \times 75$ (L×W×H) without leaving any space around the sample. Trial shrinkage testing was performed and it was found that after 24 hours the repair became detached from the substrate. This is because the mold was removed 2 hours after the fresh mix was cast and the condition of the interface at that time is very delicate so that any external movement will jeopardize the interface, causing it to debond, as shown in Figure 29. So, an overlap design was adopted to make sure the repair material had a full overlap around the base to diminish the edge effect. Finally, the base was confirmed with dimension at $385 \times 65 \times 75$ and the repair was designed with a 25mm thickness, as shown in Figure 30.

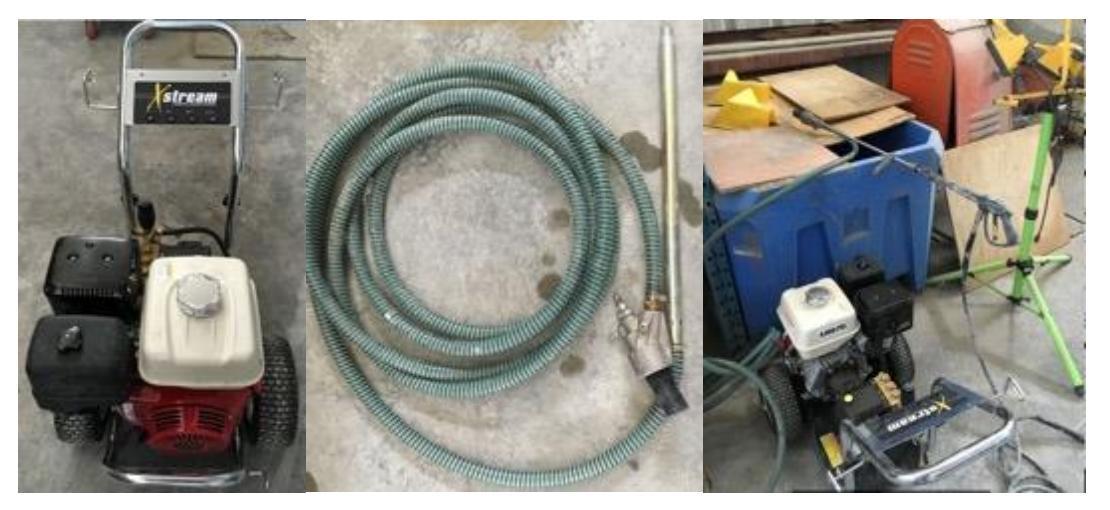
Figure 32 BE pressure washer, wet sandblasting kit and system set up

Due to very low efficiency and high cost of sand consumed in the preliminary set-up, a new 389cc Honda GX390 4000 PSI BE pressure washer, an industrial heavy duty wet sandblasting kit from ATPRO Powerclean Equipment, sandblasting tank with plywood cover and an industrial floor lamp were equipped in the sandblasting system (Figure 32).

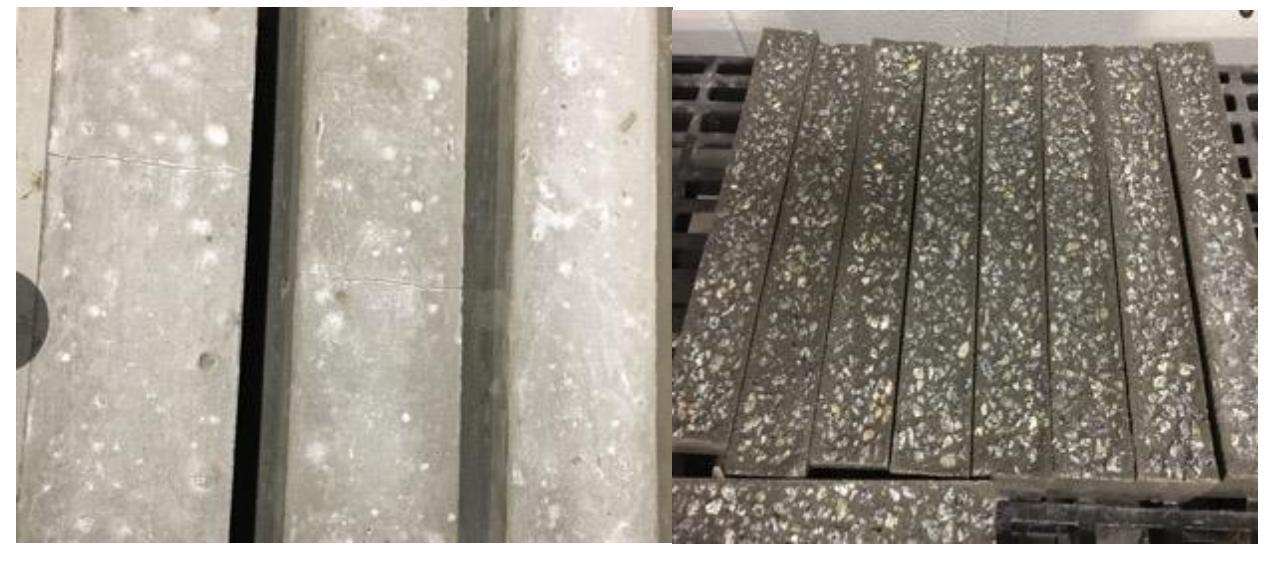
Figure 34 Sandblasted surface and shrinkage preliminary test

cracks on their surfaces, as shown in Figure 34. But the strongly sandblasted sample had bigger cracks (approximately 0.31mm), than the moderately sandblasted sample, which was approximately 0.14mm. Also, in consideration of the ease with which a replicable roughened surface could be obtained, the roughness of the strongly sandblasted (left) sample was chosen. As seen in Figure 34, on the right, the surface roughness is visually consistent.

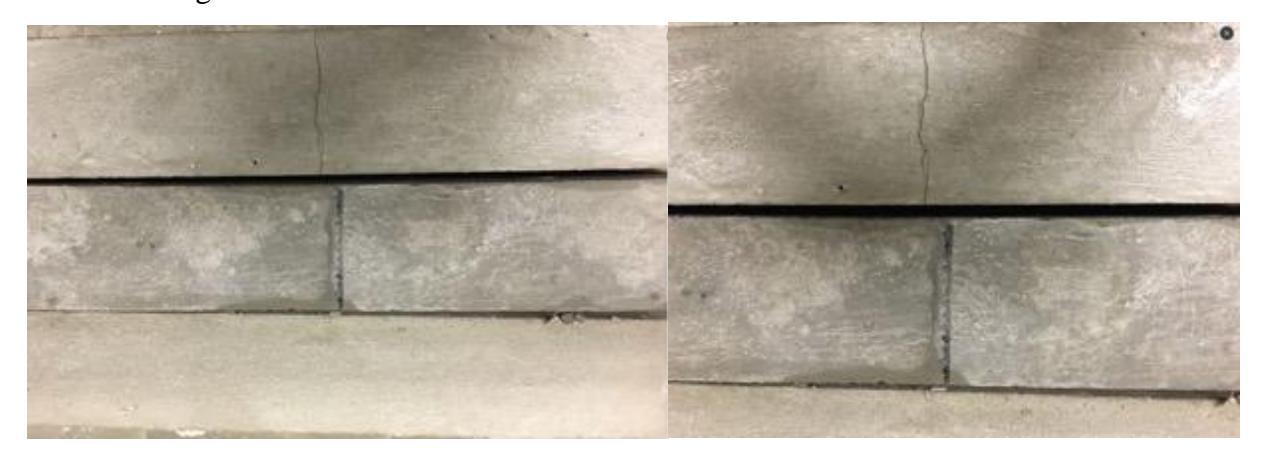
Figure 35 Replicable cracks in samples with similar roughness

In order to further prove the shrinkage results, more samples with similar roughness were cast and very similar and replicable cracks with close crack width, at around 0.29mm were obtained, as shown in Figure 35.

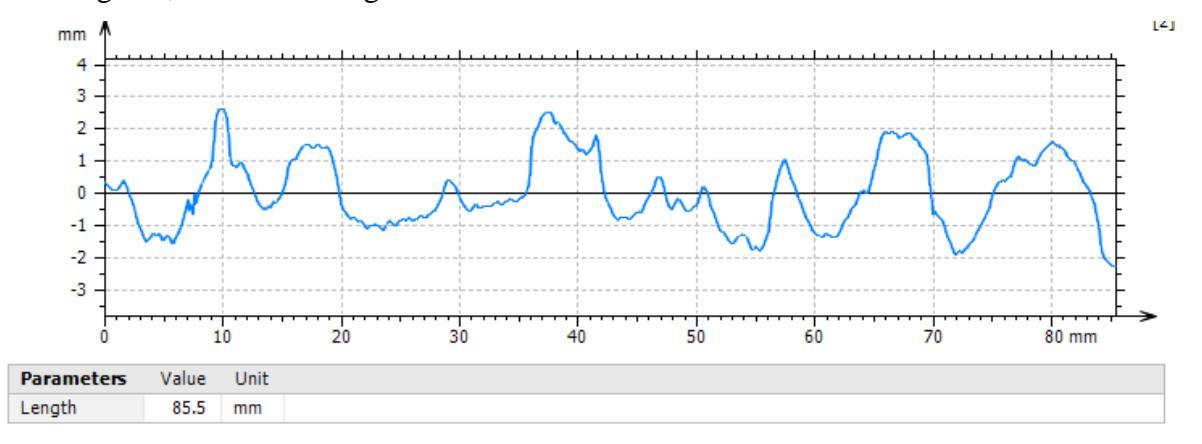
Figure 39 Form removed curve

Following the procedures specified in ISO 3274, first the form of raw data was removed and the curve was given, as below in Figure 39.

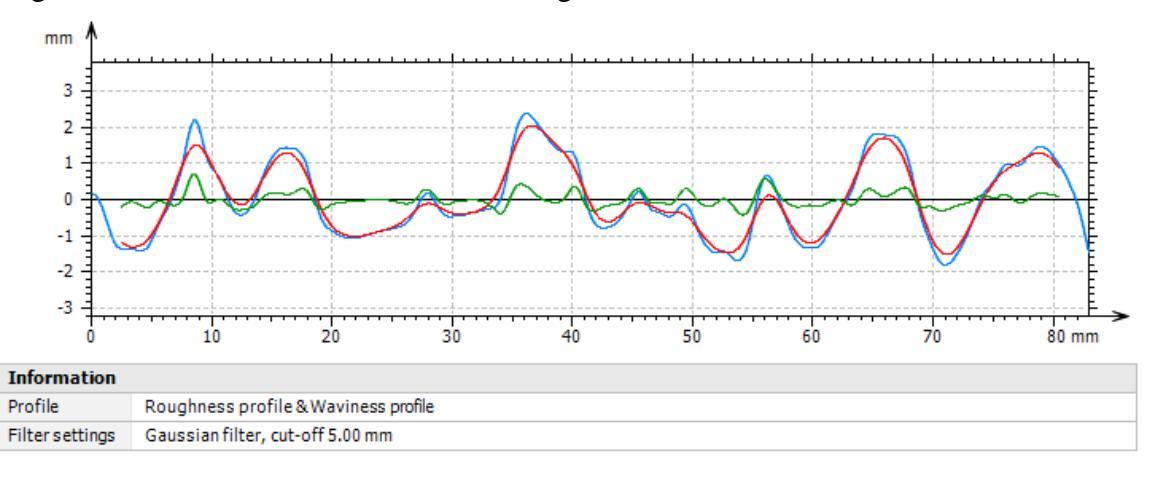
Figure 40 Roughness and waviness profile after filtering

After the form was removed, a Gaussian filter with cut-off distance at 5mm was applied to filter the roughness and waviness curves, shown in Figure 40.

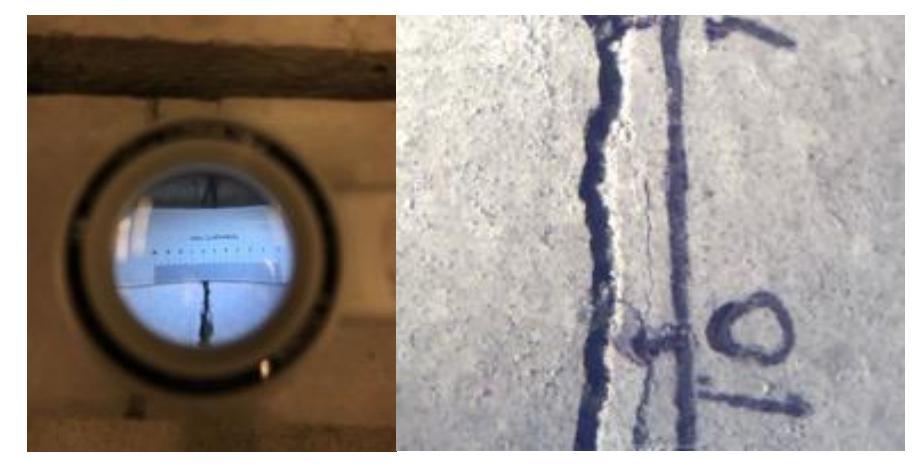
Figure 47 Crack measurements under optical magnifier and under microscope with image analysis software

Figure 47 shows how the crack width was measured under a portable magnifier using scaling measurement and under a microscope using image analysis software. A 0.297mm average crack width and a 26.864 mm² total crack area for one crack were measured from image analysis for better accuracy, as shown in Figure 48.

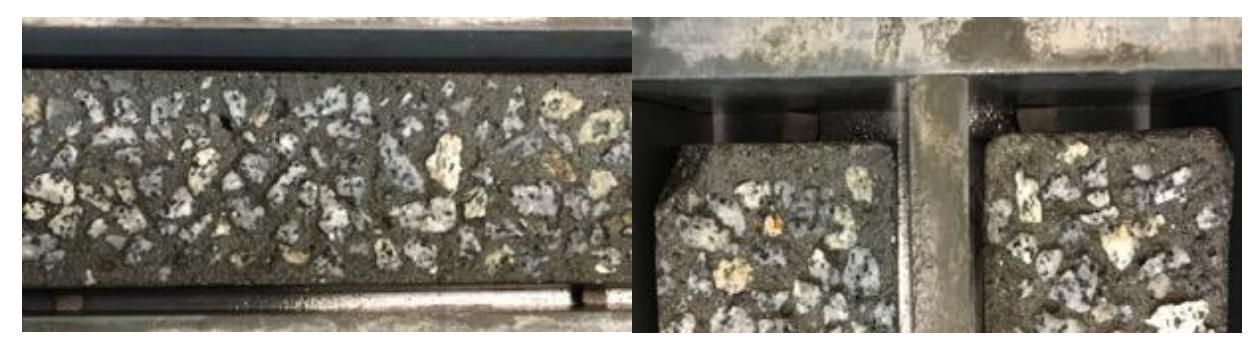
Figure 49 Plain mortar spacers to fix the substrate

spacers exert any impact on the succeeding tests, the spacers are made from exactly the same mix design as the plain mortar.

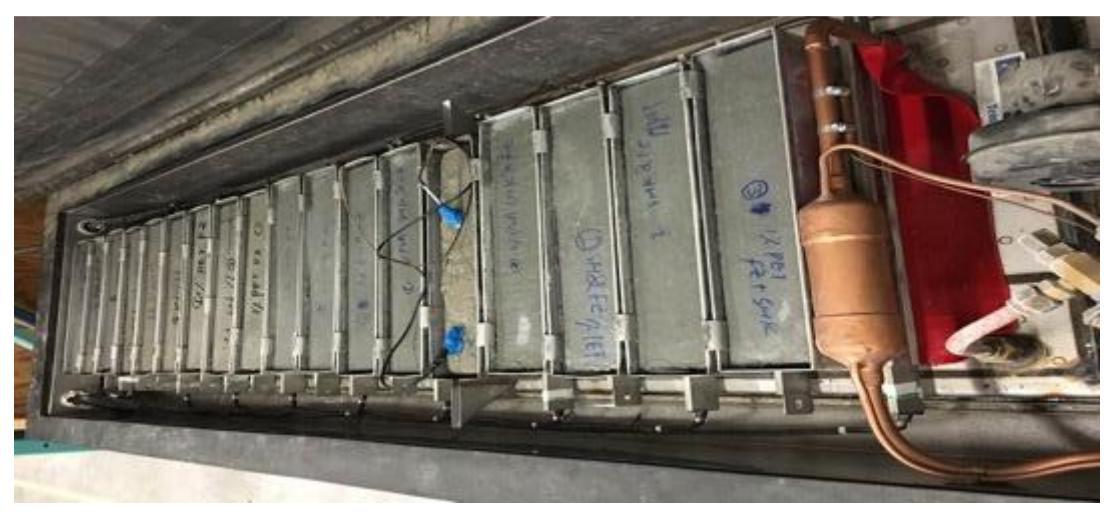
Figure 50 Freeze and thaw cabinet

The rapid freeze and thaw cabinet is manufactured by Humboldt construction materials testing equipment provider. This cabinet can fit 18 standard $405 \times 76 \times 105$ samples at the same time. A freeze and thaw control specimen was used to control cycling temperature in the chamber, so only 17 specimens can be tested at the same time, as shown in Figure 50. Two thermocouples were embedded inside the control specimen sealed with playing putty and its location was changed every 20 cycles. Water needed to be added to all trays to keep all specimens submerged in 1/8 inch water on each side due to moisture evaporation taking place with the cycles going on. Two cut 1/8 inch wires were placed at the bottom of each tray, as well, to keep the specimen from directly touching the tray.

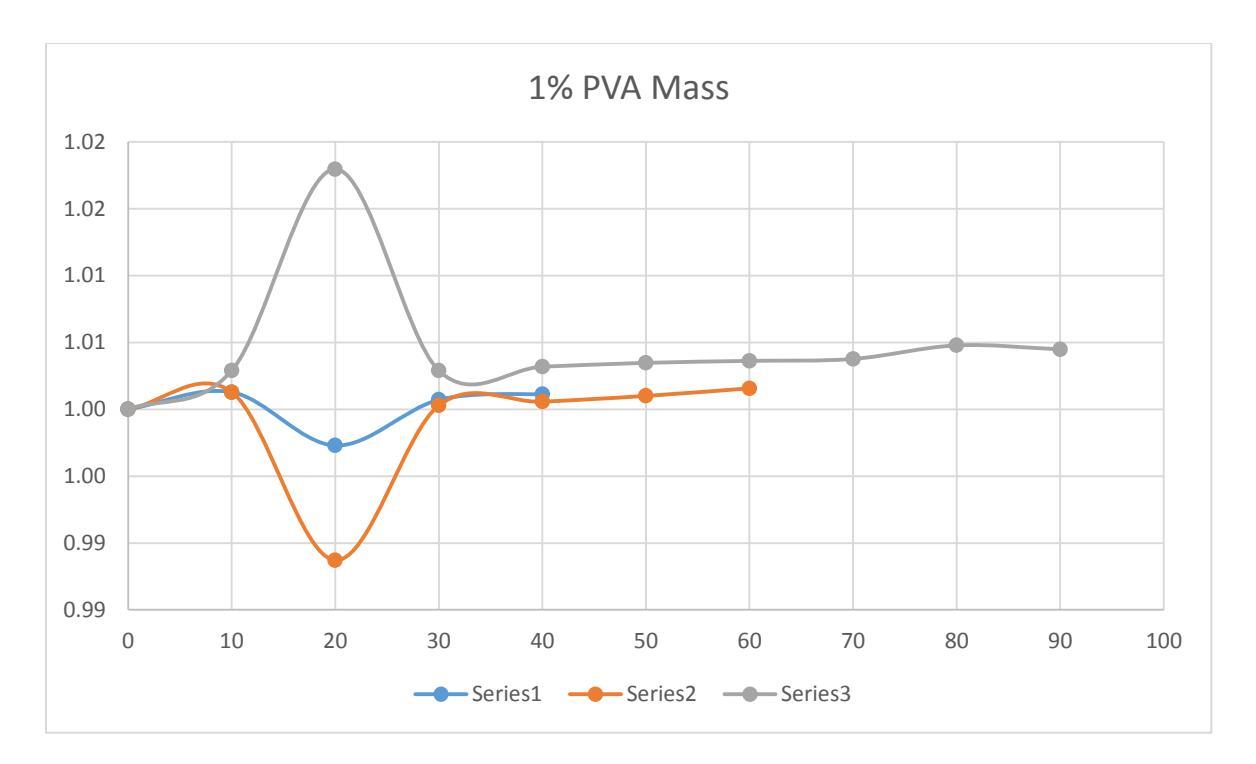
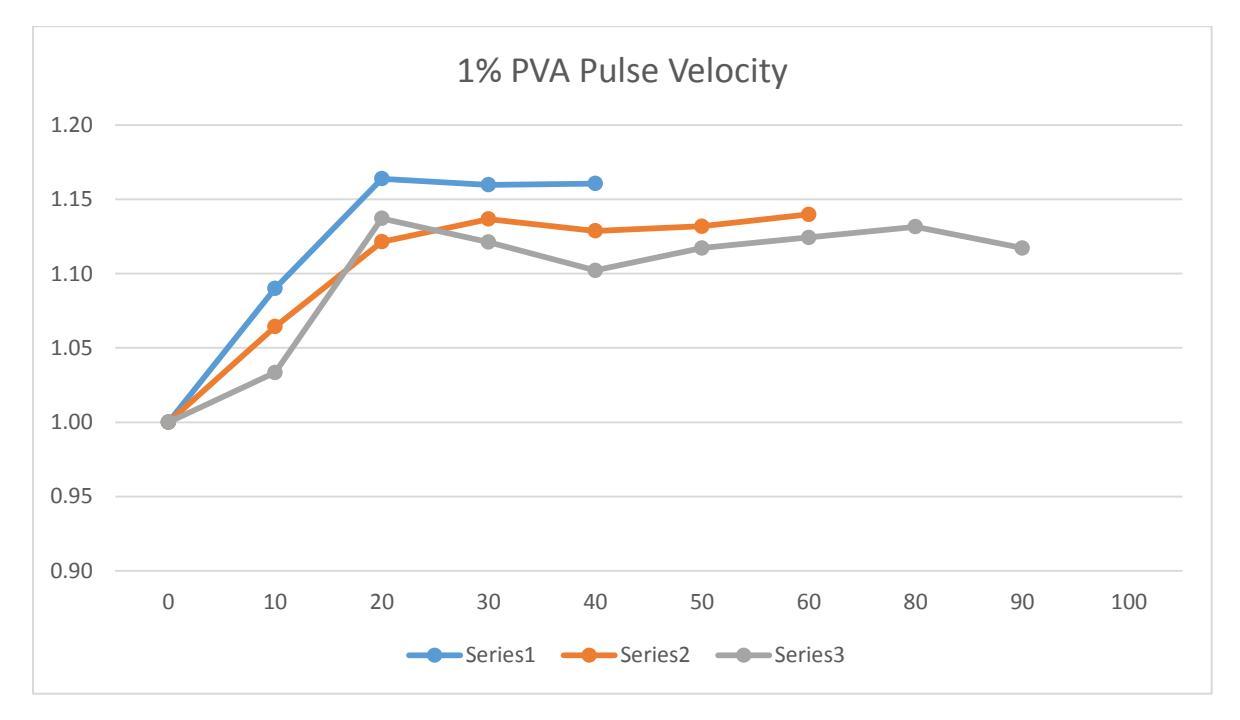
As we can see from Figure 52 and 53 pulse velocity curve, within 90 cycles no obvious drop or even a sudden increase around of 15% in the pulse velocity occurred. This indicates that no damage occurred during the EDCC repair, and also according to the mass loss curve, nearly no mass loss occurred. It could be concluded that based on ASTM C666, the freeze and thaw resistance of 1% PVA mix is adequate for at least 90 cycles. However, the bond strength between the repair and substrate, after a certain amount of freeze and thaw cycles, still remained unknown and will be discussed in next chapter. Also, no damage, such as scaling, was identified visually.

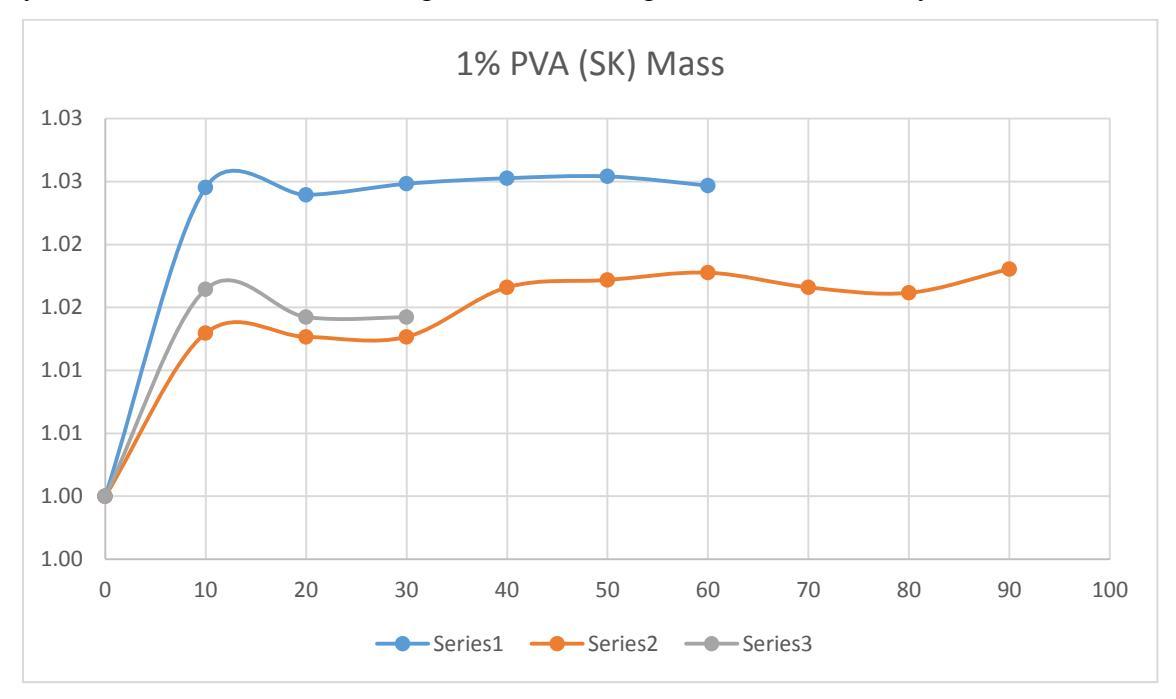
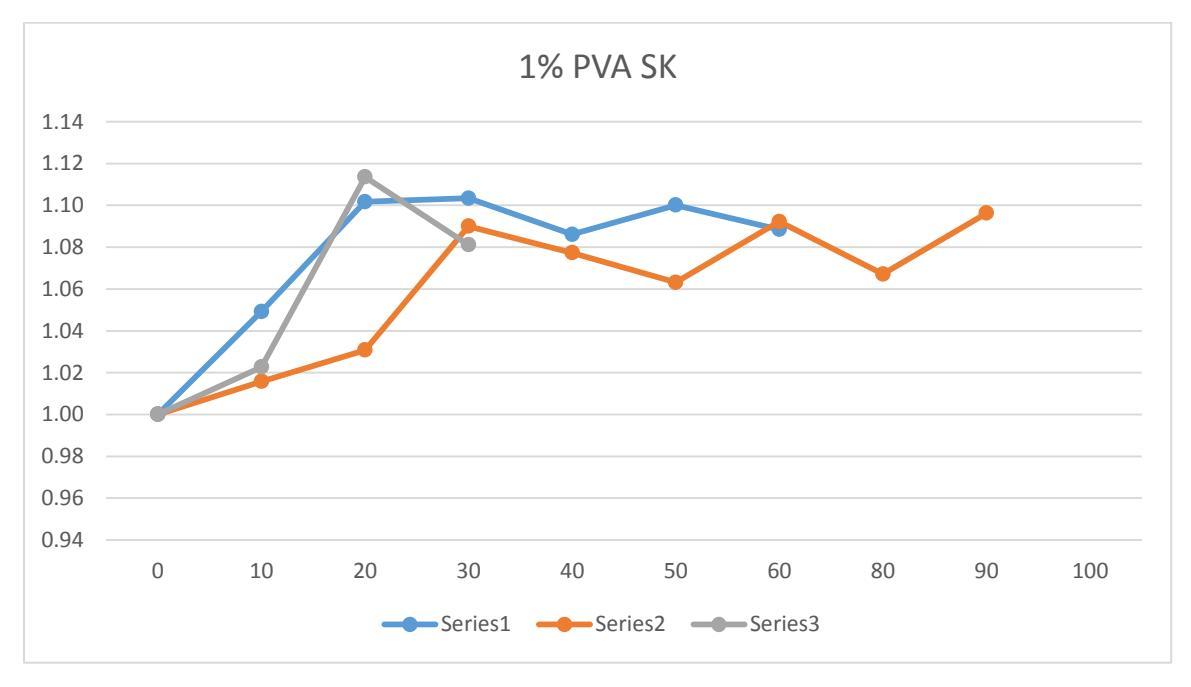
Figure 54 and 55 show that no damage was found from mass and pulse velocity loss curve (change within 5-10%). The mass and pulse velocity even increased due to water saturation after 10 cycles. Also, there was no damage, such as scaling as identified visually.

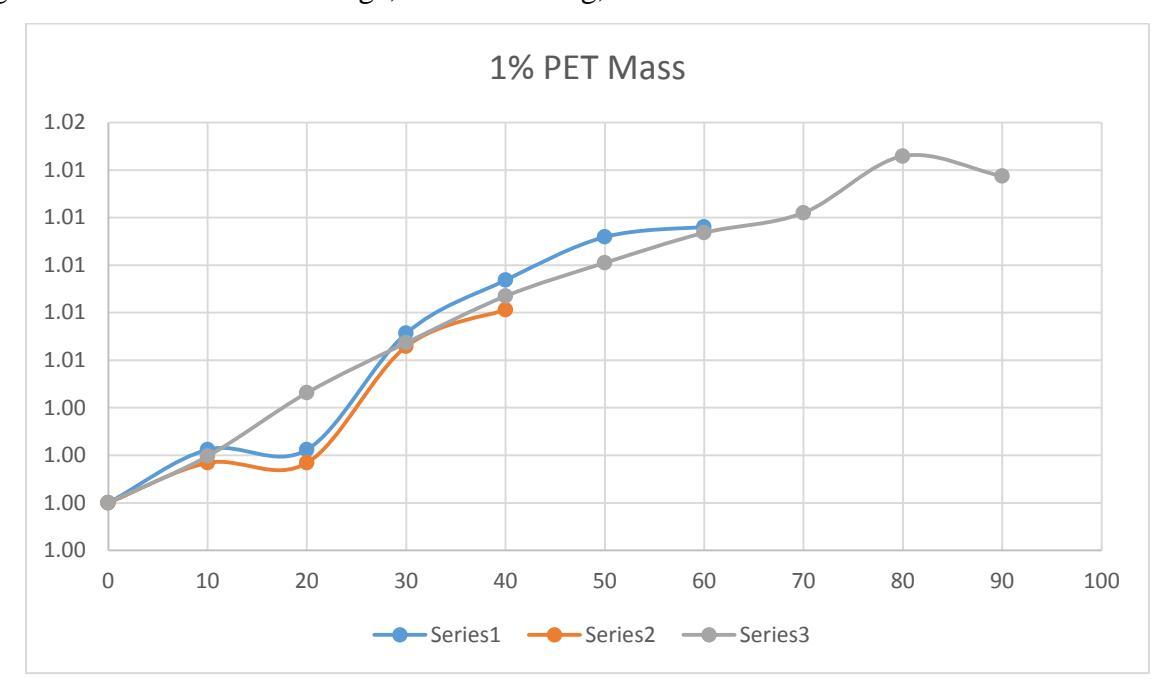
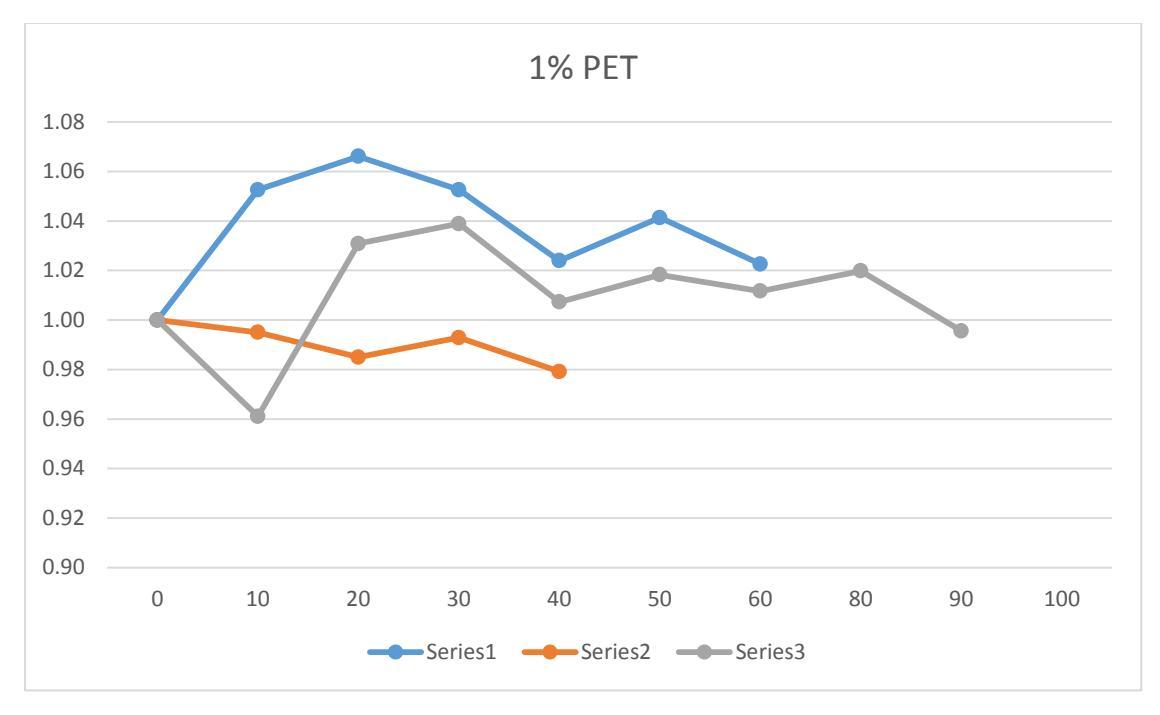
No damage was found from mass and pulse velocity loss curve (change within 2-6%), as seen in Figures 56 and 57. Little damage, such as scaling, was identified.

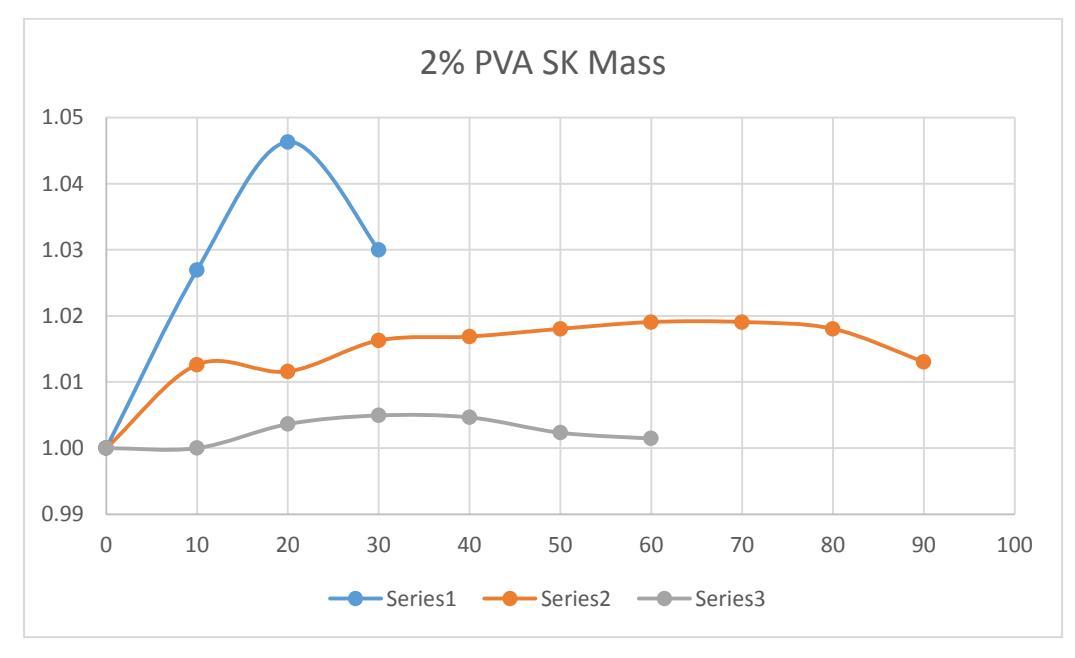
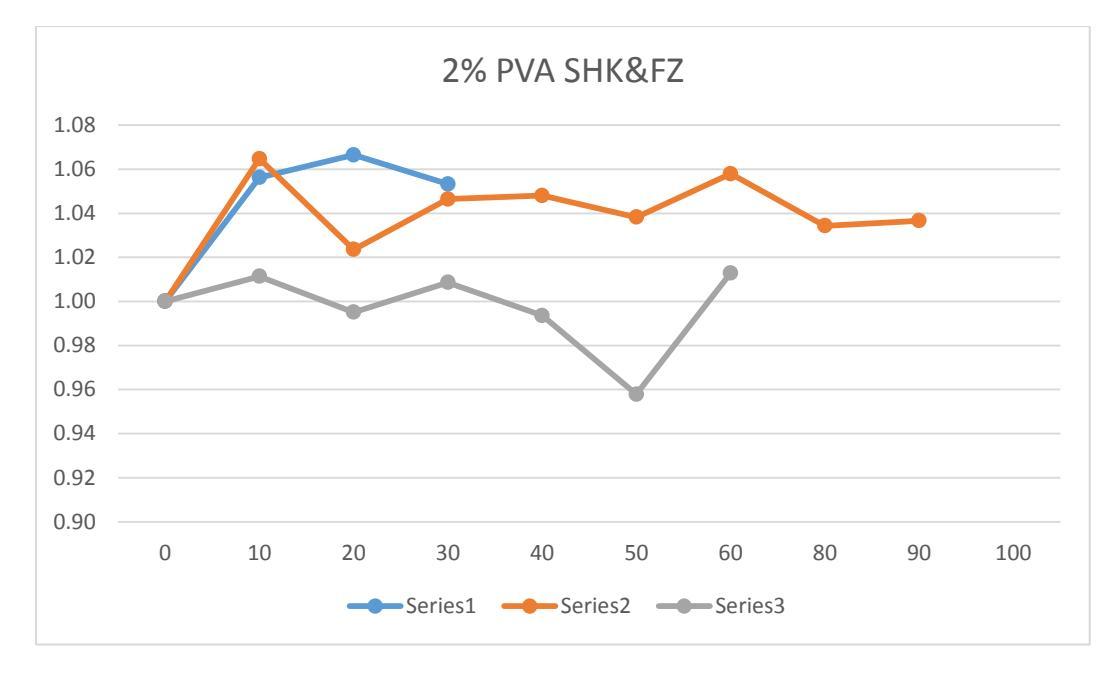
Figure 62 and 63 showed that no damage was found from mass (change within 5%) and pulse velocity loss curve (change within 5-7%) within 90 cycles. Nearly no damage was visually identified.
