### CAUSTIC CRACKING SUSCEPTIBILITY OF SAE A 516 Gr. 70 STEEL

### IN ALKALINE SULPHIDE SOLUTIONS

A THESIS IN PARTIAL FULFILLMENT OF

DEPARTMENT OF METALLURGICAL ENGINEERING

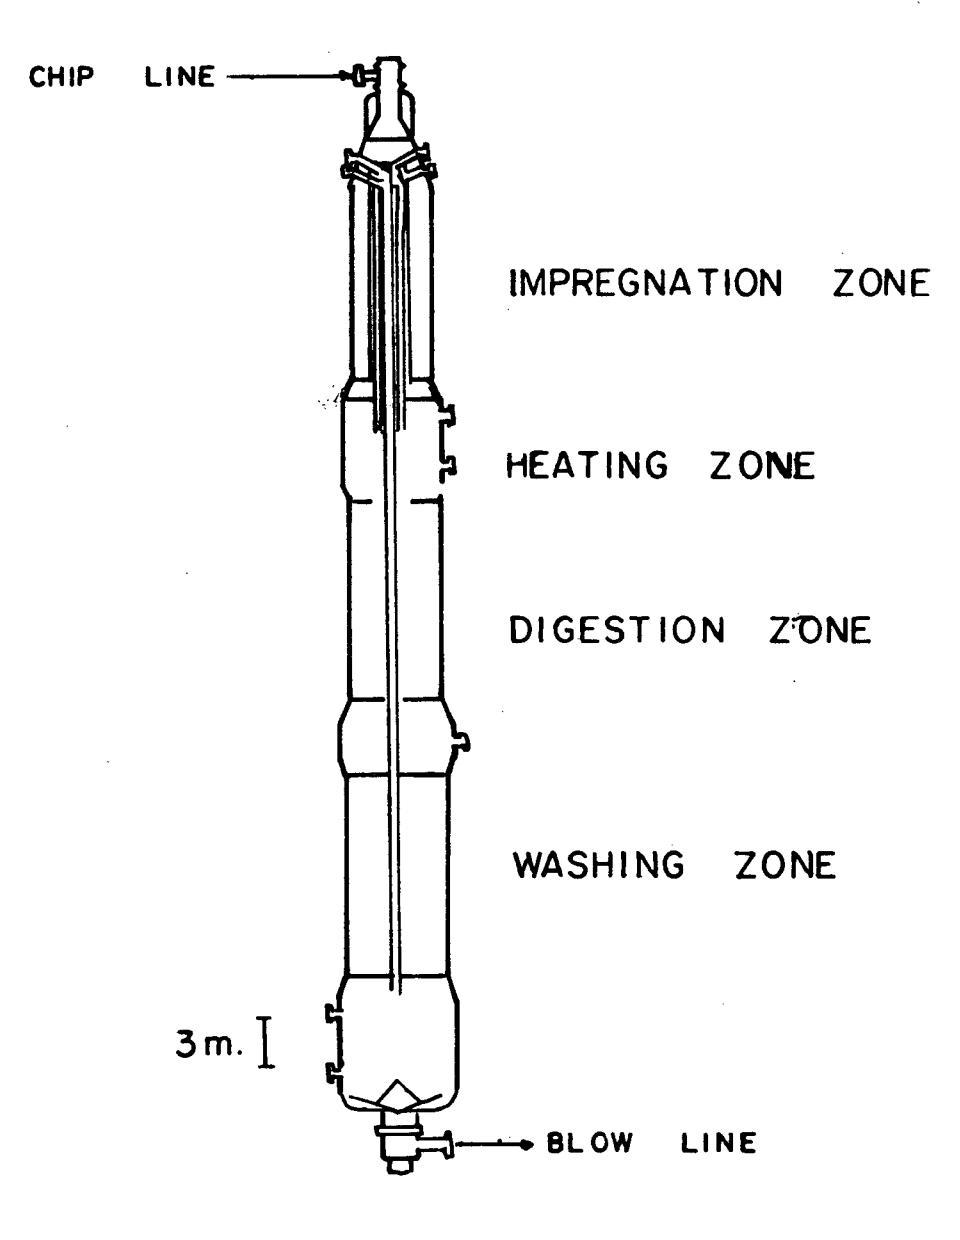
Figure 1 - A typical continuous Kraft digester.

Most SCC problems in the process were encountered in the digester. A digester is essentially a cylindrical pressure vessel, with an internal cone at the top. During September 1980, in an accident involving a digester at Pine Hill, Alabama, the entire 18 ft base diameter upper cone, welded to the cylindrical base was blown away. The failure was attributed to intergranular Stress Corrosion Cracking.<sup>8</sup>

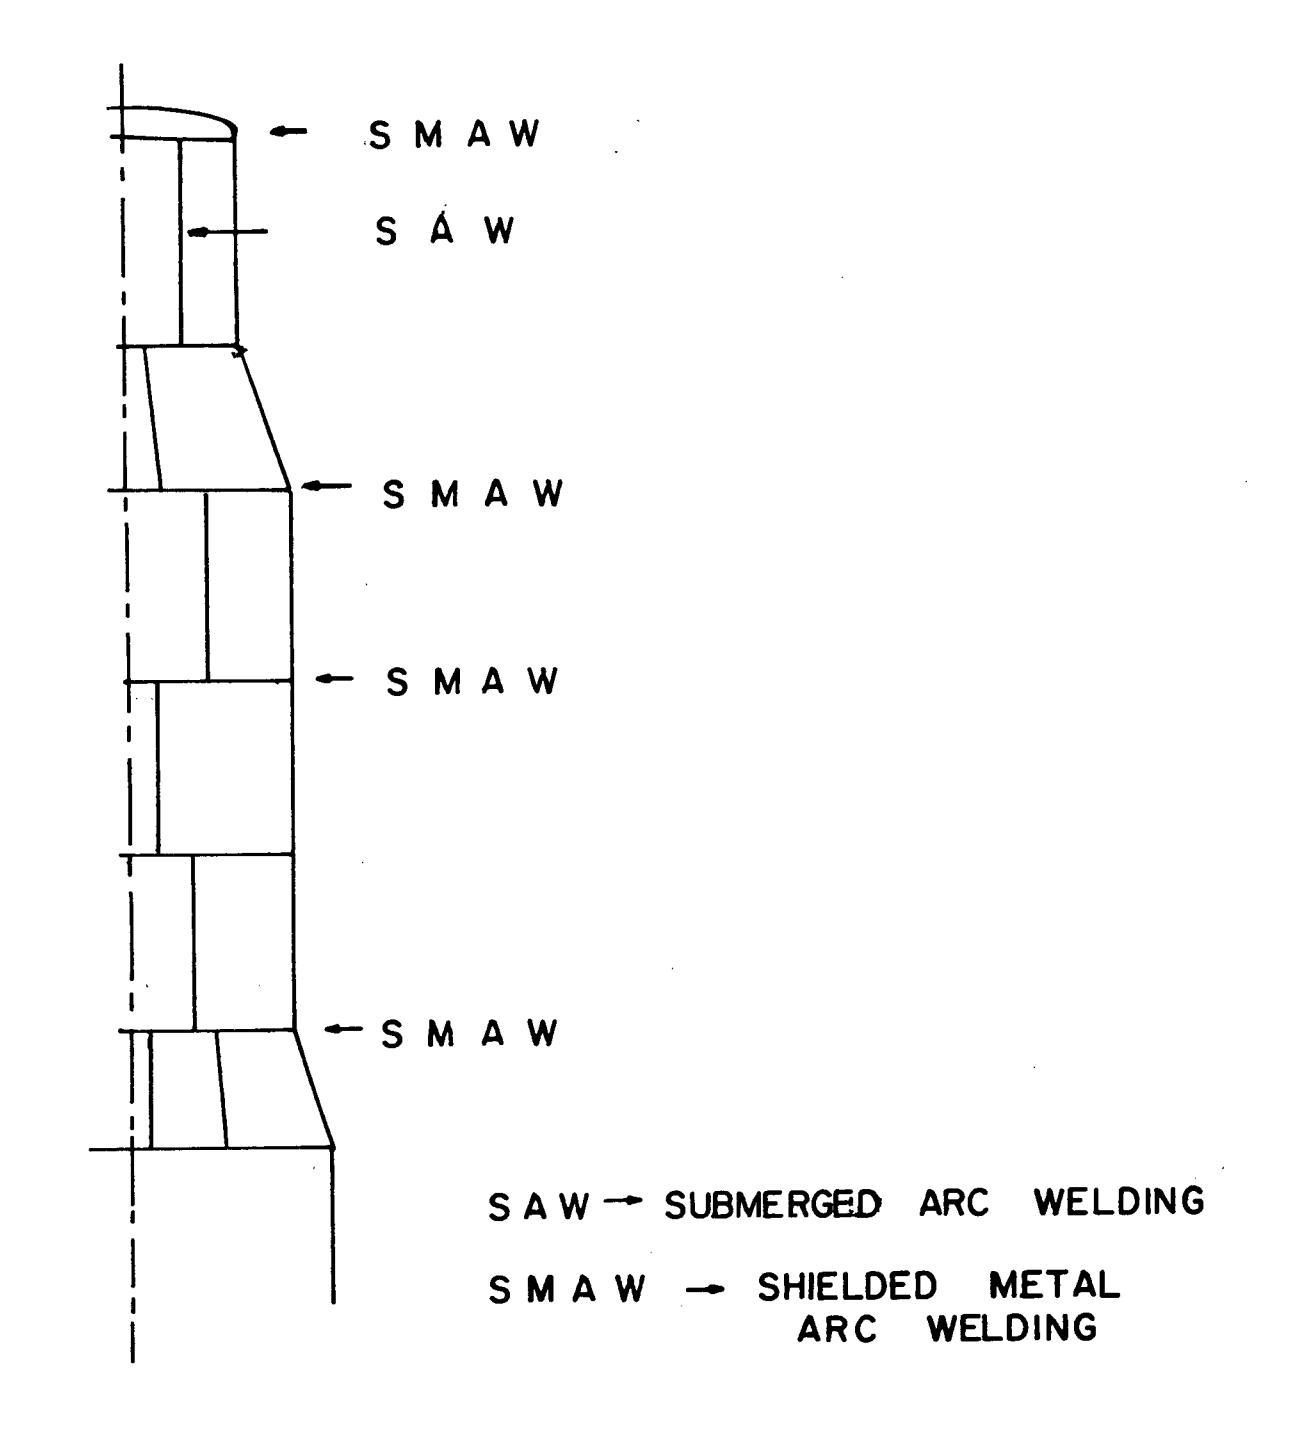
Figure 2 - Location of different welds in a continuous digester.

Since all the cracking problems in the digester occur in the vicinity of welds, it would be prudent to examine the structure and properties of various region in the weld. Fig. 2 indicates the front view of a digester, and the locations of various fusion welding processes used in its construction.

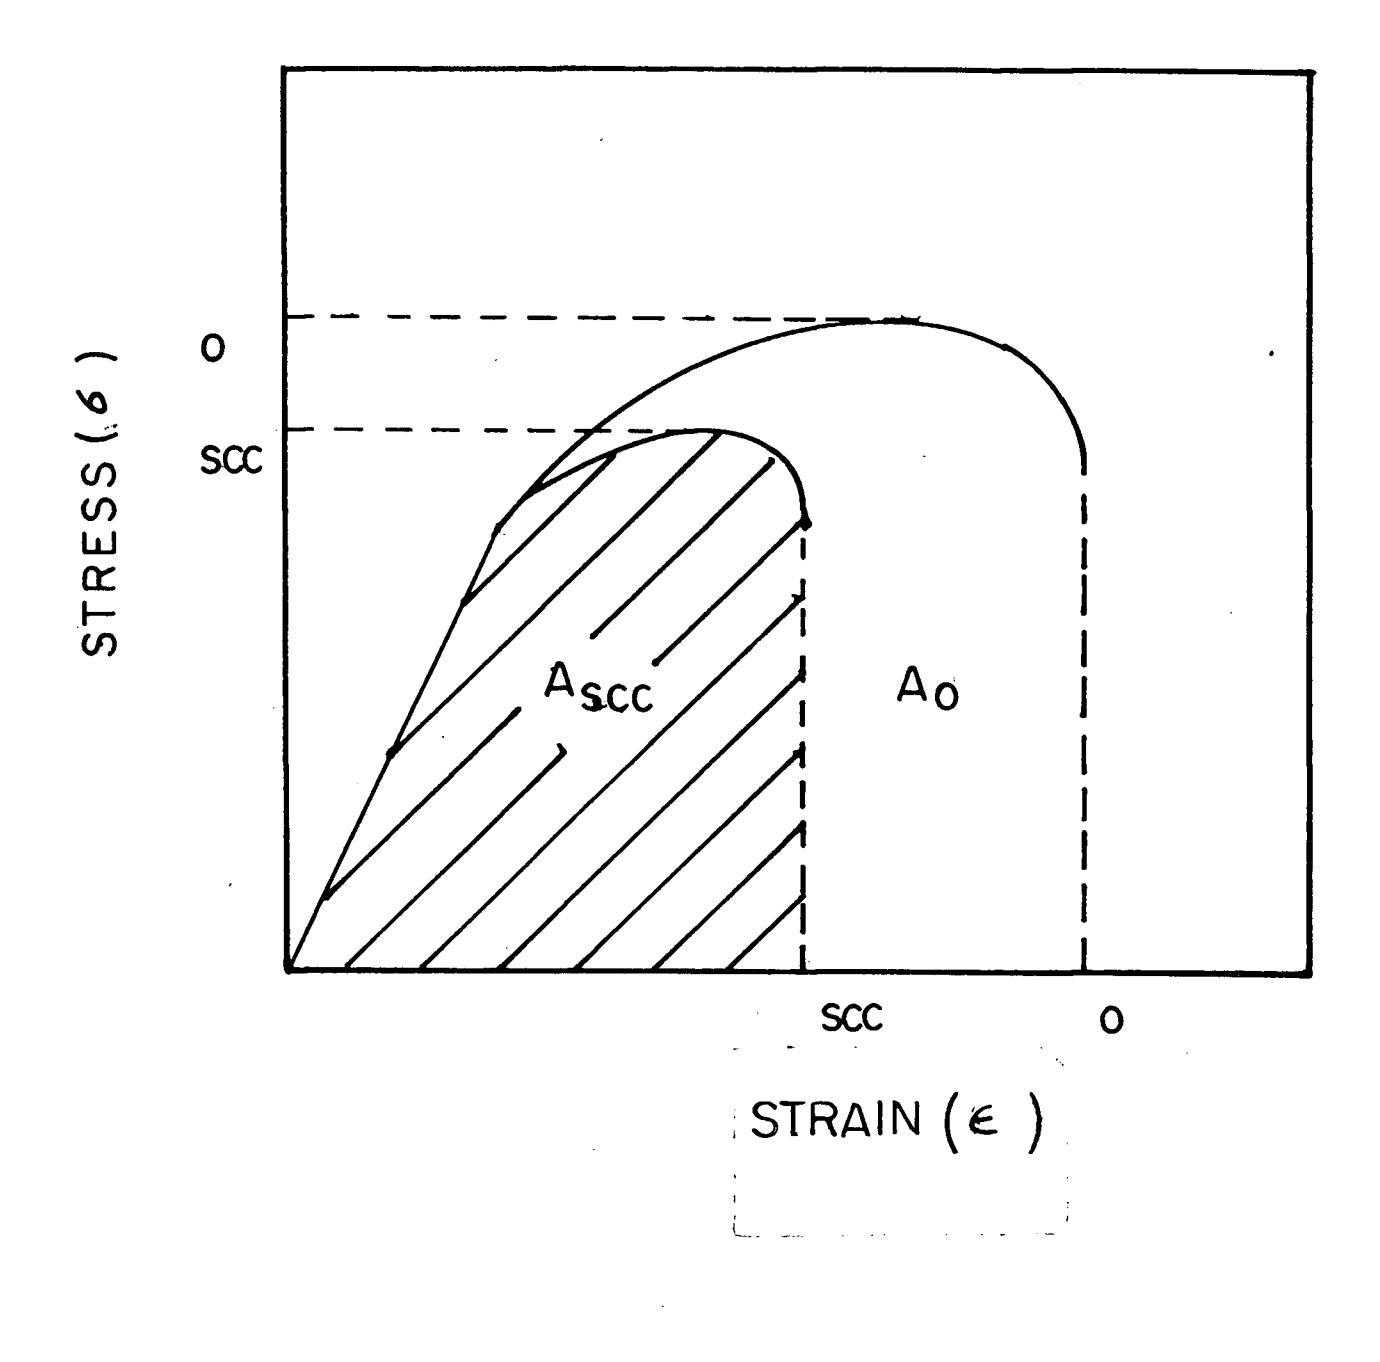
Figure 3 - Stress-strain curves for specimen tested in SCC susceptible and inert environments using SSRT, where  $A_0$  and  $A_{SCC}$  are the areas under the respective curves.

A typical SSRT test consists of pulling apart, to failure, a cylidrical tensile specimen exposed to the appropriate environment, at a low, constant, extension rate. Since the onset of SCC will affect the

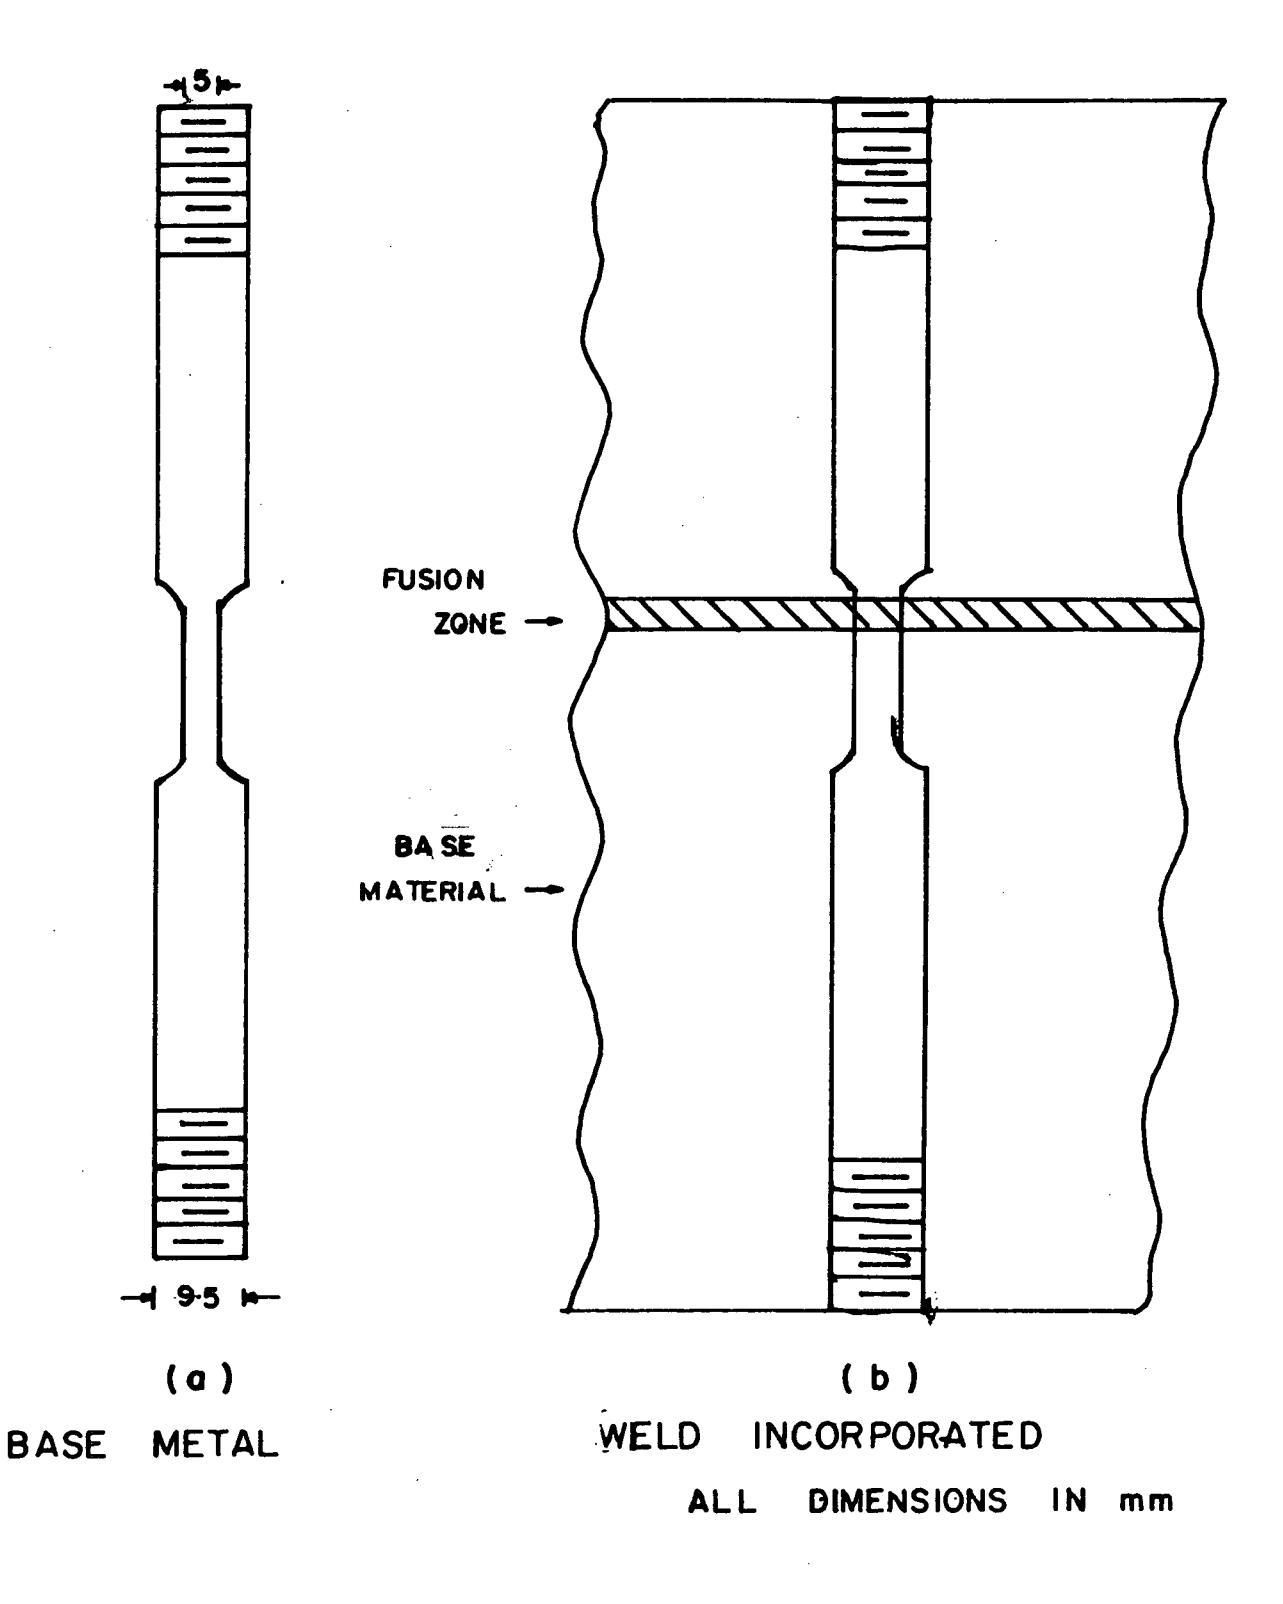
Figure 5 - SSRT specimen geometry.

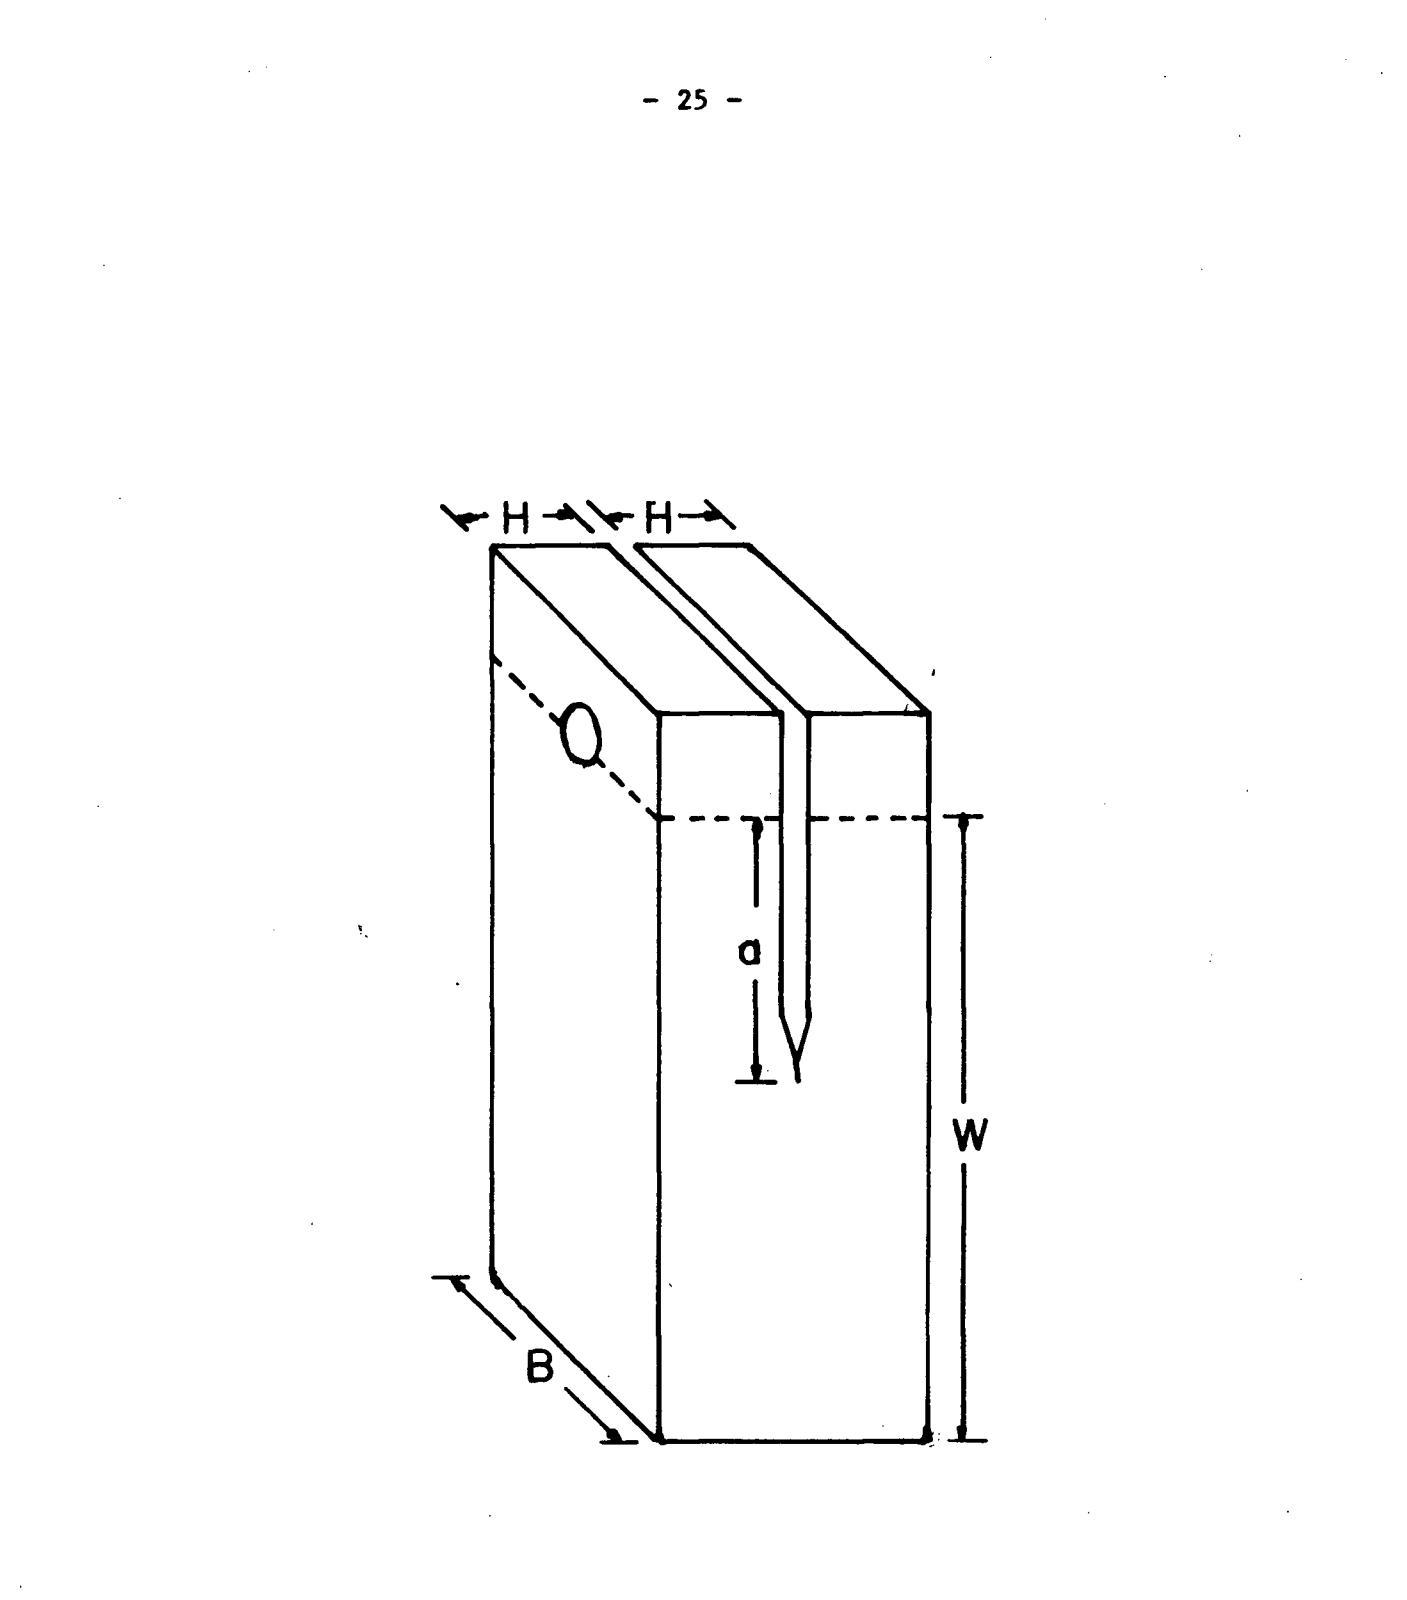
Figure 6 - DCB specimen geometry.

Double Cantilever Beam (DCB) specimen, machined from the 1" (25.4mm) plate whose geometry is shown in Fig. 6, were used for the Fracture Mechanics experiments. The Beam height (H) for these specimen was 11.6 mm, specimen length from the loading line (W) was 66.7 mm, and the specimen thickness (B) was 25.4 mm. The length of the initial machined notch from the loading line was 25.4 mm, and the beams were threaded to receive grips for the application of a load. The faces perpendicular to the crack plane were polished to a 0.3  $\mu$ m finish, washed with water, then dried with ethanol, and stored in a dessicator until further use.

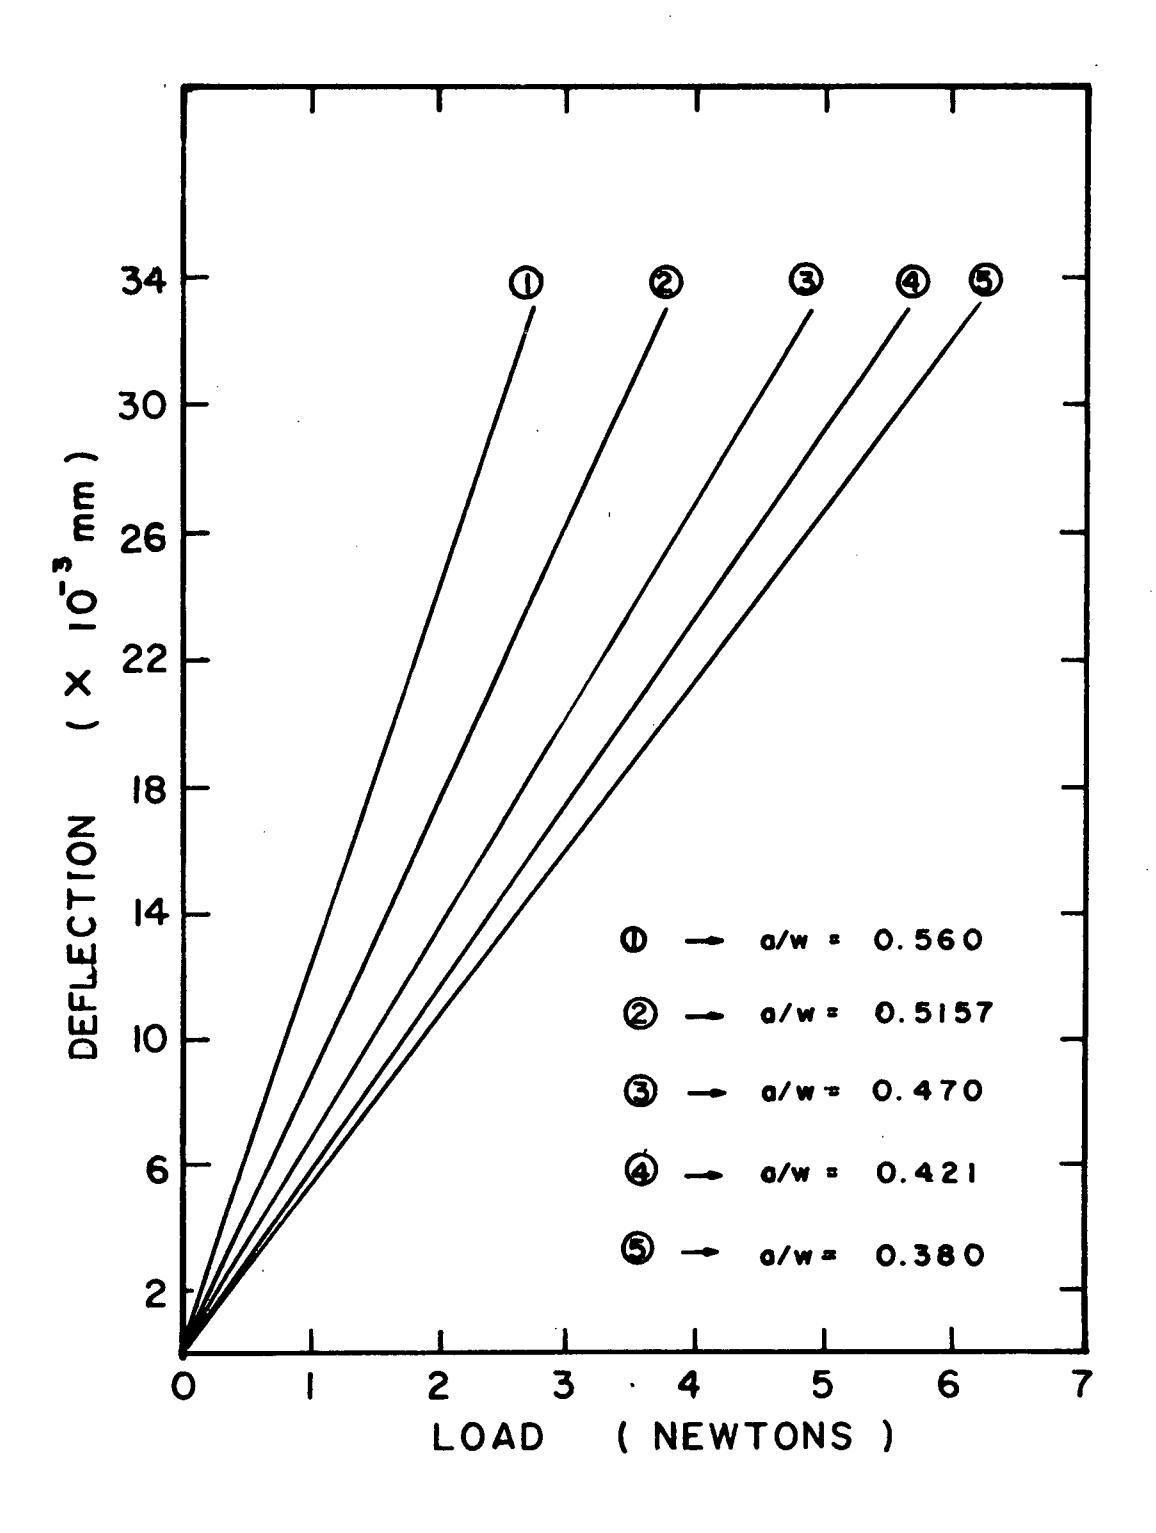
Figure 9 - Calibration curve for DCB specimen

and is illustrated in Fig. 9. Deflection of the beam was measured by a MTS model 632 COD gauge.

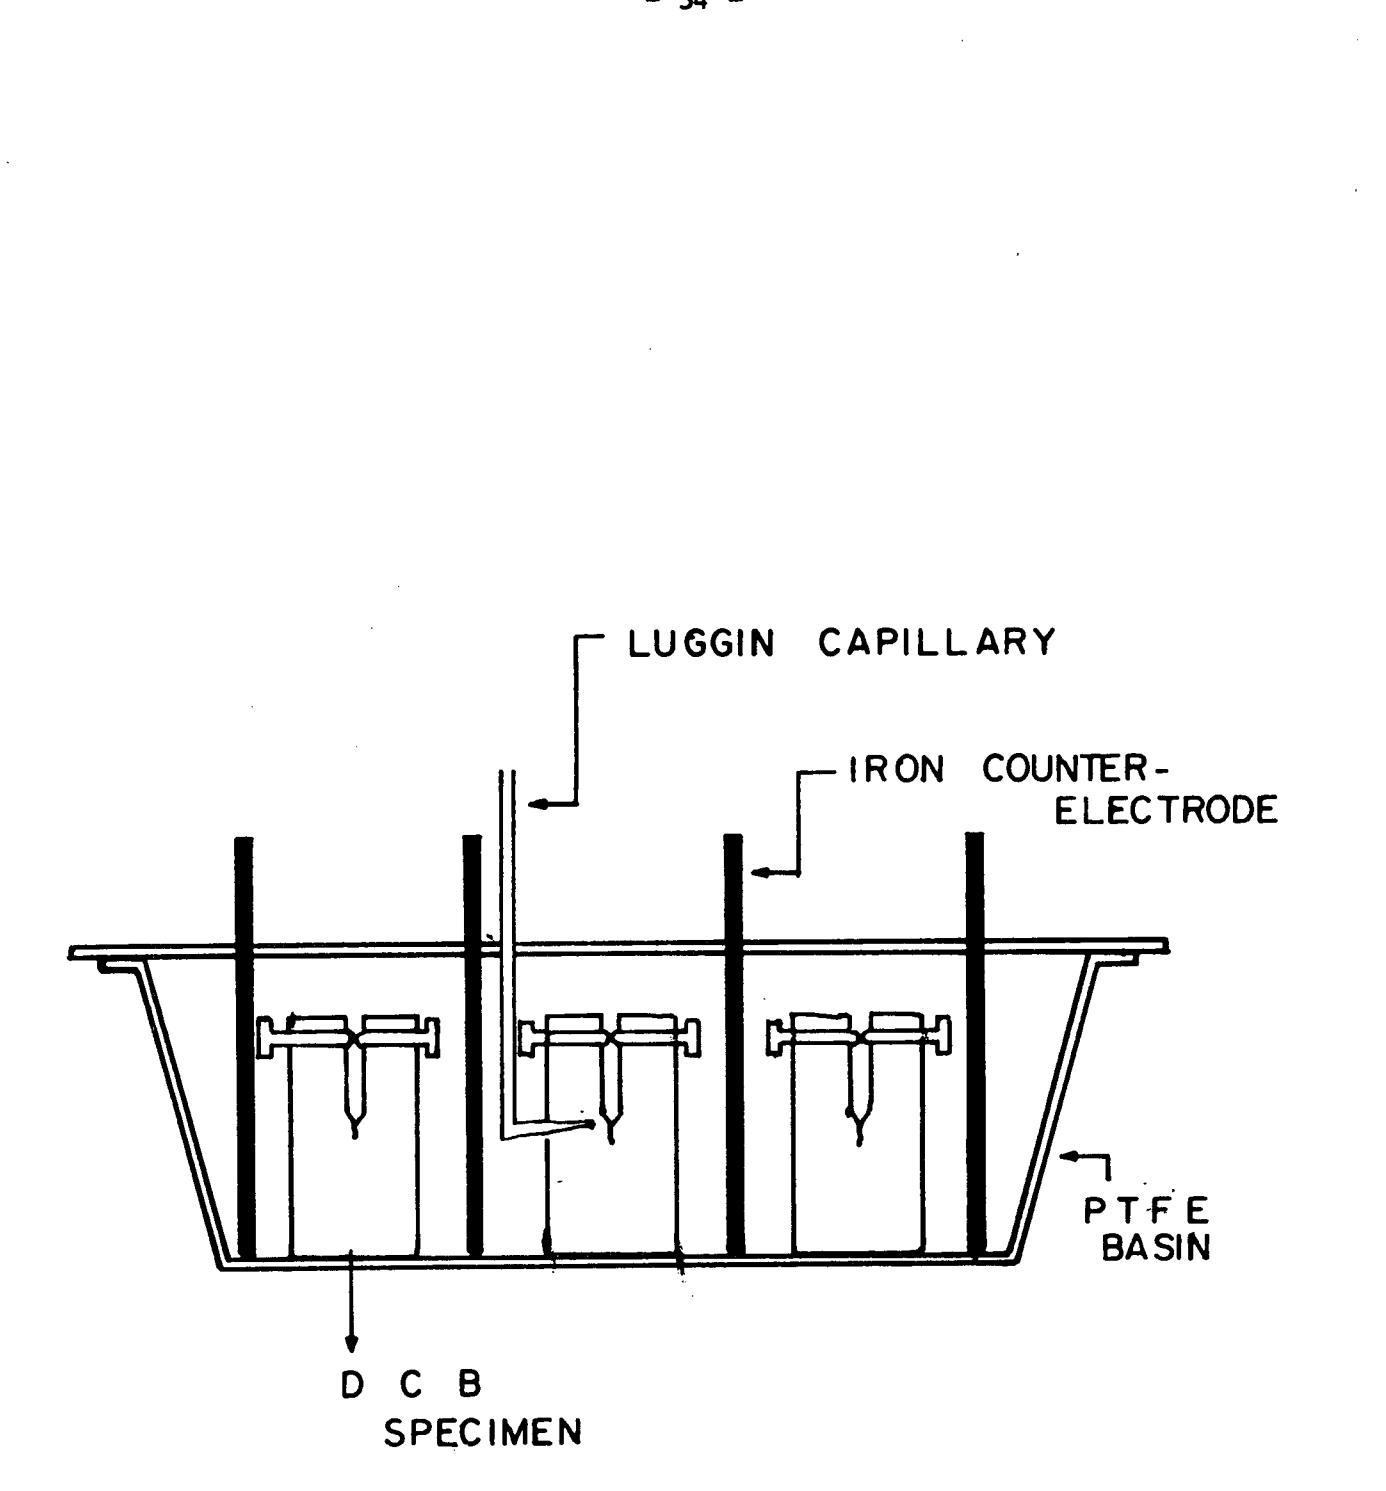
Figure 10 - Fracture mechanics test cell

Fracture mechanics tests were conducted in a Teflon basin, heated from the outside by a resistance heated tape. A nitrogen purge line, FEP coated thermistor probe, luggin capillary, and a FEP coated thermometer were inserted into the Teflon basin. Temperature was controlled in the same manner as in the SSRT experiments. Low carbon steel wires were used as counter electrodes. The text specimen were connected in parallel to ensure that all the specimen were maintained at the same potential.

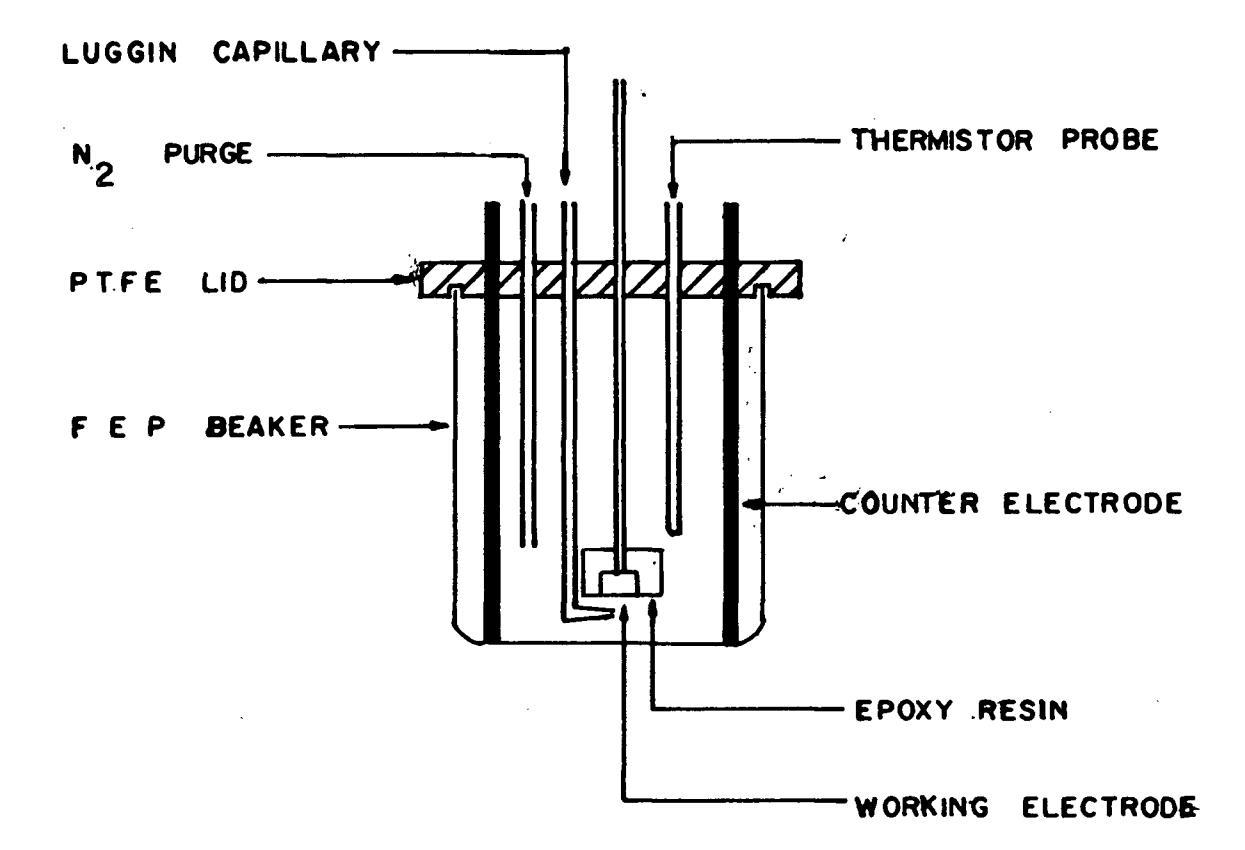
All polarization tests were conducted in a Teflon cell, provided with graphite counter electrodes, as illustrated in Fig. 11. Temperature control at 92°C was maintained in a manner explained in section 2-3, and N<sub>2</sub> was continually bubbled through the cells.

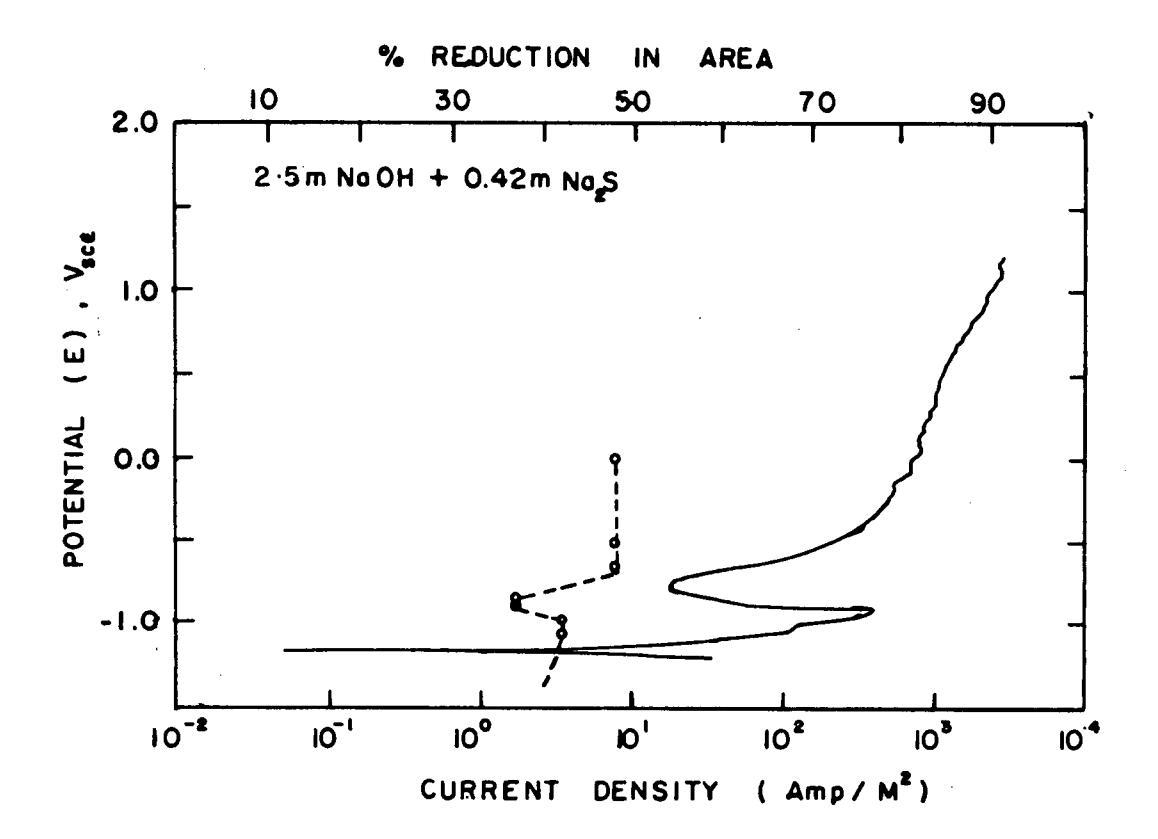
Figure 15 - Effect of potential upon reduction in area in 2.5 m NaOH + 0.42 m Na<sub>2</sub>S superimposed upon the anodic polarization curve obtained in the same solution.

Fig. 15 shows the result of the SSRT experiment superimposed on the anodic polarization curve of the steel in the same caustic sulphide environment. The results are plotted as % Reduction in area VS Potential, as illustrated in Fig. 15. The minimum reduction in area occurs in the region of transition from the active to the passive behaviour. The Active-Passive Transition (APT) has been reported to be the region most prone to SCC.<sup>13</sup> However, the % reduction in area of the failed samples in the APT zone differed from that in other regions of the anodic polarization curve by only 13%. This, combined with the fact that no secondary cracking was observed in the failed specimen, appeared to suggest that the steel was not very prone to SCC in the white liquor with a caustic concentration of 2.5 m NaOH.

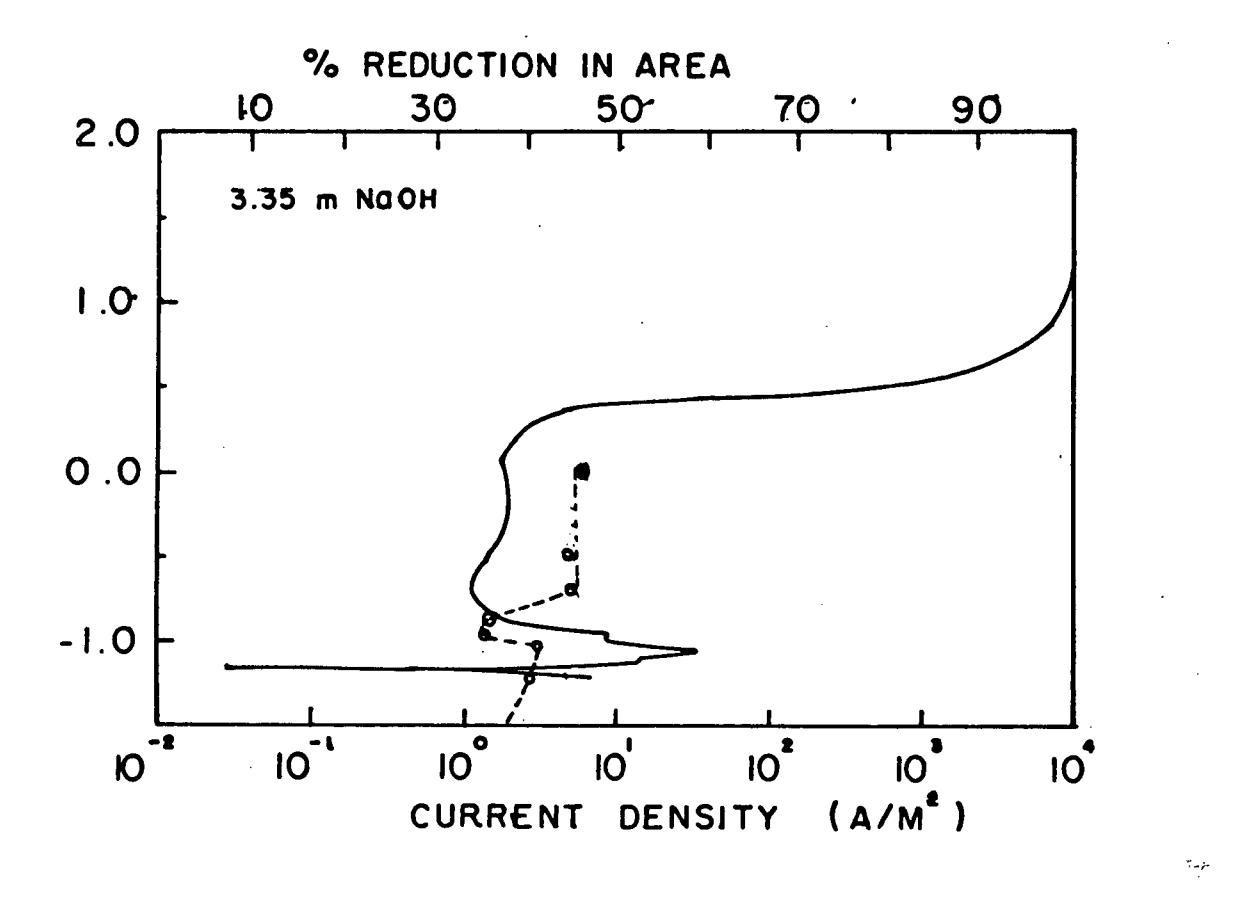
Figure 16 - Effect of potential upon reduction in area for 3.35 m NaOH superimposed upon the anodic polarization curve obtained in the same solution.

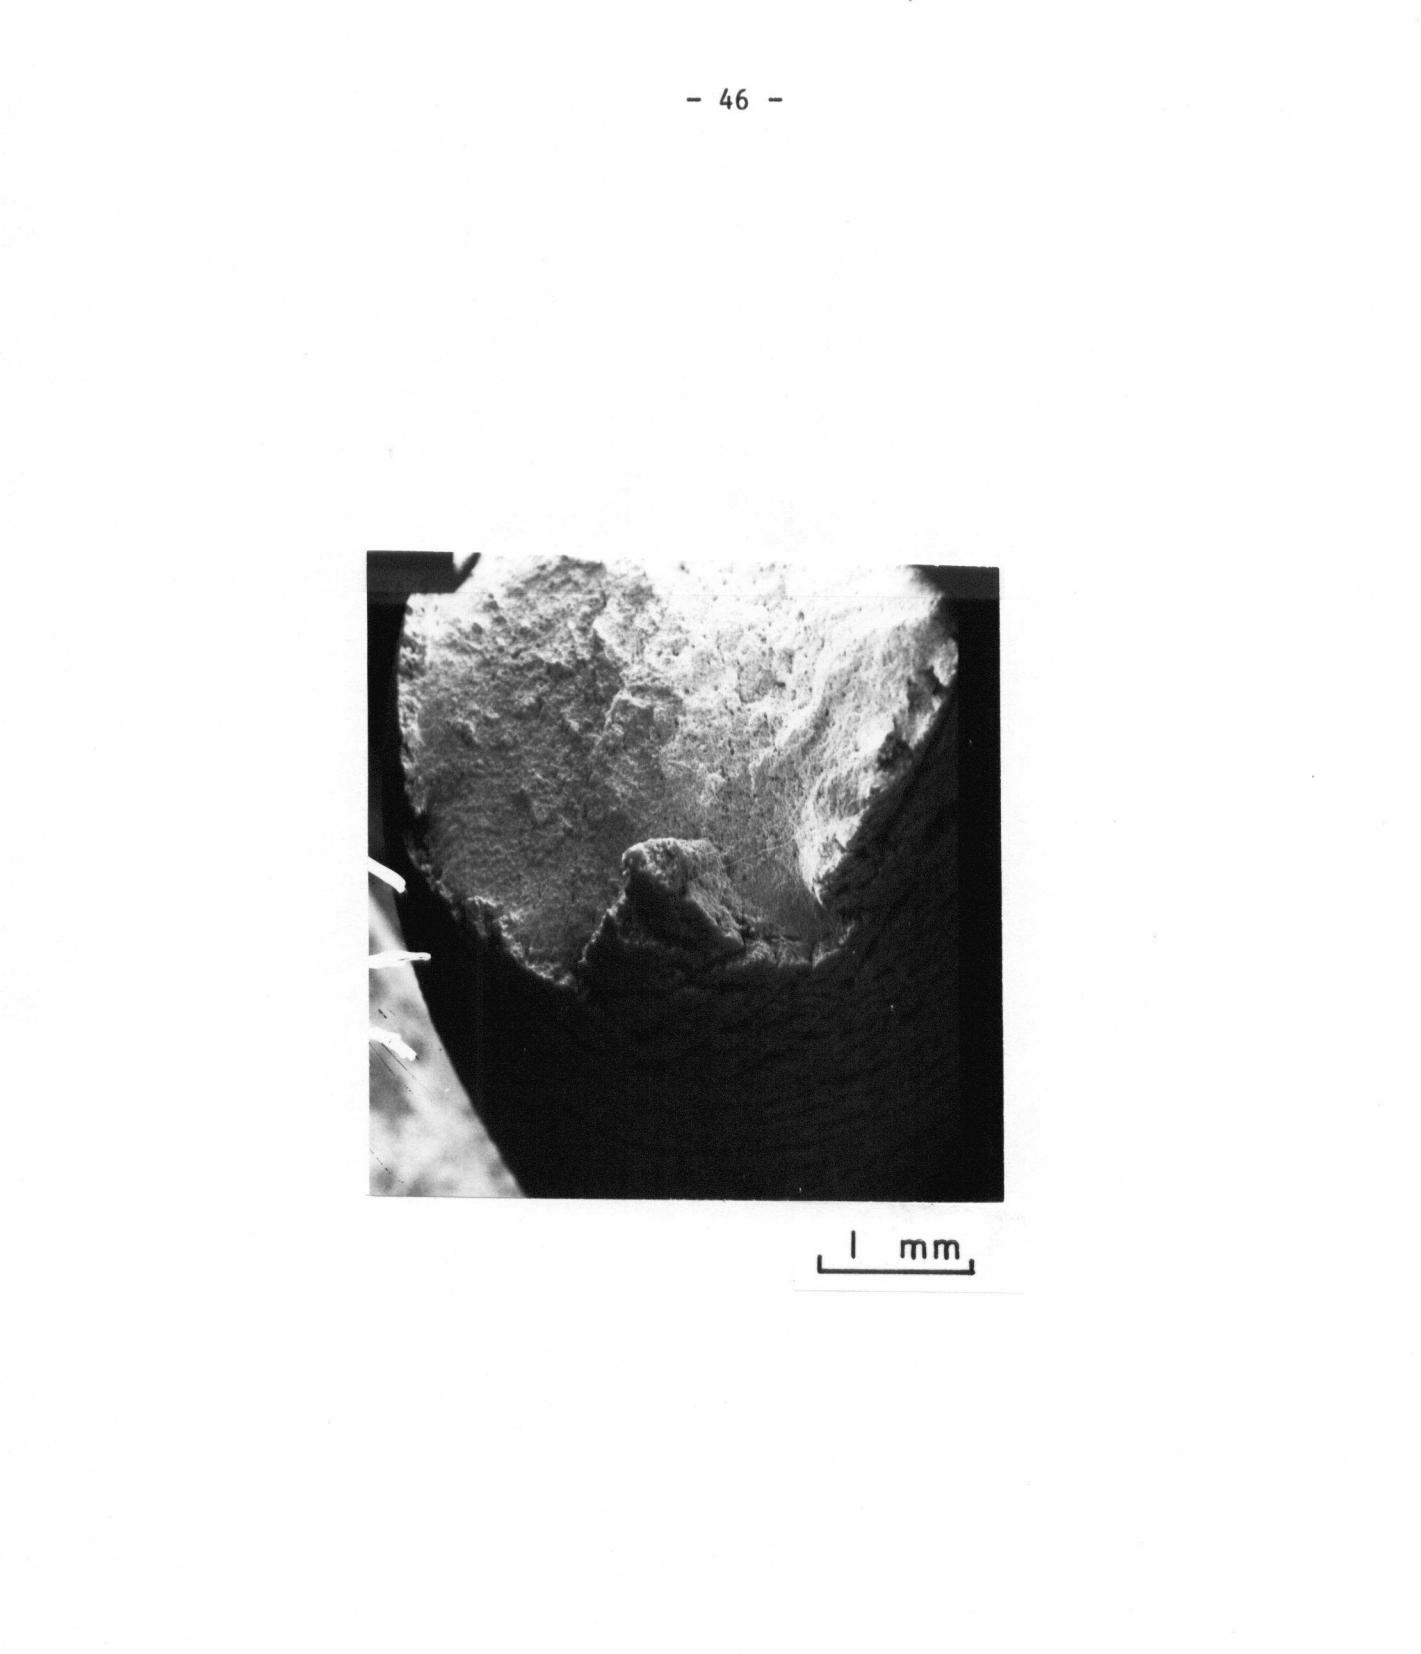
Figure 17 - Secondary cracking at -0.98 V<sub>SCE</sub> in a 3.35m NaOH environment at 92°C. reduction in area was obtained at potentials corresponding to the Active-Passive transition, as illustrated in Fig. 18. Also, extensive secondary cracking was observed at these potentials, as illustrated in Fig. 19. Some secondary cracking was observed at potentials corresponding to the passive zone, as illustrated in Fig. 20, and at less noble potentials where hydrogen is expected to be evolved. The apparent crack velocities, i.e., the ratio of the largest crack length, to the duration of the test was found to be  $1.85 \times 10^{-9}$  m/sec in the active passive transition zone, 8.1 x  $10^{-10}$  m/sec is in passive zone, and  $1.31 \times 10^{-9}$  m/sec at -1.8 V<sub>SEC</sub>, as illustrated in Tables 3 and 4. Thus the presence of S<sup>--</sup> ions enhanced SCC at potentials, other than the active-passive transition region.

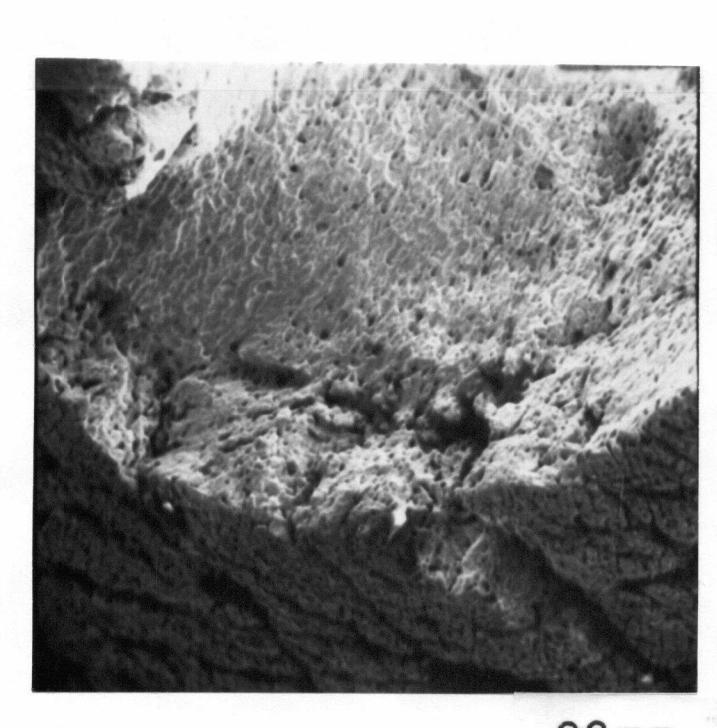
Figure 19 - Secondary cracking at -0.88  $V_{\rm SCE}$  in a 3.35m NaOH + 0.42 m Na2S environment

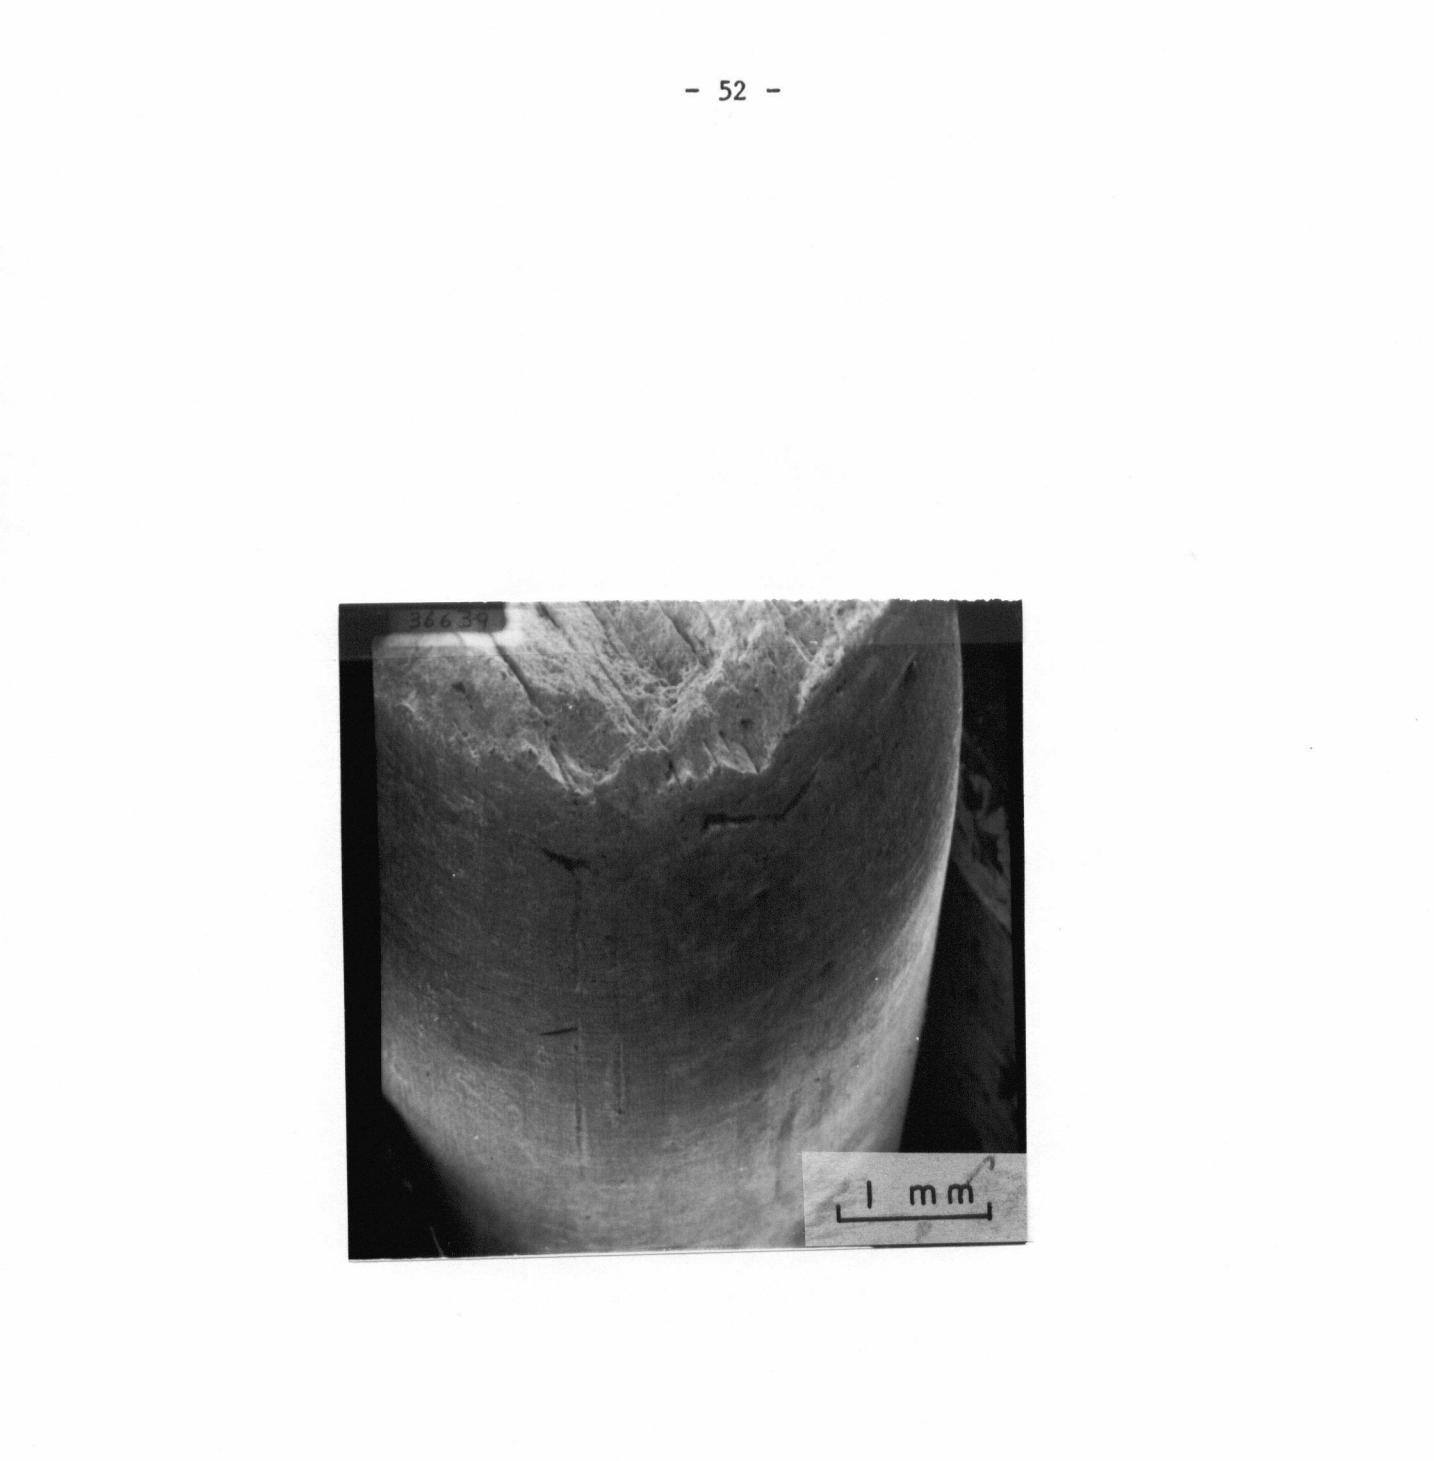
Figure 20 - Secondary cracking at -0.750  $V_{\rm SCE}$  in a 3.35m NaOH + 0.42 m Na2S environment
