### CAUSTIC CRACKING SUSCEPTIBILITY OF SAE A 516 Gr. 70 STEEL

### IN ALKALINE SULPHIDE SOLUTIONS

A THESIS IN PARTIAL FULFILLMENT OF

DEPARTMENT OF METALLURGICAL ENGINEERING

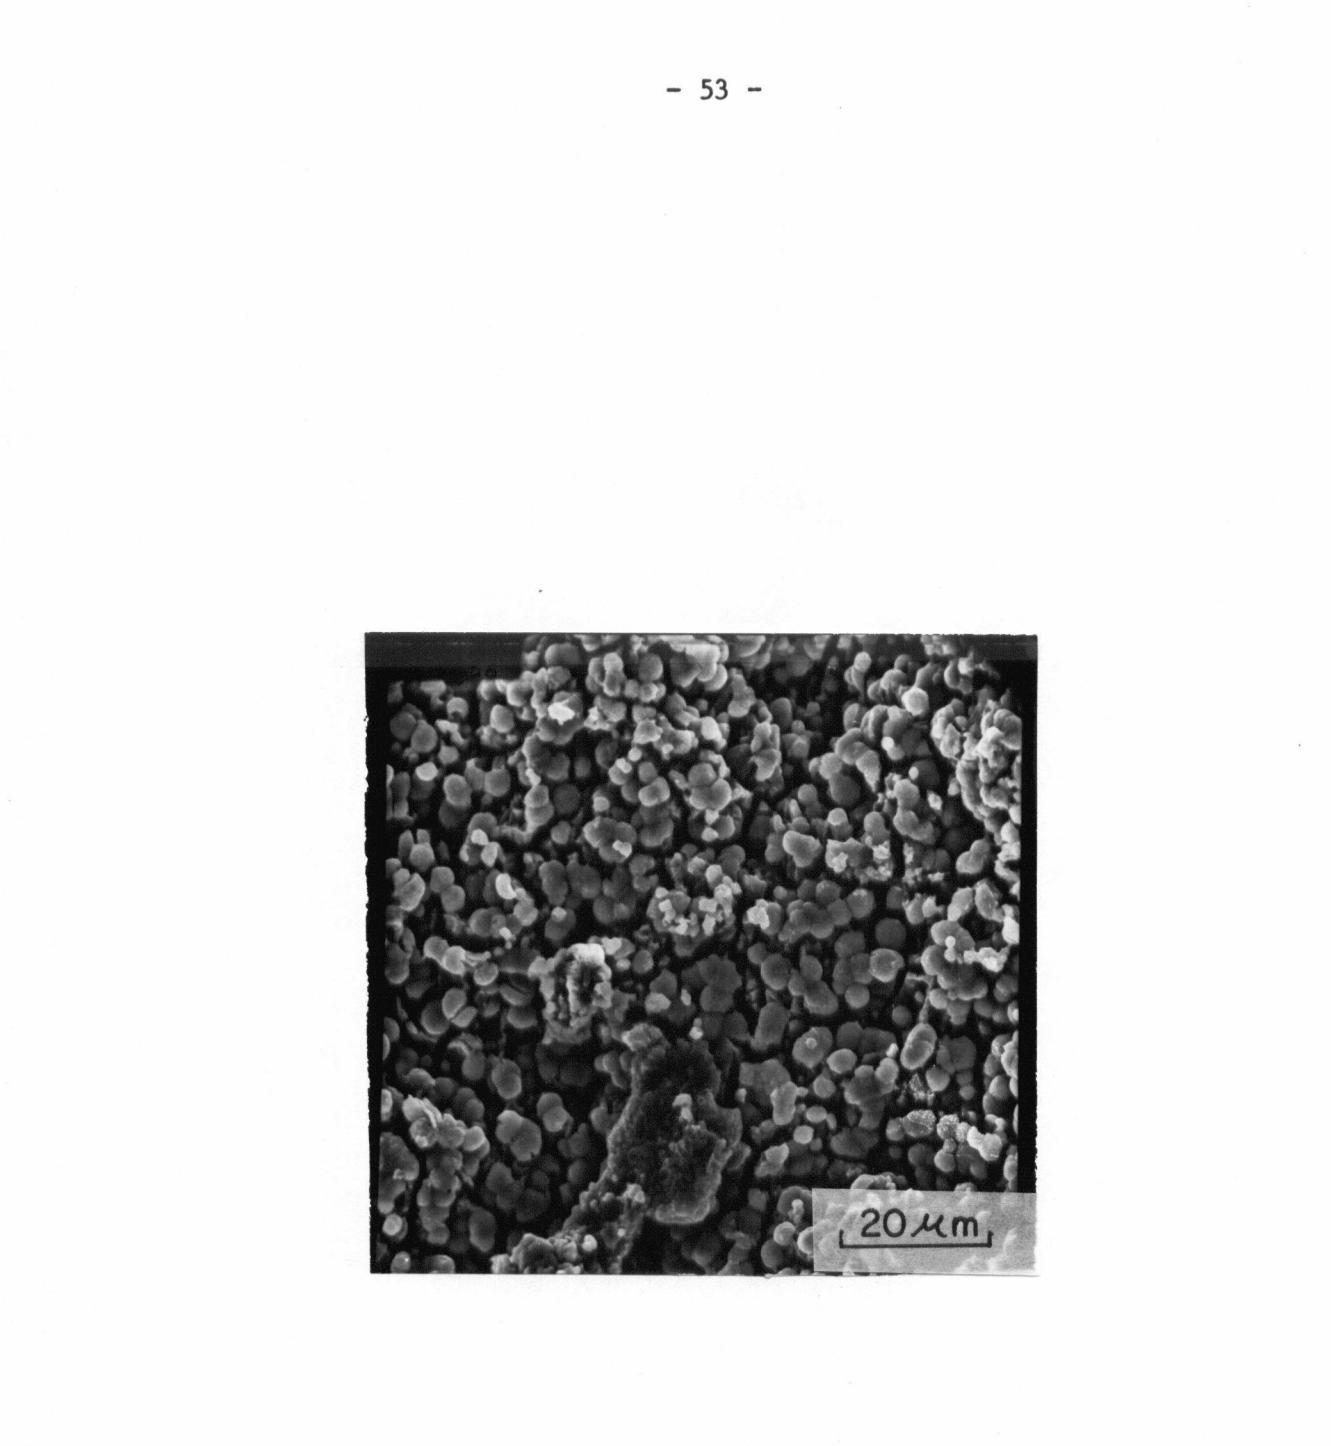
Figure 21 - Oxide scale on a SSRT specimen at -0.88  $V_{SCE}$  in a 3.35 m NaOH + 0.42 m Na<sub>2</sub>S environment.

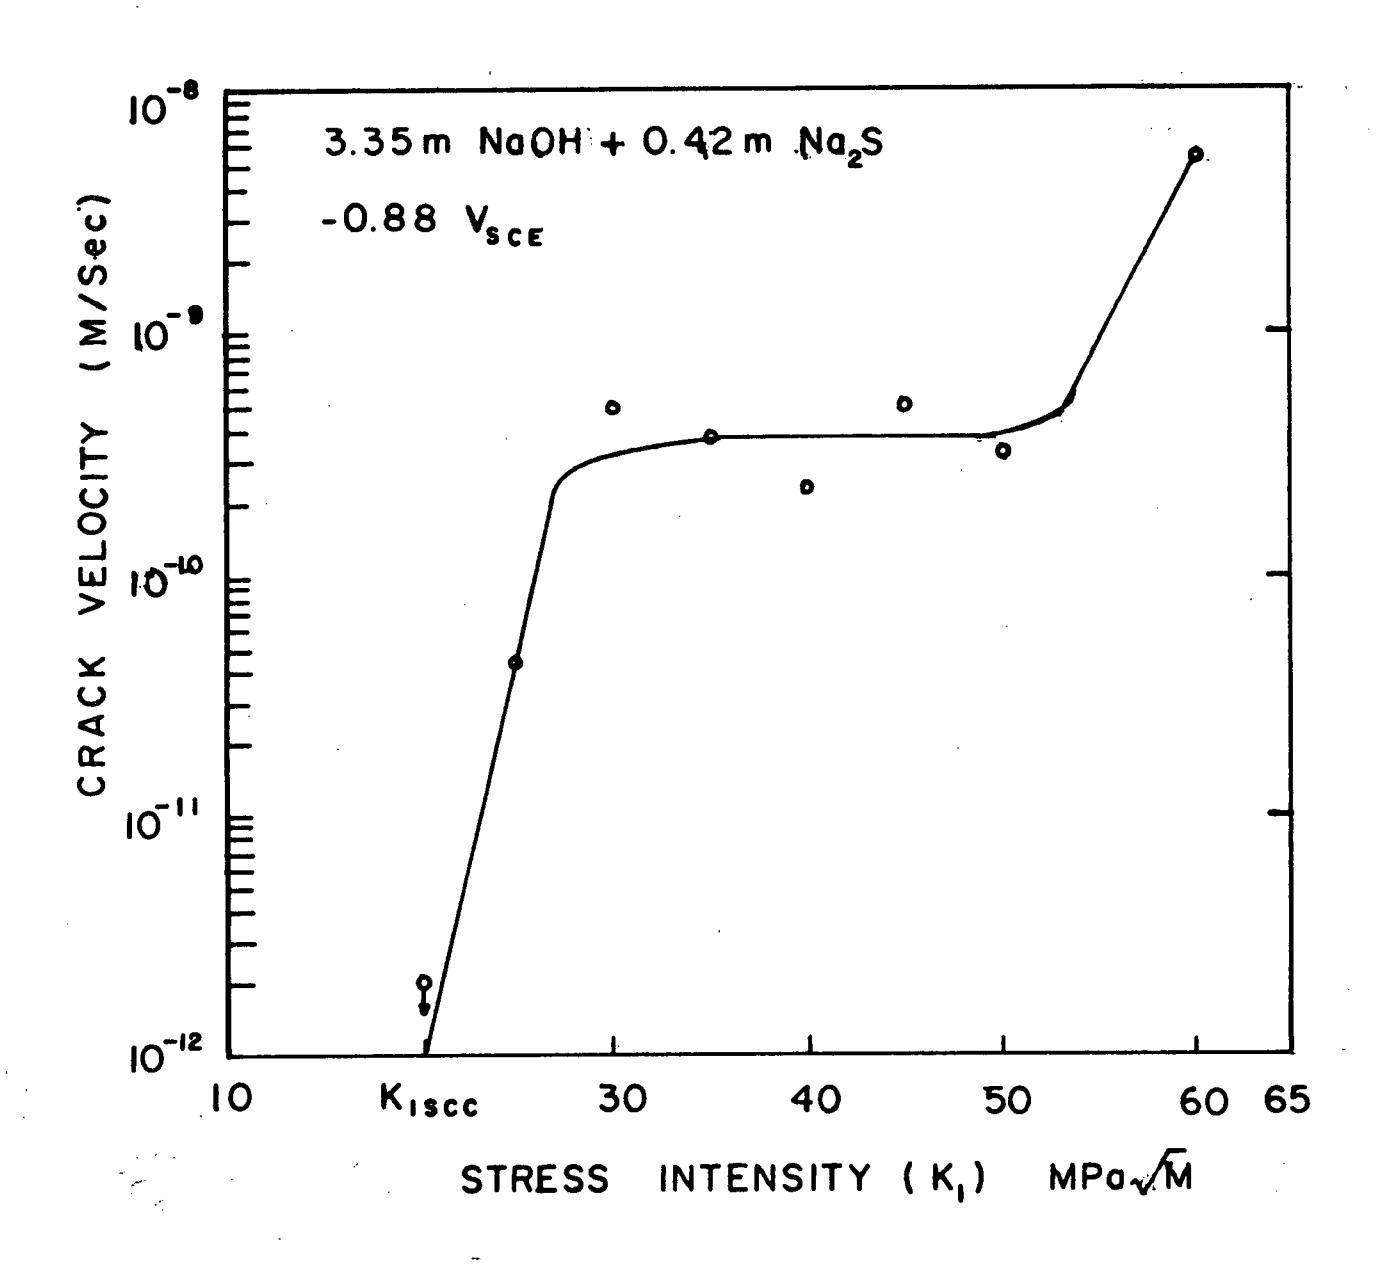
Figure 22 - Effect of stress intensity on crack growth in a 3.35 m NaOH + 0.42 m Na<sub>2</sub>S environment at  $-0.88 V_{SCE}$

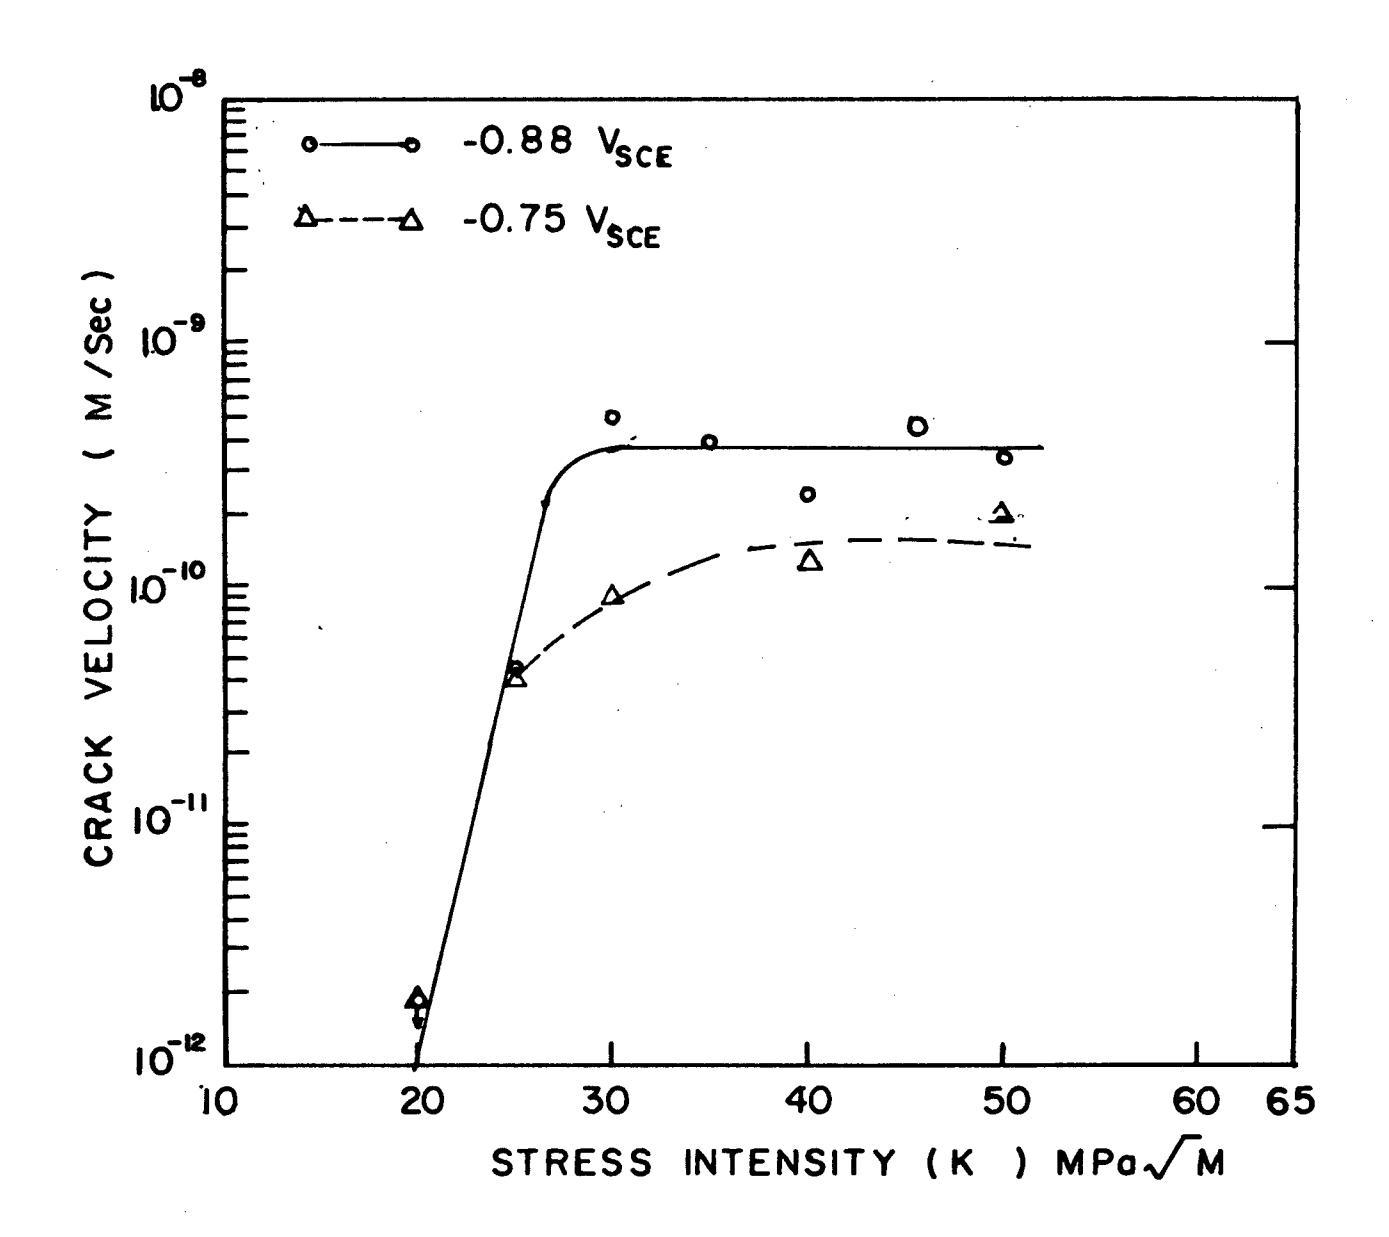
Figure 23 - Effect of potential on crack growth in a 3.35m NaOH + 0.42 m Na<sub>2</sub>S environment.
$V_{SCE}$  and 1.5 x  $10^{-10}$  m/sec at -0.75  $V_{SCE}$ , as illustrated in Fig. 23. Thus, the ratio of the stage II velocities at -0.88  $V_{SCE}$  and -0.75  $V_{SCE}$  was found to be 2.6, which compared favourably with the ratio of the apparent crack velocities at the aforementioned potentials, obtained from the SSRT tests, which was found to be 2.35. Also, the threshold stress intensity for crack propagation was not significantly affected by a change in potential.

DCB specimens were tested at -0.88  $V_{SCE}$  and -0.75  $V_{SCE}$ , i.e., potentials corresponding to the active-passive transition zone, and the passive zone of the anodic polarization curve respectively. The threshold stress intensities for SCC, at both the above mentioned potentials were found to be approximately 20 MPa/m. The stage II crack propagation rate was found to be approximately 4 x 10<sup>-10</sup> m/sec at -0.88

These results suggest that digester cracking rates could be reduced by at least a factor of 2, by imposing an anodic protection potential of -0.75  $V_{SCE}$ , where the current requirement is not excessive.

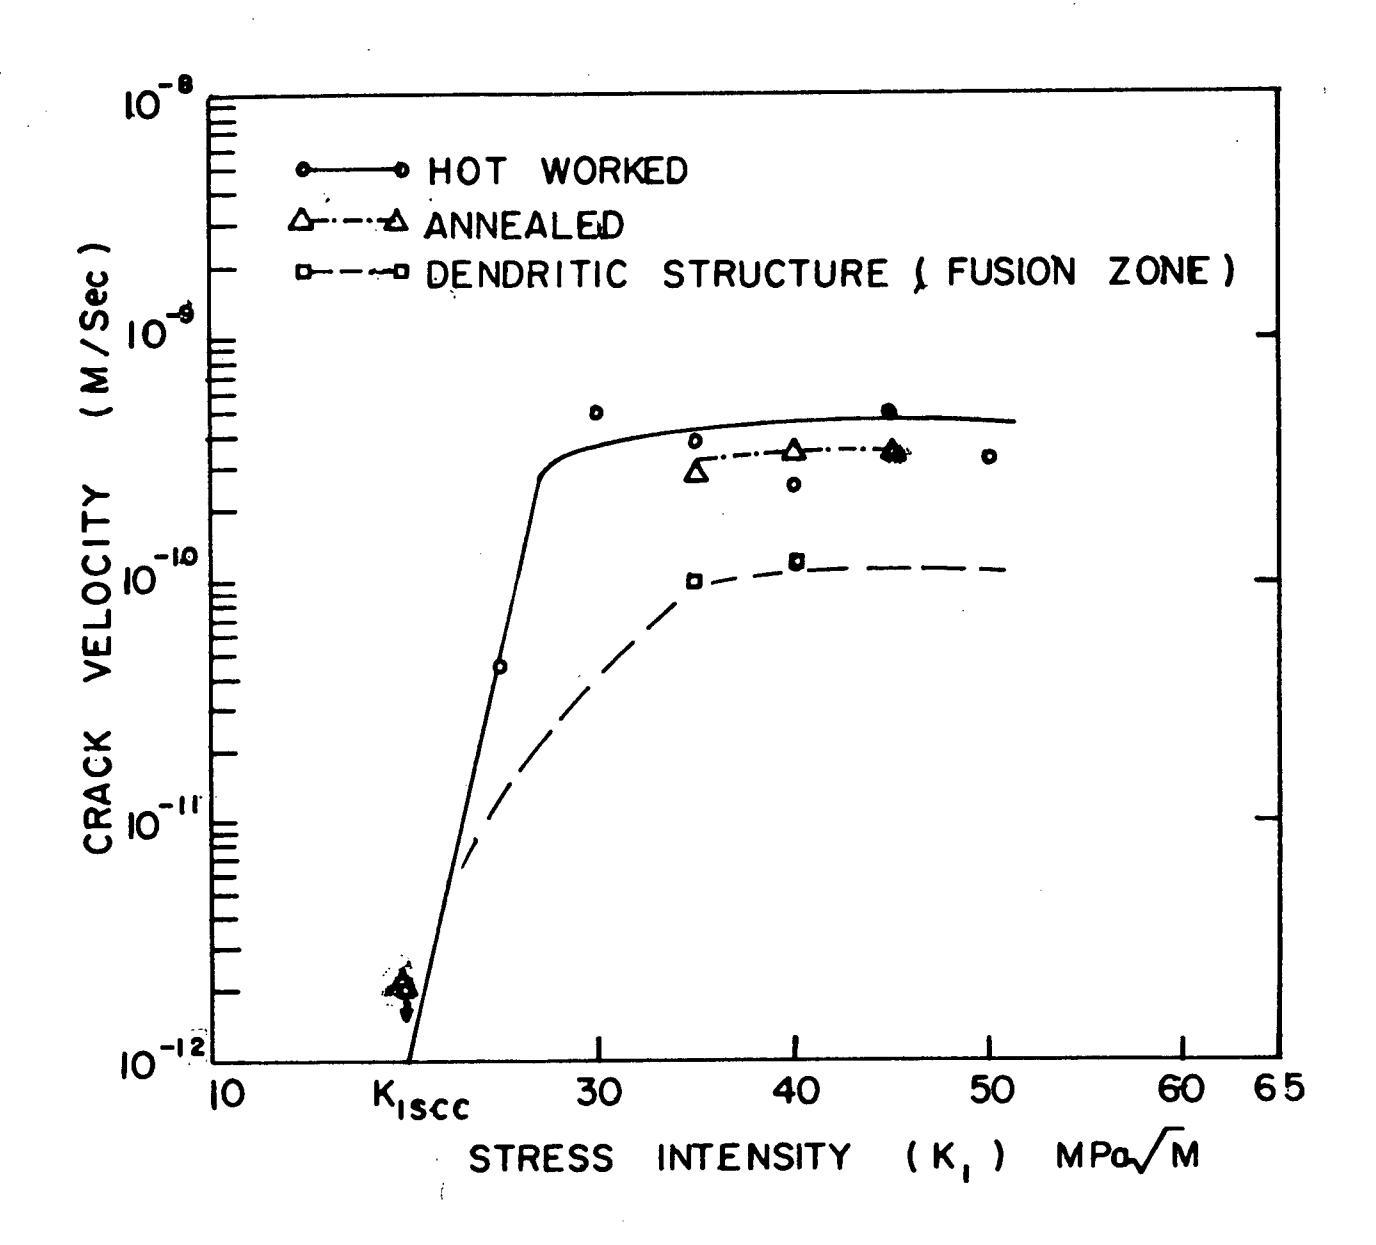
Figure 24 - Effect of microstructure and heat-treatment on crack propagation in a 3.35m NaOH + 0.42m Na<sub>2</sub>S environment.

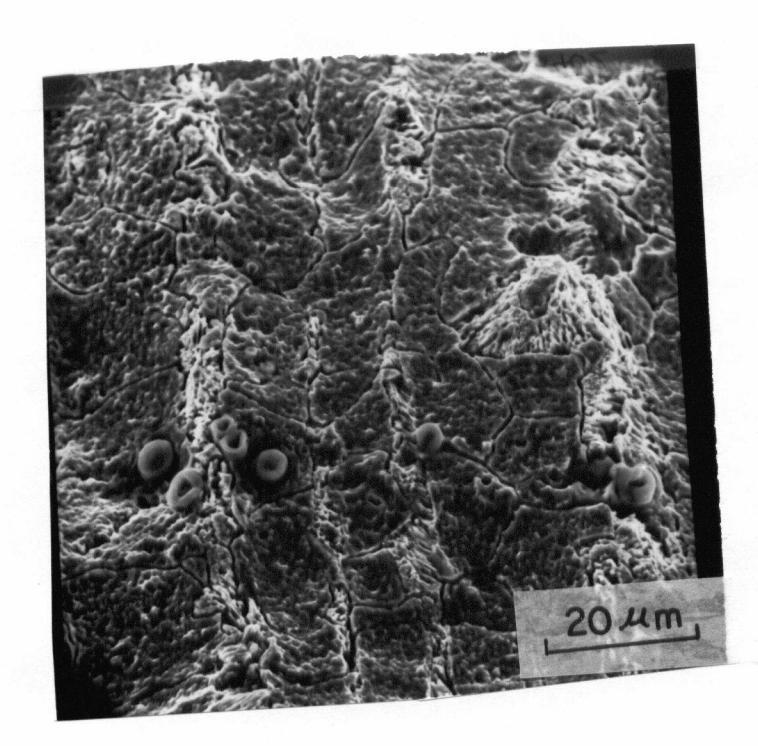
Figure 25 - Fatigue surface, on the DCB specimen, showing evidence of etching

discernable from the SCC crack. The fatigue surface was featureless, and had retained its original banded structure. Evidence of etching of the surface by the environment was visible, as illustrated in Figure 25. In contrast, the zone of overload failure showed a brittle, transgranular mode of failure, as illustrated in Fig. 26.

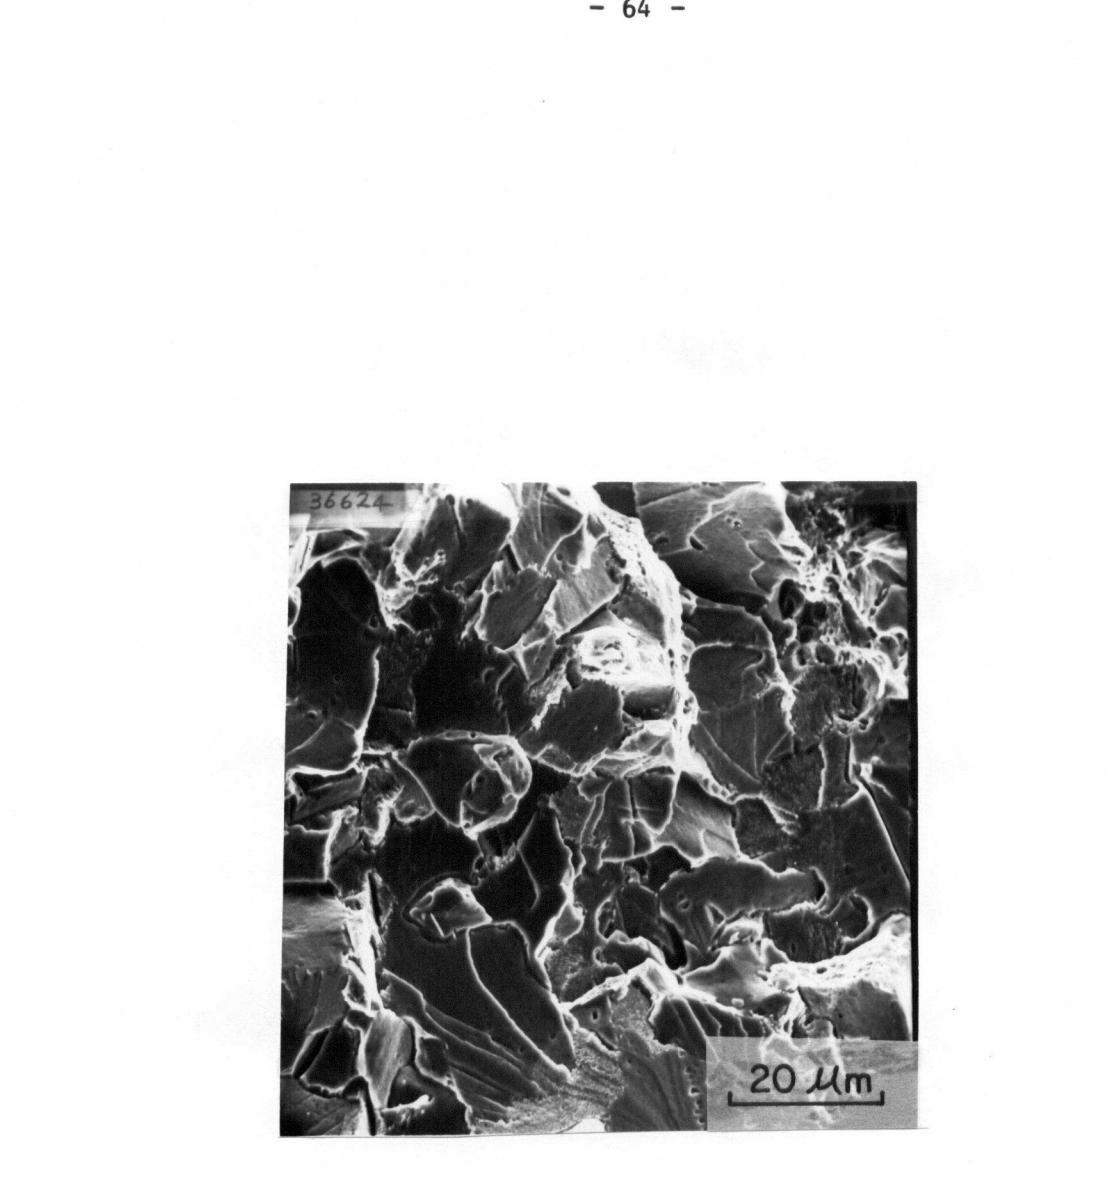
Figure 26 - Brittle overload failure zone, showing a transgranular mode of failure

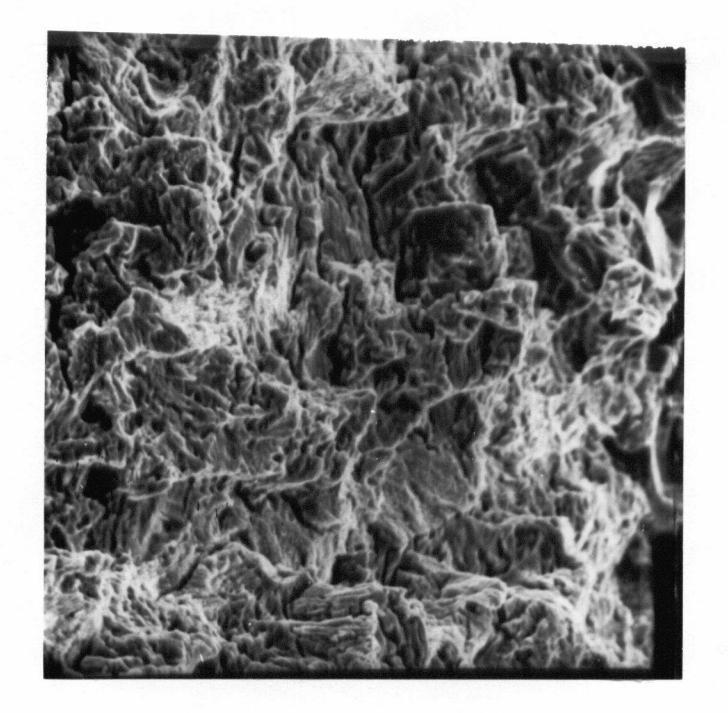
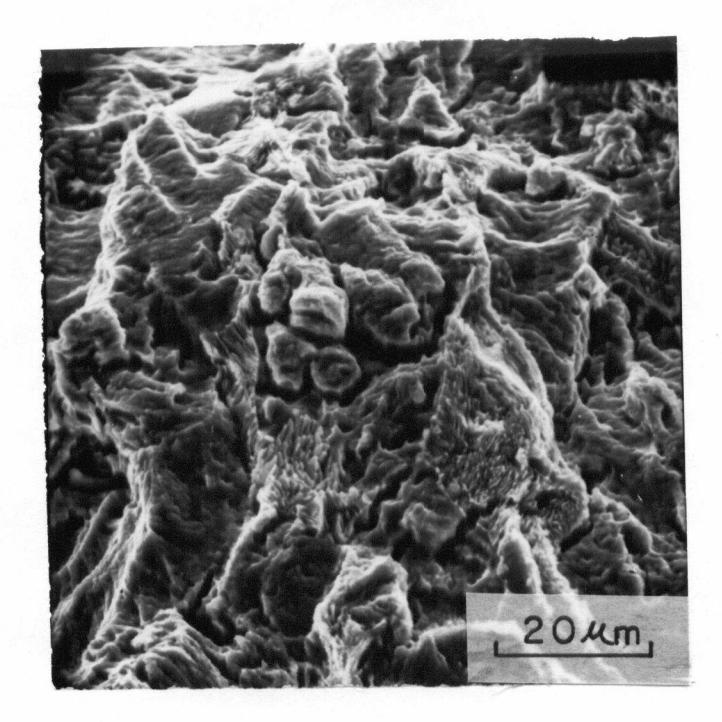
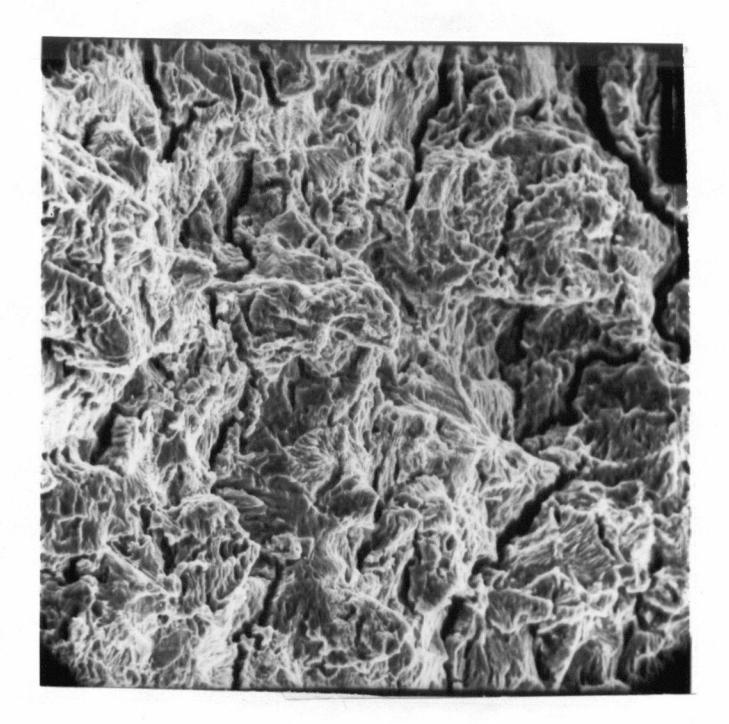
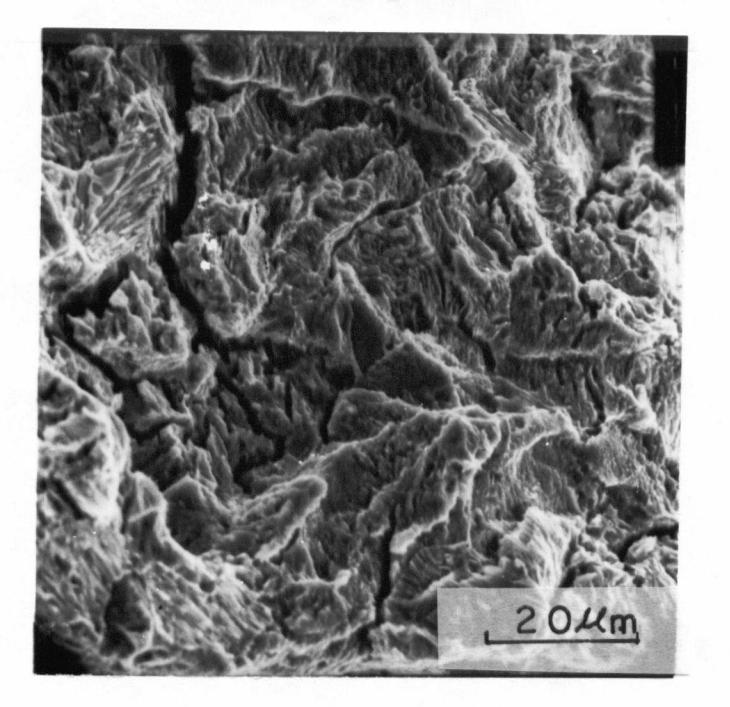
Figure 27 - Variation of fractography with stress intensity in a 3.35 m NaOH + 0.42 m Na\_2S environment at -0.750  $\rm V_{SCE}$

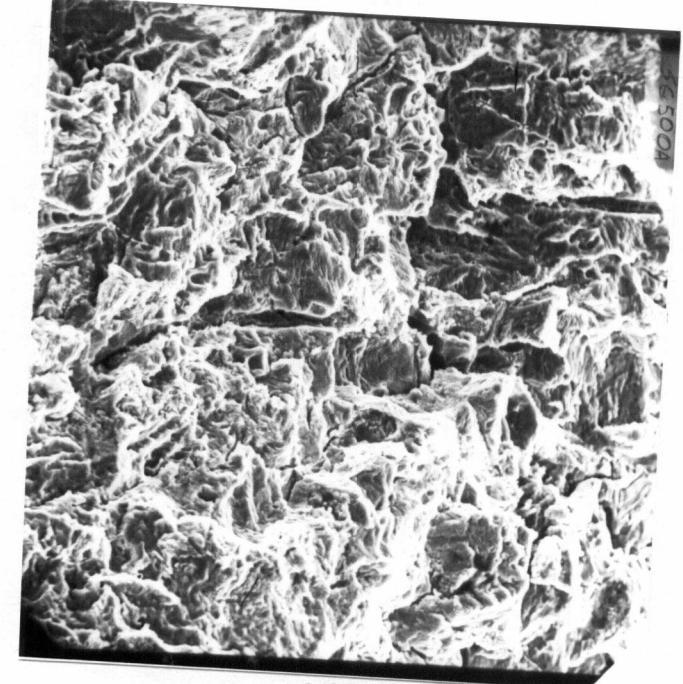
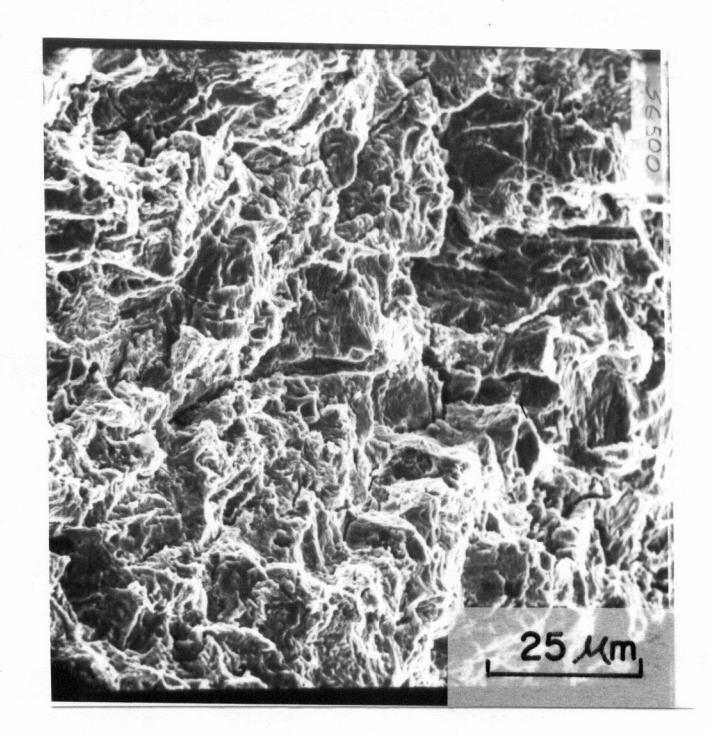
Figure 28 - Stereographic photographs of crack front at 40 MPa/m, -0.75  $V_{\rm SCE}$

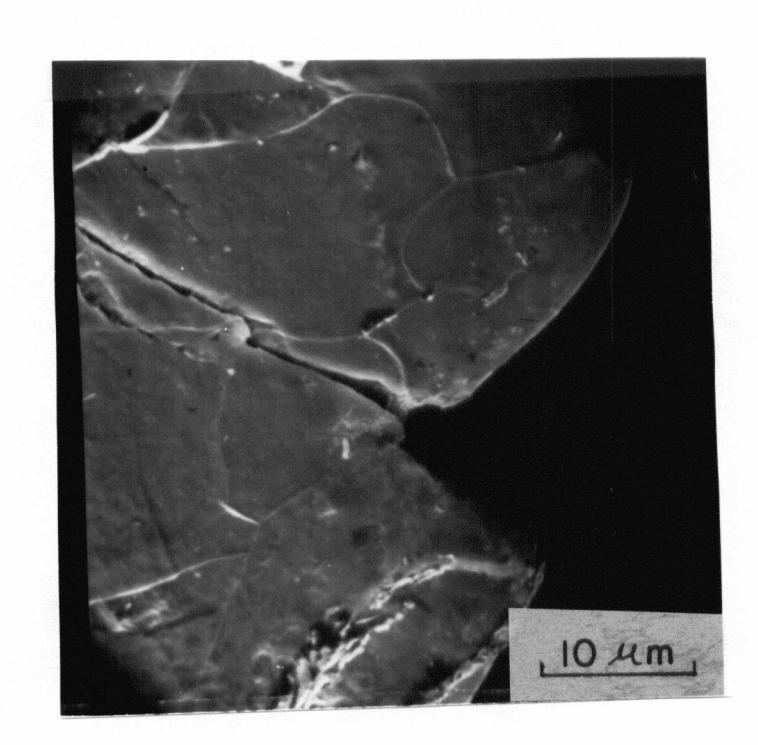
Figure 29 - Transgranular secondary cracks at 40 MPa/m,  $-0.75~\rm V_{SCE}$

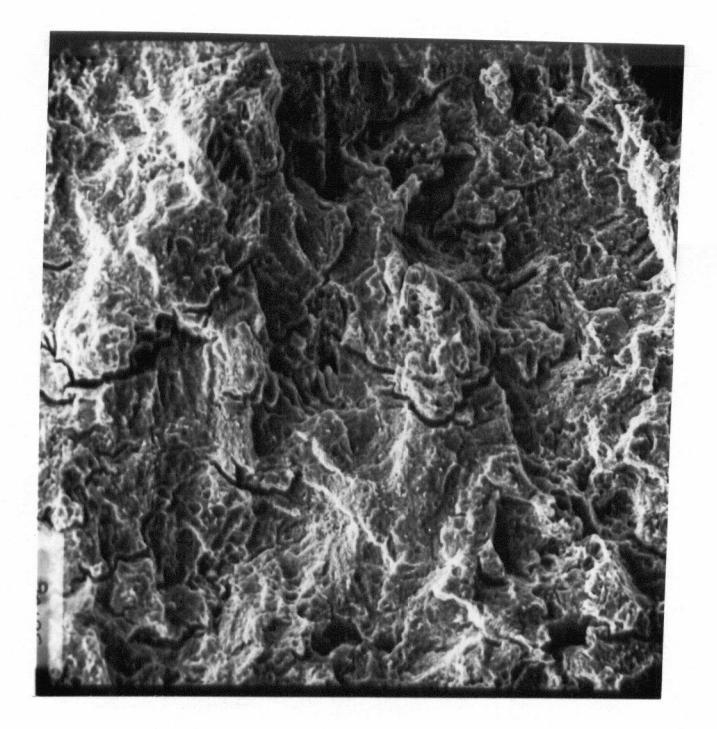
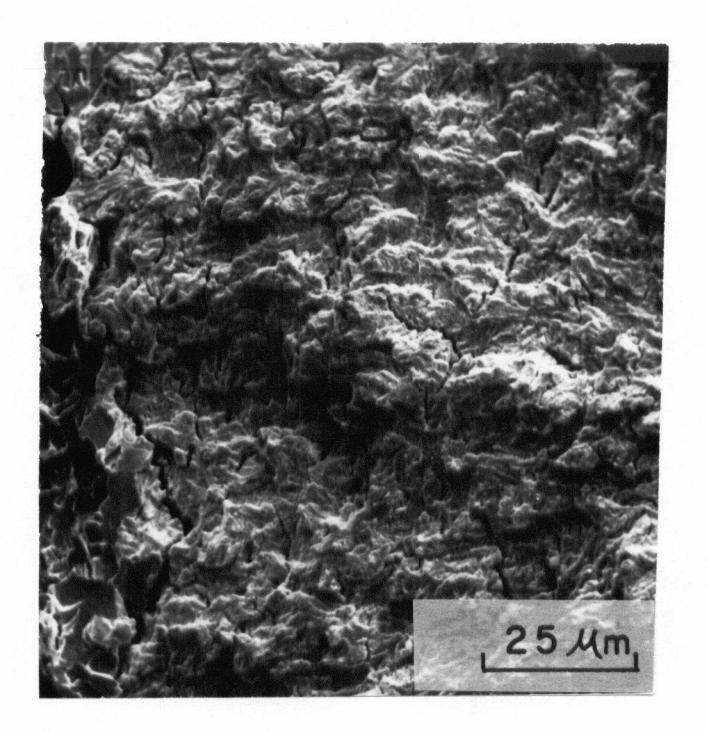
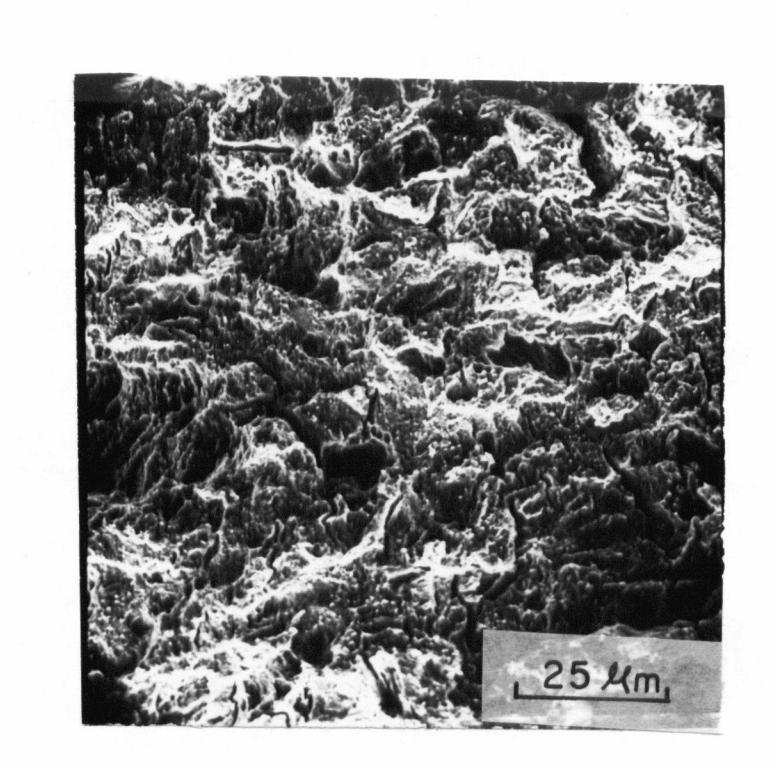
Figure 30 - Variation of fractography with stress intensity in a 3.35 m NaOH + 0.42 m Na\_2S environment at -0.88  $\rm V_{SCE}$

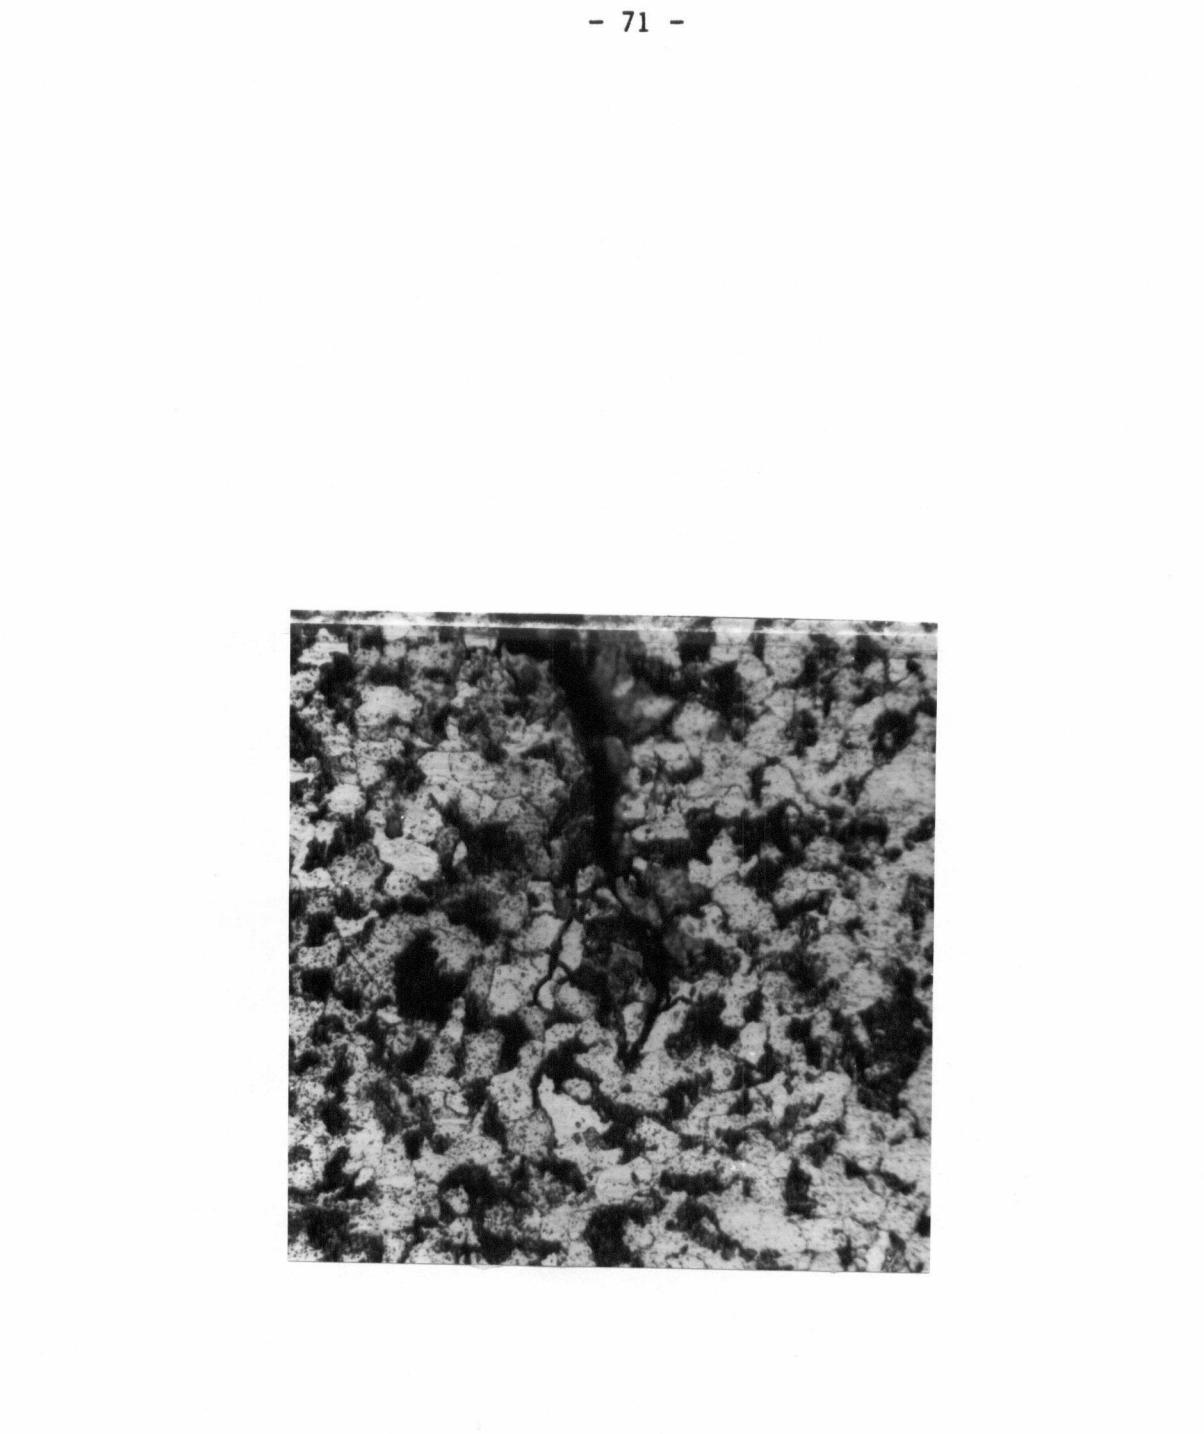
Figure 31 - Intergranular crack path at 40 MPa/m, -0.88  $V_{\rm SCE}$

primary and secondary crack perpendicular to the crack plane, before the sample was fractured in a liquid Nitrogen environment, as illustrated in Fig. 31. Examination of stereo photographs of the stress corrosion crack front revealed a mildly faceted topography, as illustrated in Fig. 32a-b. secondary cracks, which were intergranular in nature were visible, as illustrated in Fig. 33.

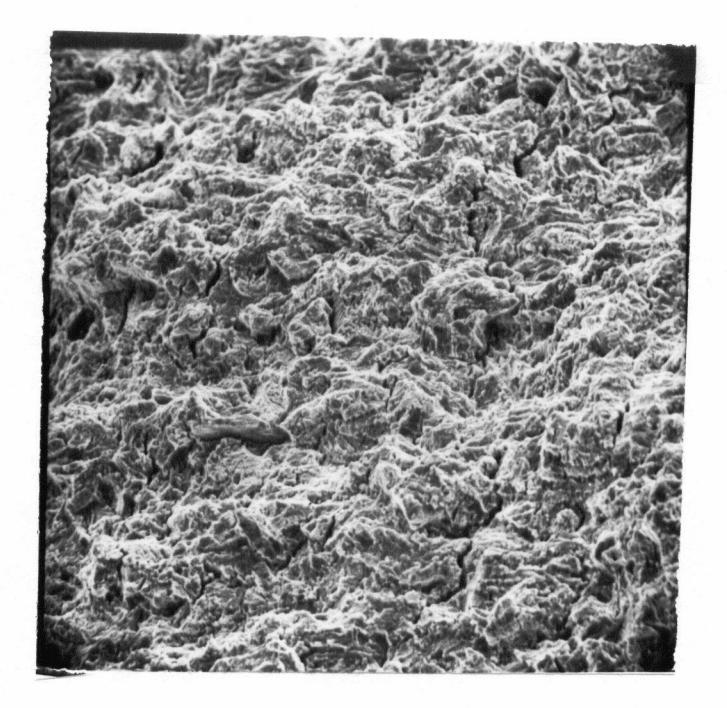
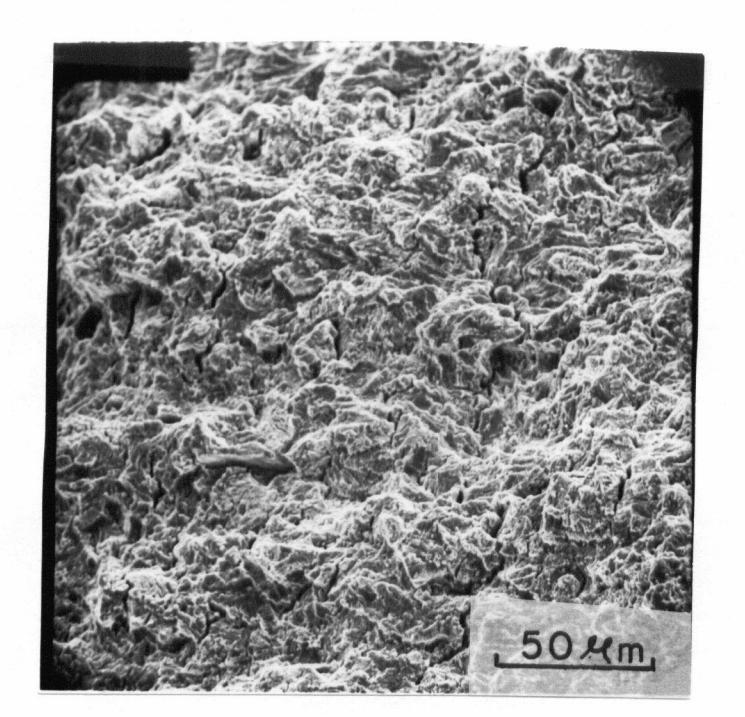
Figure 32 - Stereographic photographs of crack front at 40 MPa/m, -0.88  $V_{\rm SCE}$

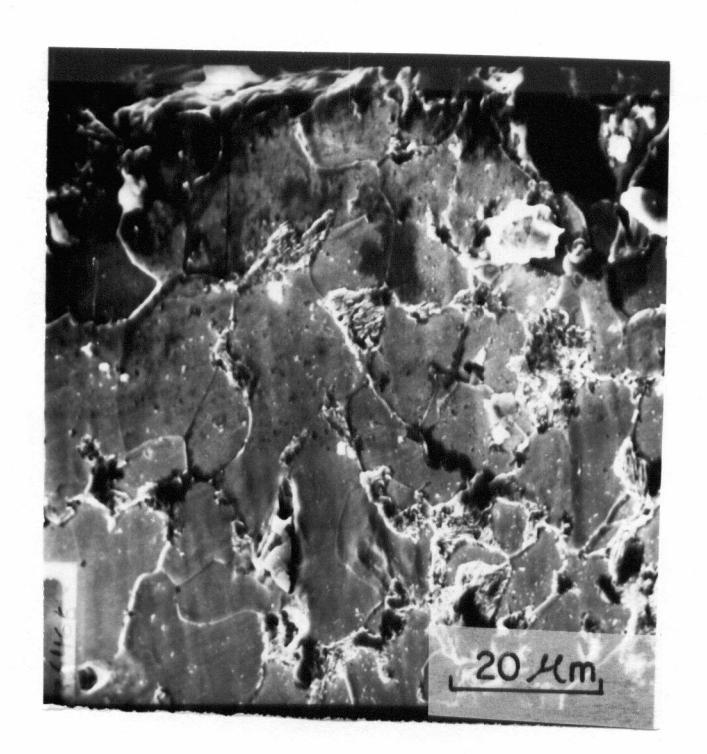
Figure 33 - Intergranular secondary cracks at 40 MPa/a,  $-0.88~V_{\rm SCE}$

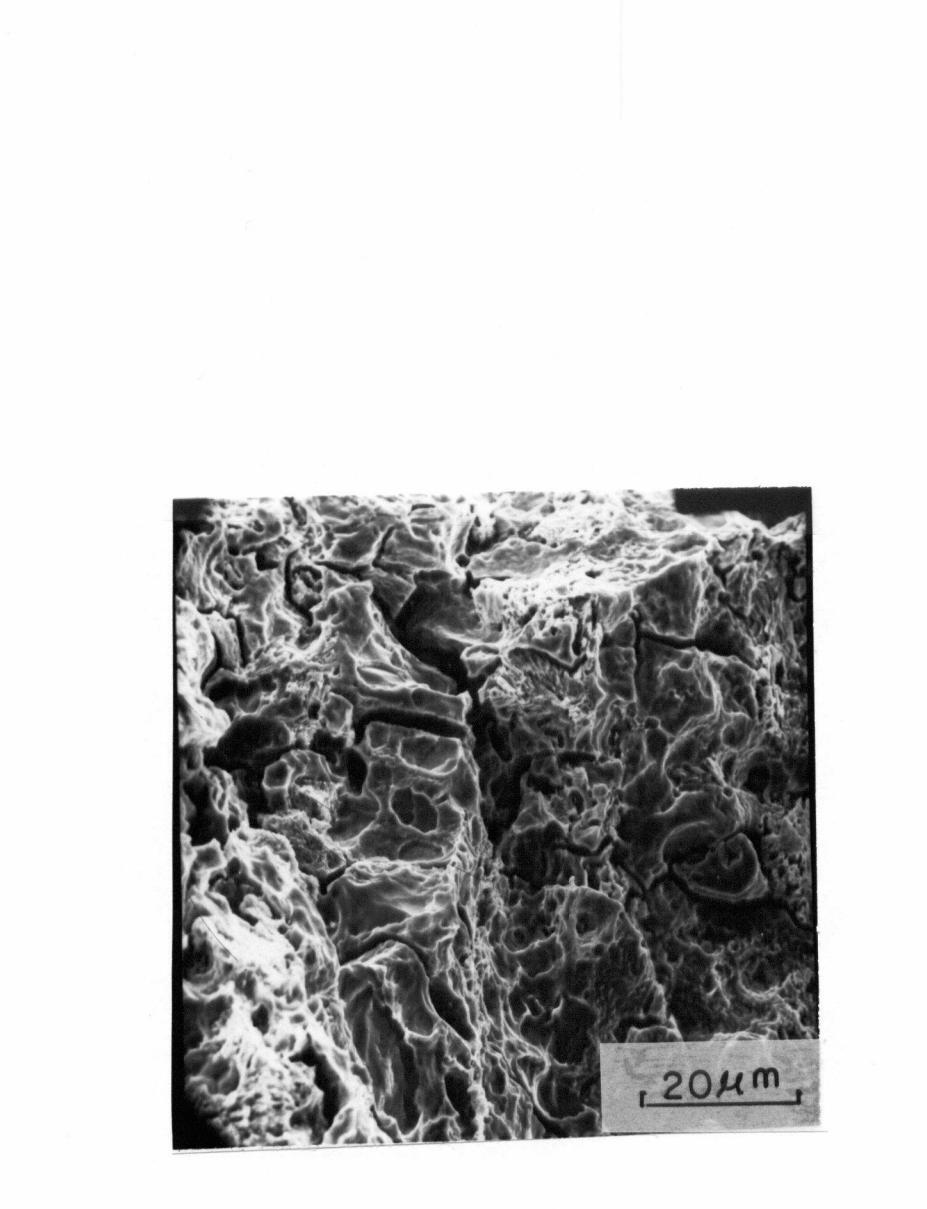
Figure 34 - SCC crack front in the heat treated specimen at 40 MPa/m, -0.88  $\rm V_{SCE}$

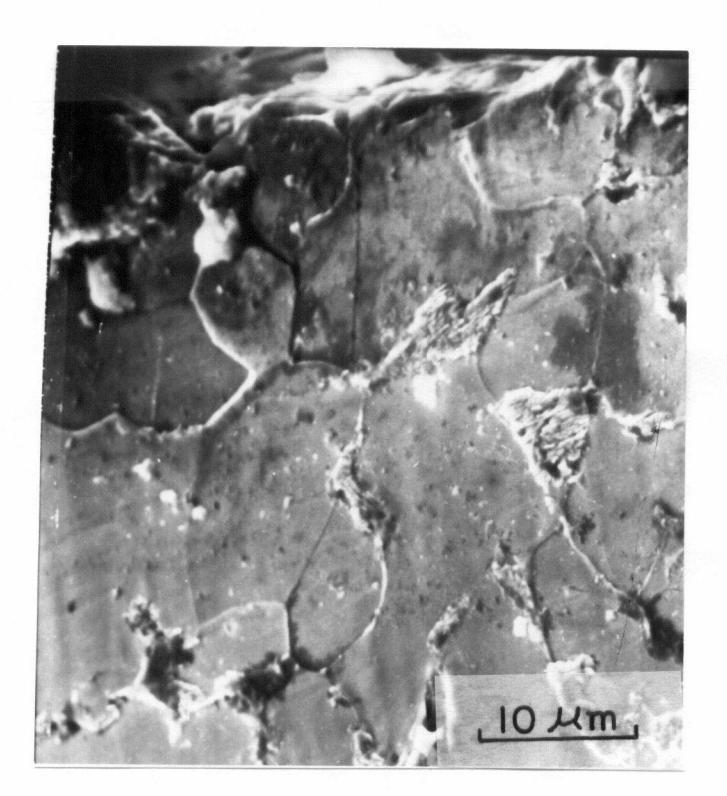
Figure 35 - Intergranular secondary cracks in heat treated specimen at 40 MPa/m, -0.88  $\rm V_{SCE}$

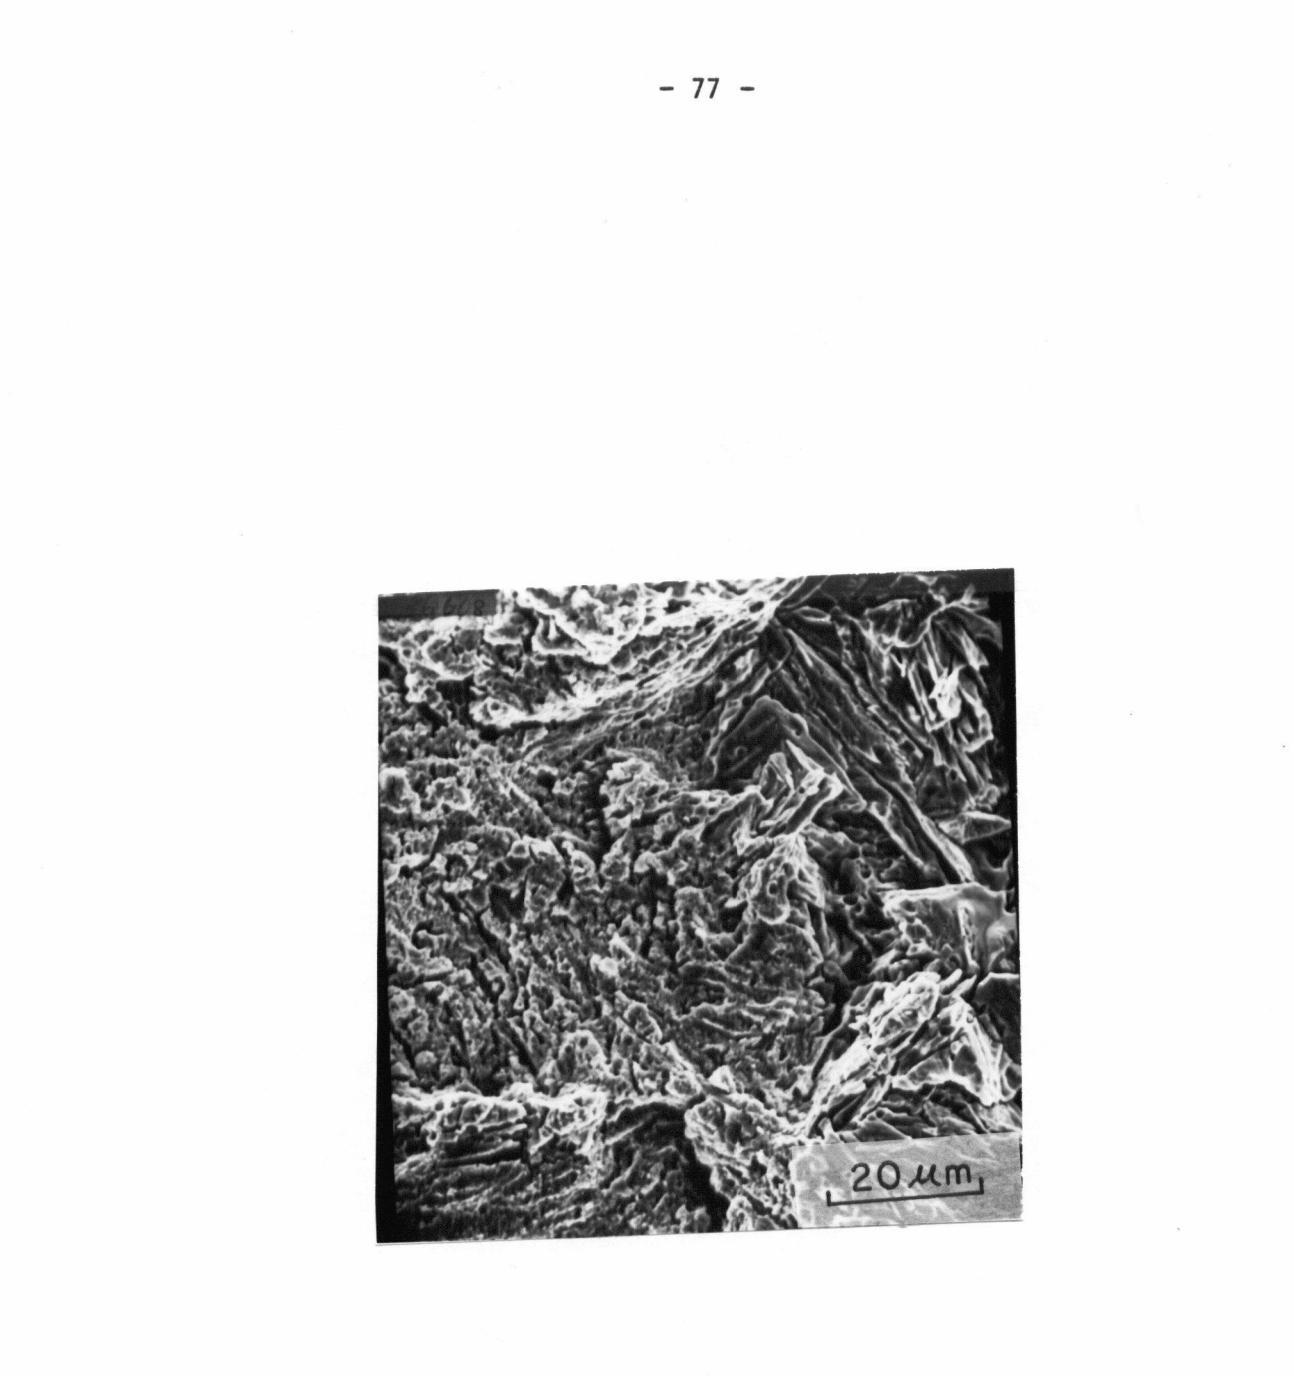
Figure 36 - Fractograph of DCB specimen incorporating a weld, indicating the crack front and the overload region.

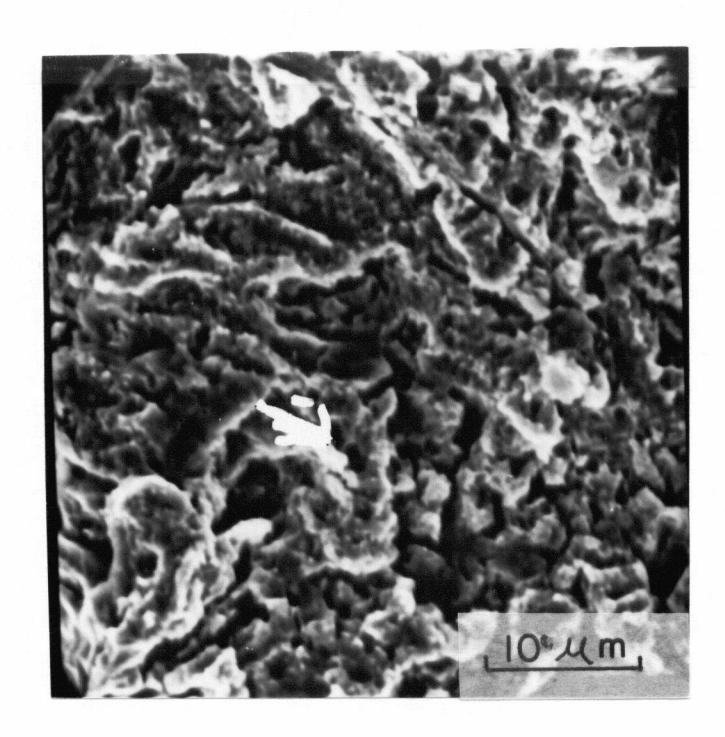
Figure 37 - SCC crack front in the DCB specimen incorporating a weld
