### CAUSTIC CRACKING SUSCEPTIBILITY OF SAE A 516 Gr. 70 STEEL

### IN ALKALINE SULPHIDE SOLUTIONS

A THESIS IN PARTIAL FULFILLMENT OF

DEPARTMENT OF METALLURGICAL ENGINEERING

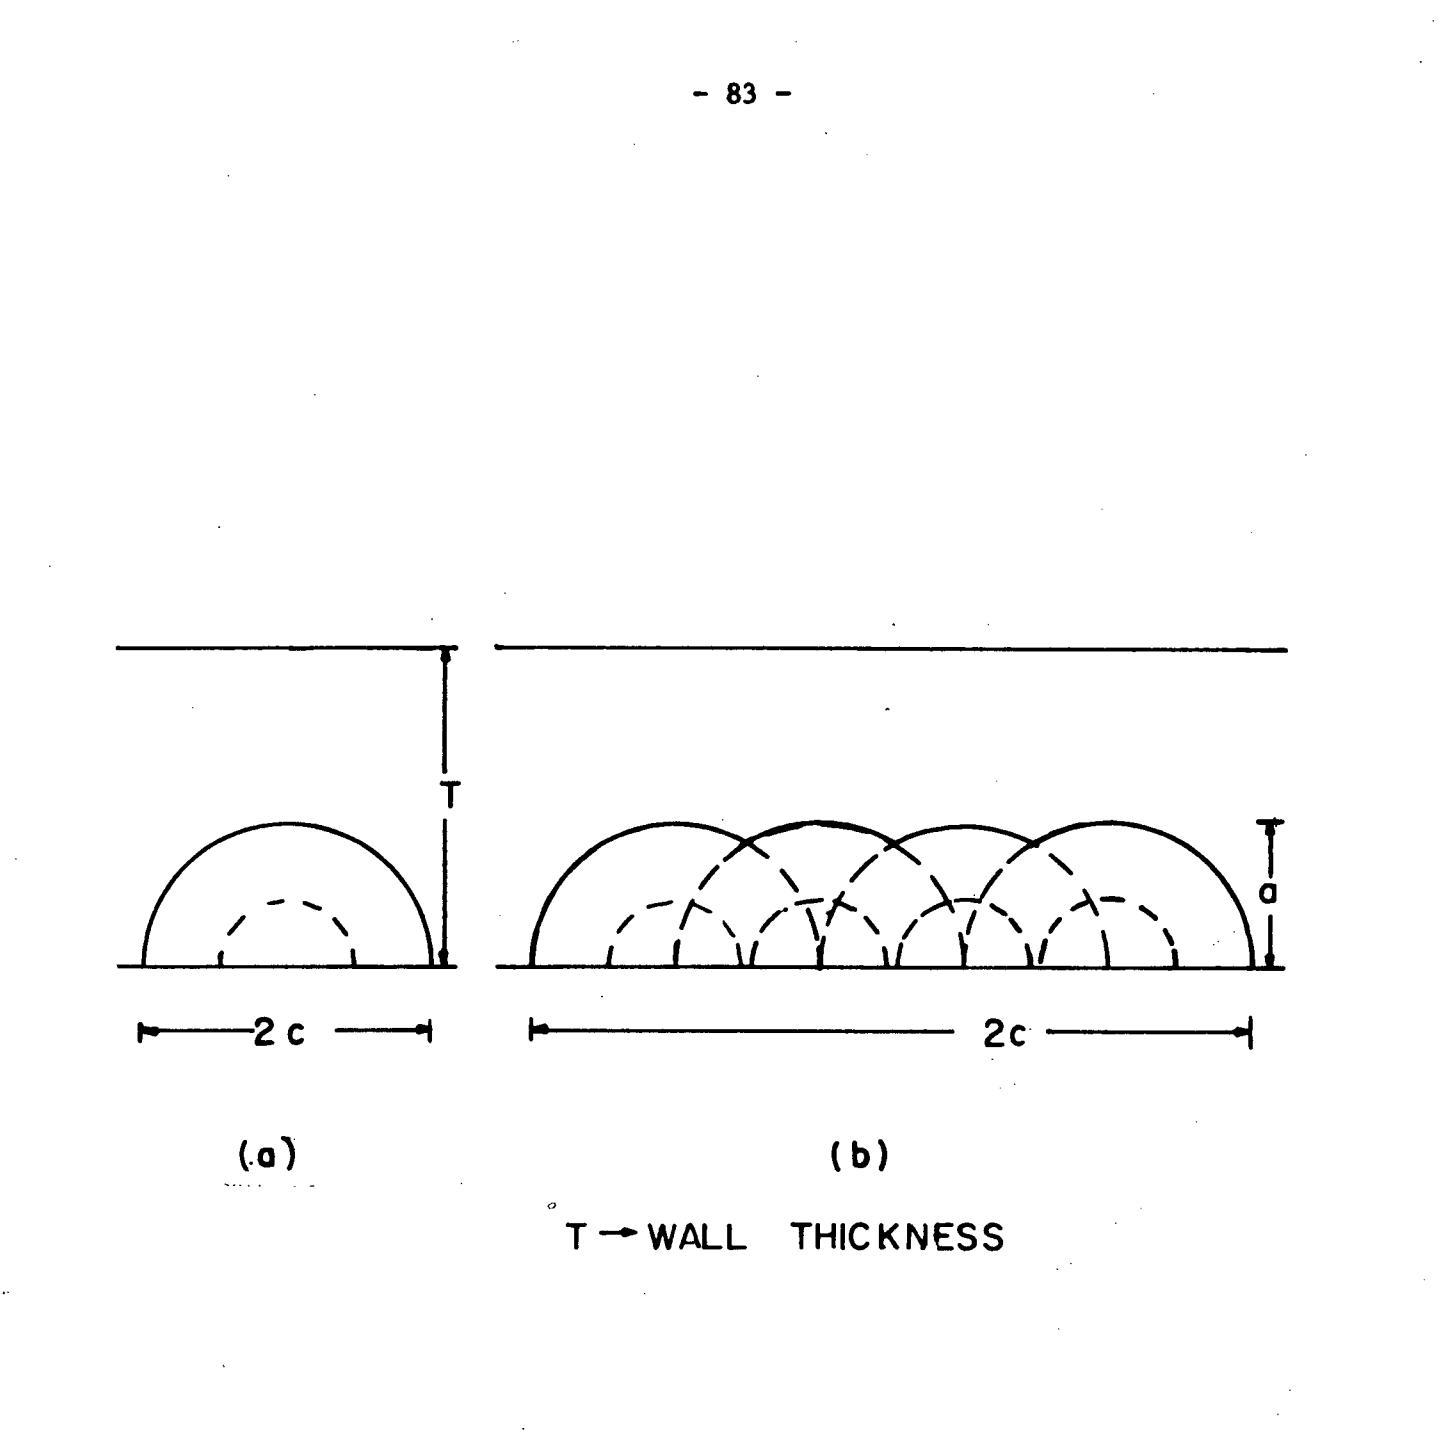
Figure 38 - Proposed mode of propagation of flaws in the digester wall

The driving force for the propagation of this flaw would be provided by a tensile, hoop stress,

$$\sigma_{\rm HOOP} = \frac{PD}{2t} \tag{8}^{55}$$
