International tailings failures and best available technology

Jeremy Boswell and John Sobkowicz
Thurber Engineering, Canada

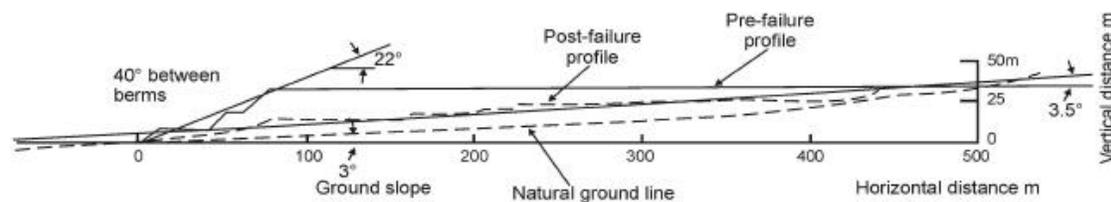
The sketch below from Blight & Fourie (2003) shows a pre-failure embankment slope angle of 22 degrees flattened to no more than 3.5 degrees post failure on the El Cobre old dam. The natural ground slope was only 3 degrees.

Figure 1. Pre-and post-failure profiles of El Cobre old dam (from Blight & Fourie [2003])

As a result of the El Cobre failure, in 1970 the Chilean authorities intervened by issuing a decree (Decree No. 86) which imposed far reaching effects on Chilean tailings practice. Among the many changes were abolition of the upstream construction method for tailings dams, and requirements to apply the laws of soil mechanics to tailings dam construction (Cabrera, 2011).

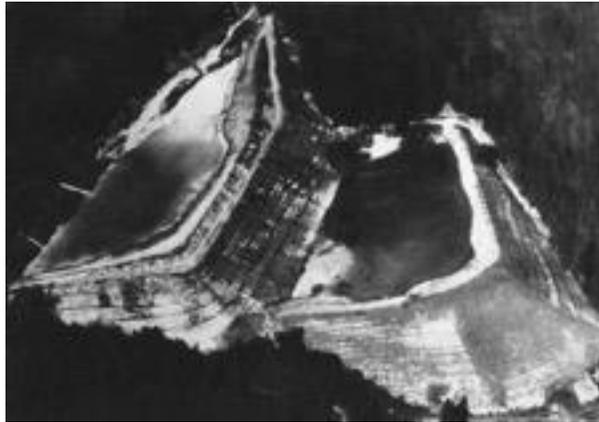
Figure 2. Aerial view of the dams at Stava before failure (ref Foundation Stava 1985'
<http://www.stava1985.it/>)

According to the subsequent inquiries, the collapse was caused by the chronic instability of the dams, especially in the upper one, which were below the minimum factor of safety required to avoid collapses. The upper basin measured 34 metres in height and was built at an angle of 40 degrees as an upstream tailings dam, on natural ground whose slope was approximately 25 percent.

The Commission further found “the decision to enlarge the bank according to the upstream method, which was the quickest and most inexpensive, but also the most dangerous”.

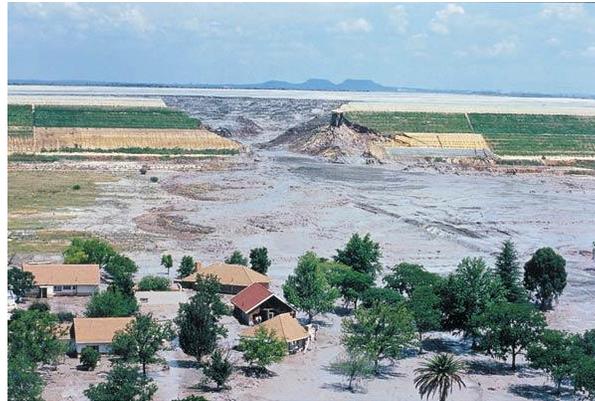
On the night of 22 February 1994 a 31 m high tailings dam upslope of Merriespruit, a suburb of the town Virginia, failed with disastrous consequences (Wagener et al, 1997). The dam failed a few hours after 30 to 50 mm of rain fell in approximately 30 minutes during a late afternoon thunderstorm. The failure resulted in some 600 000 m³ of liquid tailings flowing through the town, taking the lives of 17 people and causing wide-spread devastation of property and environmental damage.

Static liquefaction during undrained loading of the Merriespruit tailings contributed substantially to the catastrophic flow slide that occurred in February 1994 (Fourie et al, 2001). Why previous incidents of slope failure or overtopping of gold tailings dams in South Africa did not also result in catastrophic flow-slide failures was that much of the Merriespruit tailings were in an intrinsically unstable state in situ prior to the failure. The underlying cause was the same

Figure 3. Merriespruit tailings failure (www.infomine.com)

The Merriespruit disaster provided an impetus for both the South African mining industry and the state to take a more responsible and serious approach to disposal of tailings (Wagener et al, 1997). A fundamental re-assessment of the philosophies for design, management and operation of tailings dams was initiated in South Africa. The mining industry began to carry out independent self-audits, viewing tailings dams and associated problems far more seriously than in the past. In 1995, work started to draft an obligatory Code of Practice for the design, operation management, rehabilitation and closure of tailings dams. It was published in 1998 as SABS 0286: Code of practice for mine residue.

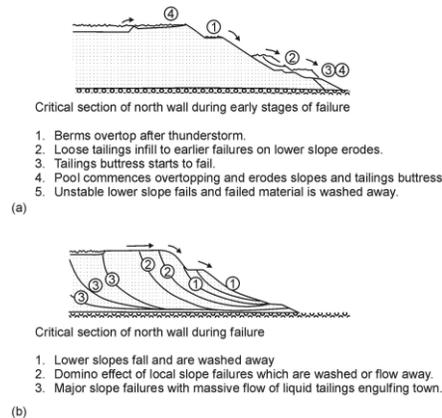
Figure 4. Merriespruit progression of failure (Blight & Fourie, 2000)

In comparison with other catastrophic tailings failures, the tailings volume released at Merriespruit was relatively small (600 000 m³). However, there were many grievous human errors that contributed further to the severity and consequences of the failure:

- The design decision to locate the recycle water dam upstream of the tailings facility, thus disallowing the gravity flow of supernatant and precipitation from the impoundment to the recycle water dam.
- The planning decision to allow the construction of a mine village immediately downstream of the tailings facility in the early planning stages of the mine.
- The operational decision to combine the upper and lower compartments of the facility years before the failure, by accelerating the rate of rise of the lower compartment.

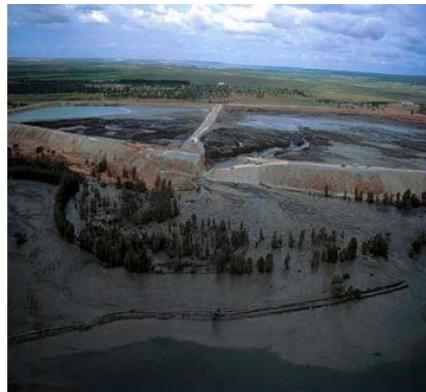
The 25-m-high dam rested on roughly 4 m of river-terrace alluvium underlain by 70 m of blue marl. At a depth of approximately 10 m into the marl, overstressing of the marl beyond its peak strength by construction-induced pore pressures allowed the dam, alluvium, and shallow marl to slide along a near-horizontal bedding plane to the east (Eptisa, 1998). This resulted in liquefaction of the pyrite tailings, which in turn increased the loading on the dam as the foundation resistance was decreasing. These processes accounted for the 60 m horizontal displacement of the dam, which is considered unusually high. Other factors like earthquakes, blasting, acidic drainage, and seepage of groundwater were ruled out as contributors to the dam failure.

Figure 5. Los Frailes tailings failure (Ref http://en.wikipedia.org/wiki/Dam_failure)
